AFRL-VA-WP-TR-2002-3032

**CORROSION MORPHOLOGY IN
LAP JOINTS**

JUNE 2000

Final Report for 01 April 1999 – 31 May 2000

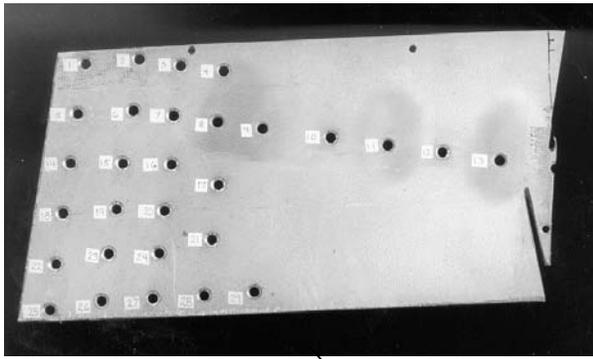
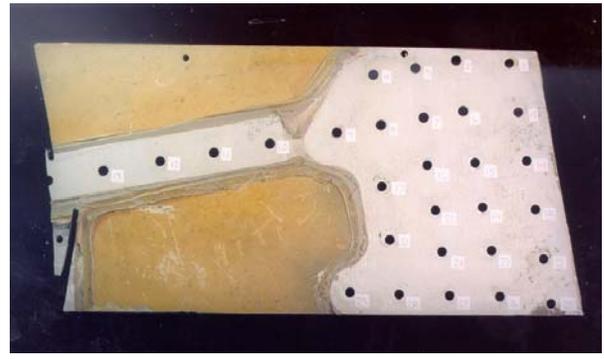
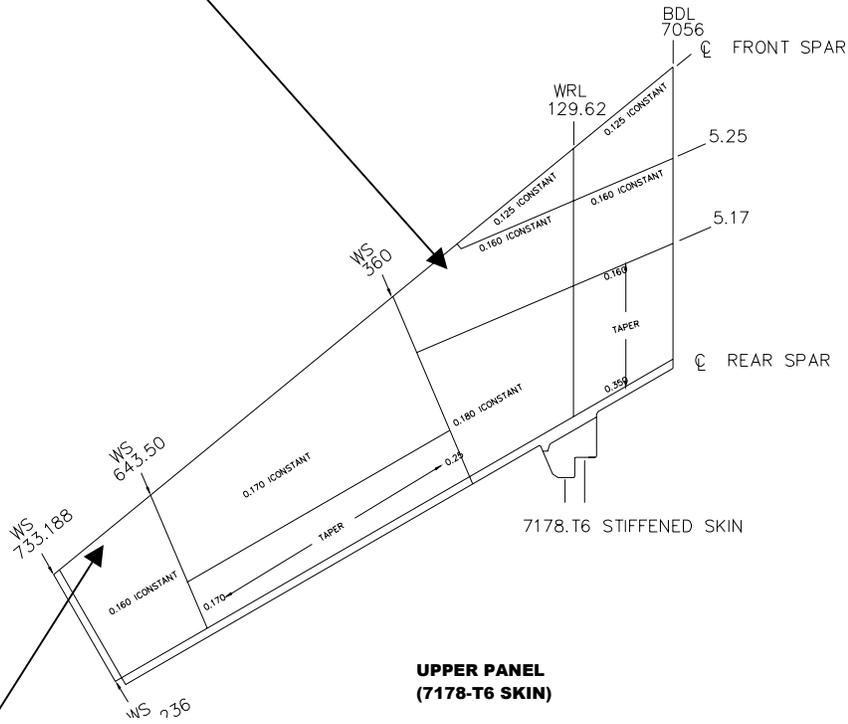
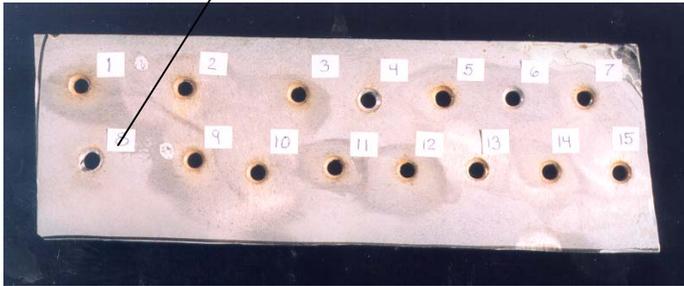
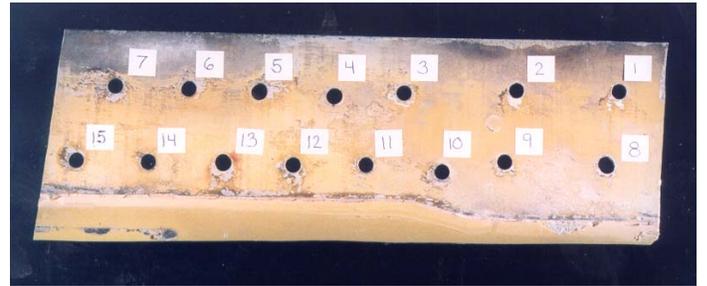
The photographs in Figure 1 show cut sections viewed from the outside and inside of the wing. Clearly visible are the grindout marks at the fastener holes, which were made during maintenance to remove corrosion in these areas. Several metallographic cross sections were made in areas on the panels where significant corrosion was suspected. Selection of the areas for metallographic cross sectioning was guided by fastener holes and other locations with grindout indications. In areas where corrosion was observed on the metallographic cross sections, metallographic crosscuts were made so that three-dimensional montages of the corrosion damage could be produced.

Figure 1. Schematic Diagram and Sections of Upper Wing Skin Panel of KC-135 (A/C 69149)
 Photographs a and b show the exterior and faying surface of the inboard section.
 Photographs c and d show the exterior and faying surface of the outboard section.

The inboard upper wing skin section lap joint showed no evidence of corrosion on the exterior surfaces other than the grindout marks (see Figure 1). Little corrosion was found on the faying surface. Upon careful examination of the fastener holes, metallographic cross sections were made at those locations where corrosion was visible. Figure 5 shows a three-dimensional montage of a section through the lap joint. It indicates the presence of only minor exfoliation near the exterior surface. Small corrosion penetrations also were observed on the walls of the fastener holes. Figure 6 shows an example of a fastener hole corrosion where both pitting and exfoliation were present just below the fastener hole chamfer.

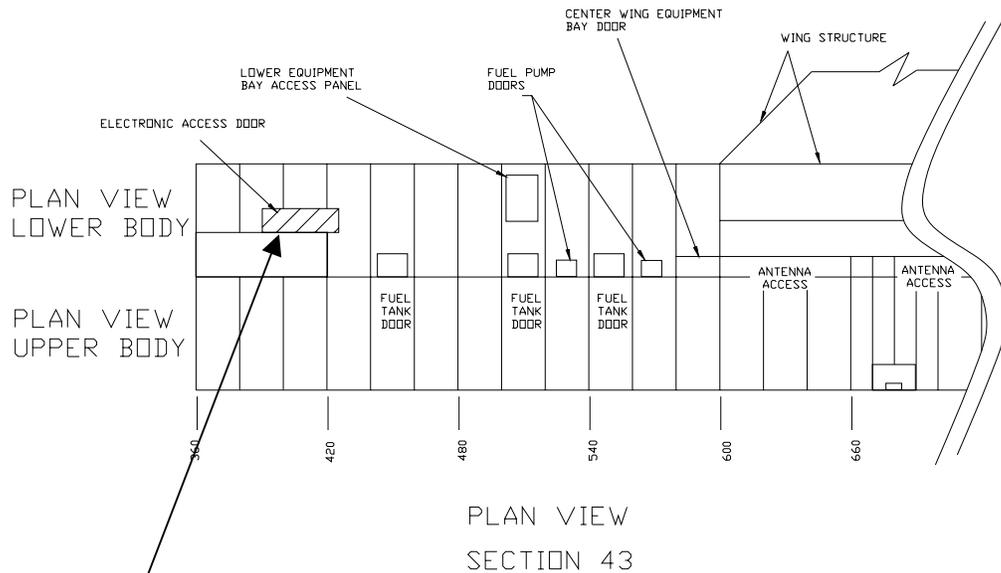
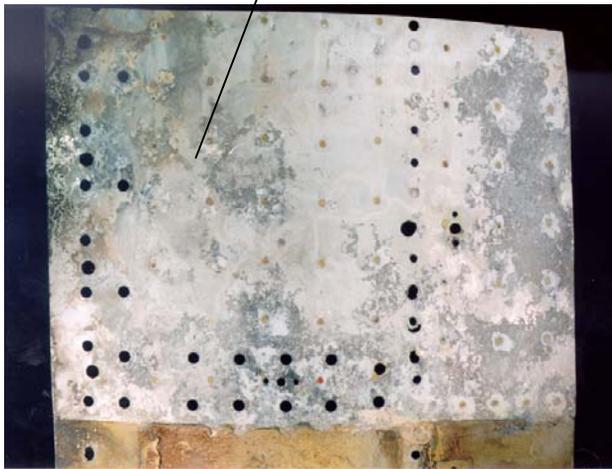
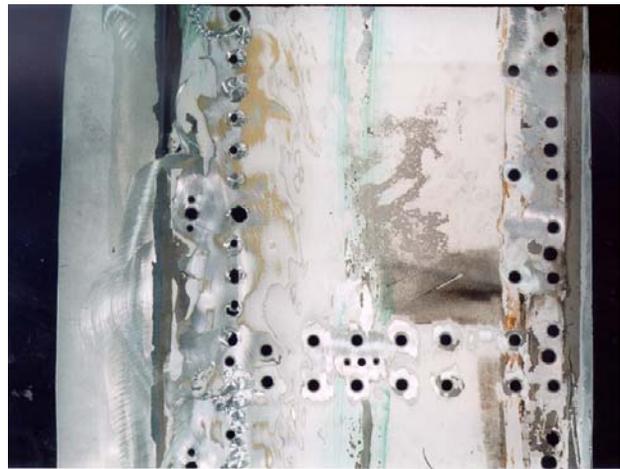
A fuselage lap joint section was removed from the fuselage adjacent to a manhole at BS 420 and S28 of A KC-135 (A/C 69149) (see Figure 2). Again, several areas could be identified where the material was ground off in an apparent attempt to remove corrosion. Based on the location of the ground areas and the amount of corrosion found on the faying surface, areas for metallographic examination were selected.

Figure 2. Schematic Diagram of Fuselage Section of KC-135 (A/C 69149) with the Cutout Section Indicated by the Arrow
 Photographs a and b show the matching faying surface and exterior surface of the section.

Examination of the 2024-T3 aluminum alloy lap joint sections in Figure 2 show the extensive grinding on the exterior surface and the presence of large amounts of corrosion products on the faying surface. In fact, when the lap joint panels were separated, powdery corrosion products that had build up in the joint fell out. Microscopic examination of metallographic cross section at various locations on the joint indicated that the alloy 2024 sheet contained clad on both sides and that the corrosion products had resulted from corrosion of the aluminum clad layer. Examination of several micrographs, such as shown in Figure 15, indicated extensive corrosion of the clad layer on the faying surface, but no corrosion in the 2024-T3 core material. It was further noted that corrosion of the clad was not uniform, but that shallow pits coalesced resulting in a scalloped surface texture.

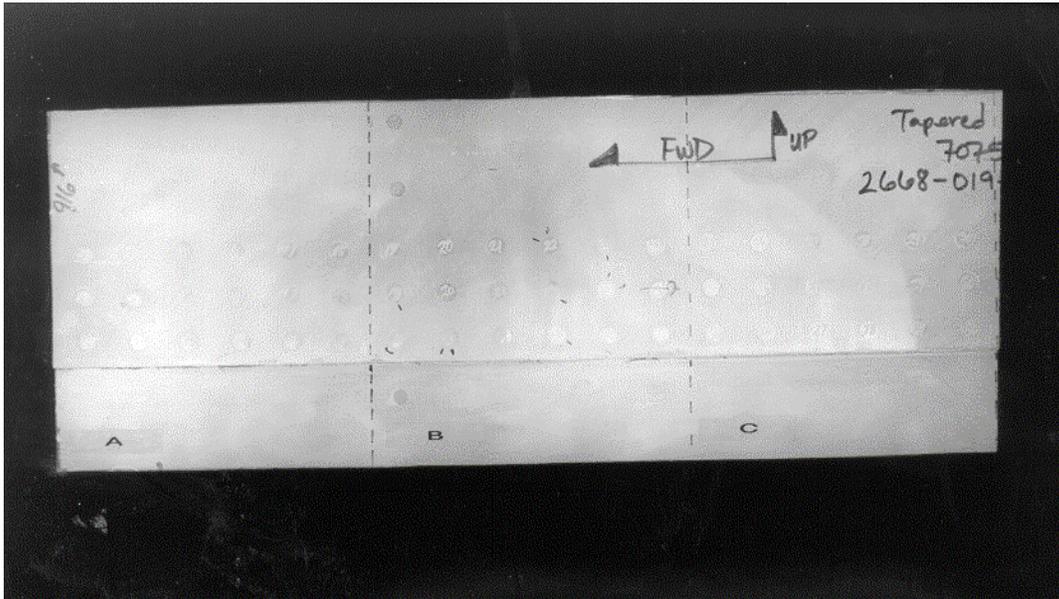
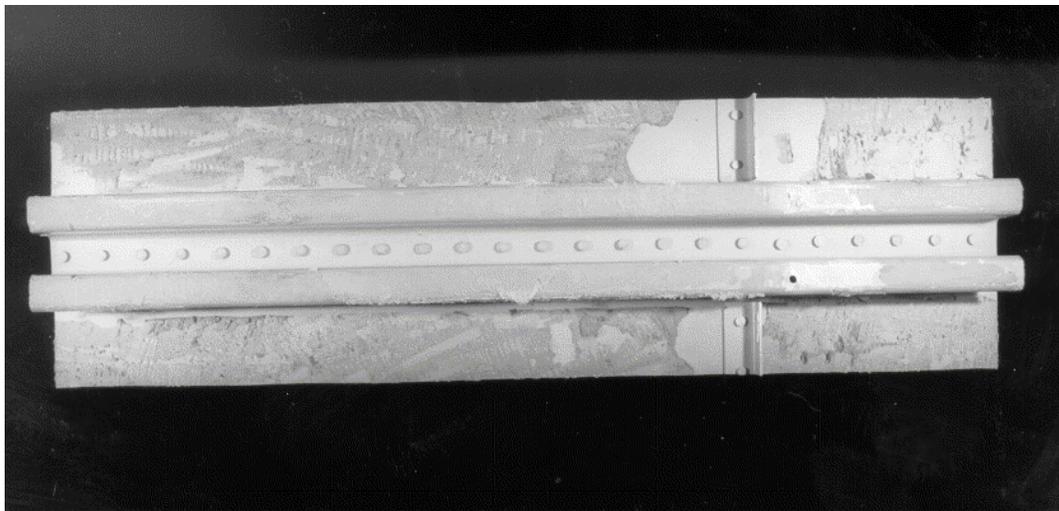
Finally, a fuselage crown section of tapered Al 7075-T6 was removed between BS916 and BS938 of a KC-135 (A/C 2668-019-B). A photograph of this cut section is shown in Figure 3.

Figure 3. A Fuselage Crown Section Removed from an Area Between BS916 and BS938 of KC-135 (A/C 2668-19-B)

The alloy 7075-T6 crown section lap joint showed no visual evidence of corrosion on the exterior or faying surface of the lap joint (see Figure 3). Metallographic cross-sectioning indicated some corrosion near the edge of most of the fastener holes. An example is shown in Figure 16a, where pitting corrosion is seen on a metallographic cross section through a fastener hole. Further, extensive corrosion of the clad layer on the outside of the skin surface was observed (see Figure 16b). The micrographs clearly indicate that corrosion of the clad layer starts as localized pitting and extends across the clad surface.

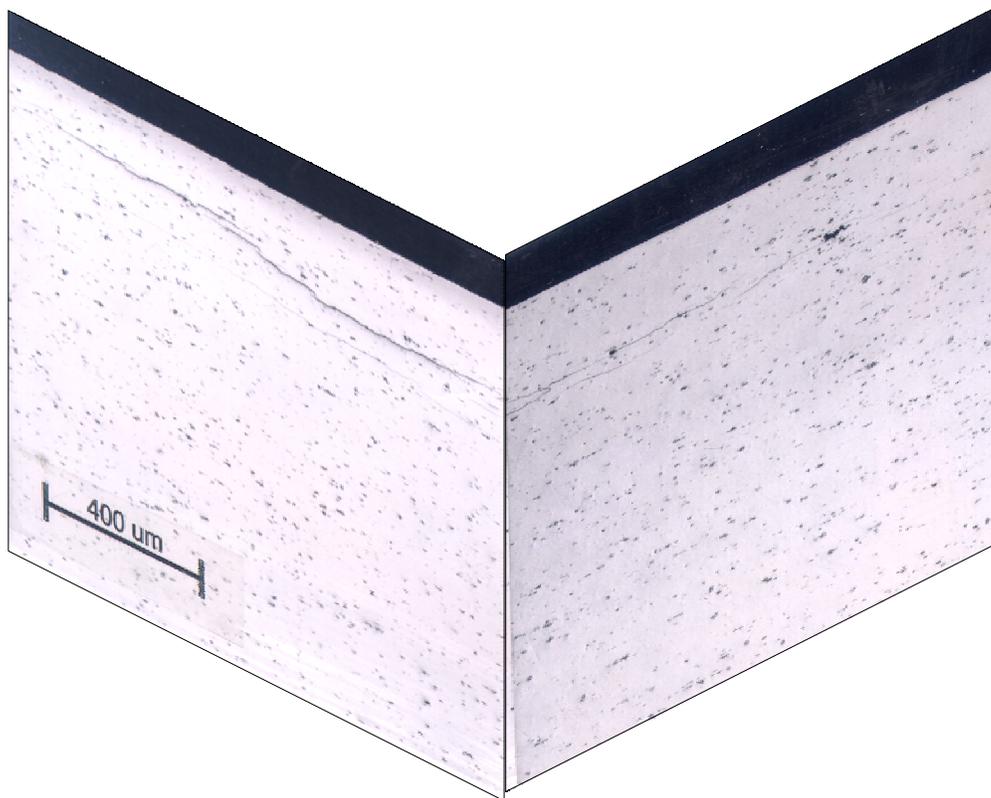
Figure 5. Three-Dimensional Image of Metallographic Cross Sections near Exterior of Inboard Wing Section Lap Joint

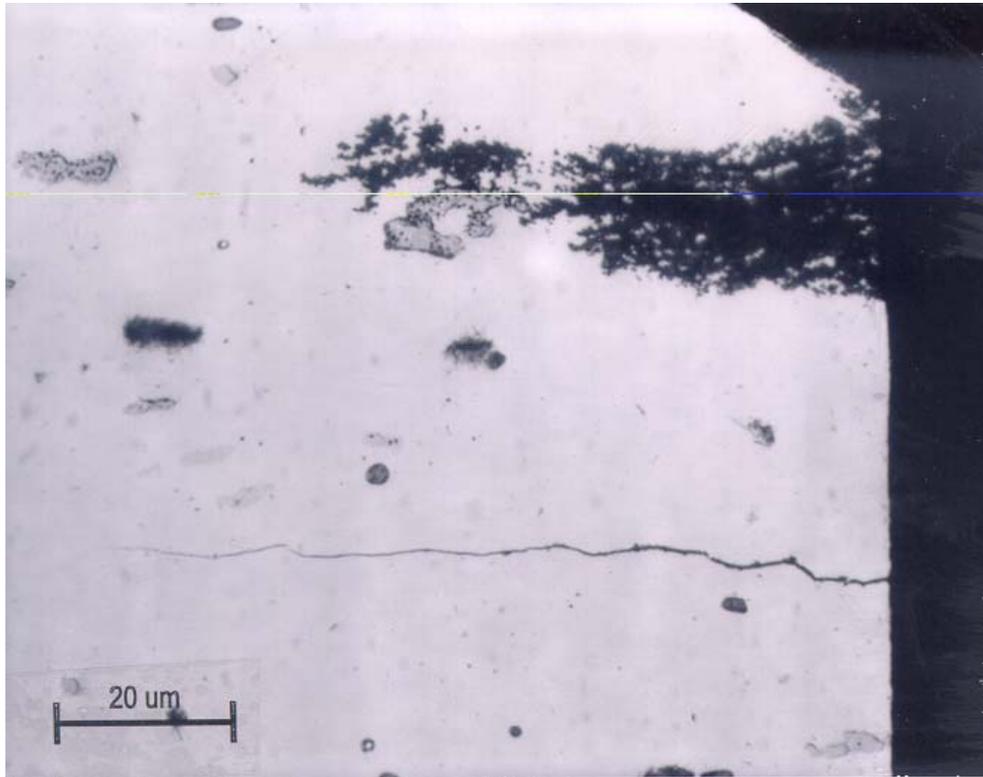
Figure 6. Optical Micrograph of Metallographic Cross Section Through Fastener Hole in Inboard Wing Section Lap Joint, Showing Minor Pitting and Exfoliation Corrosion

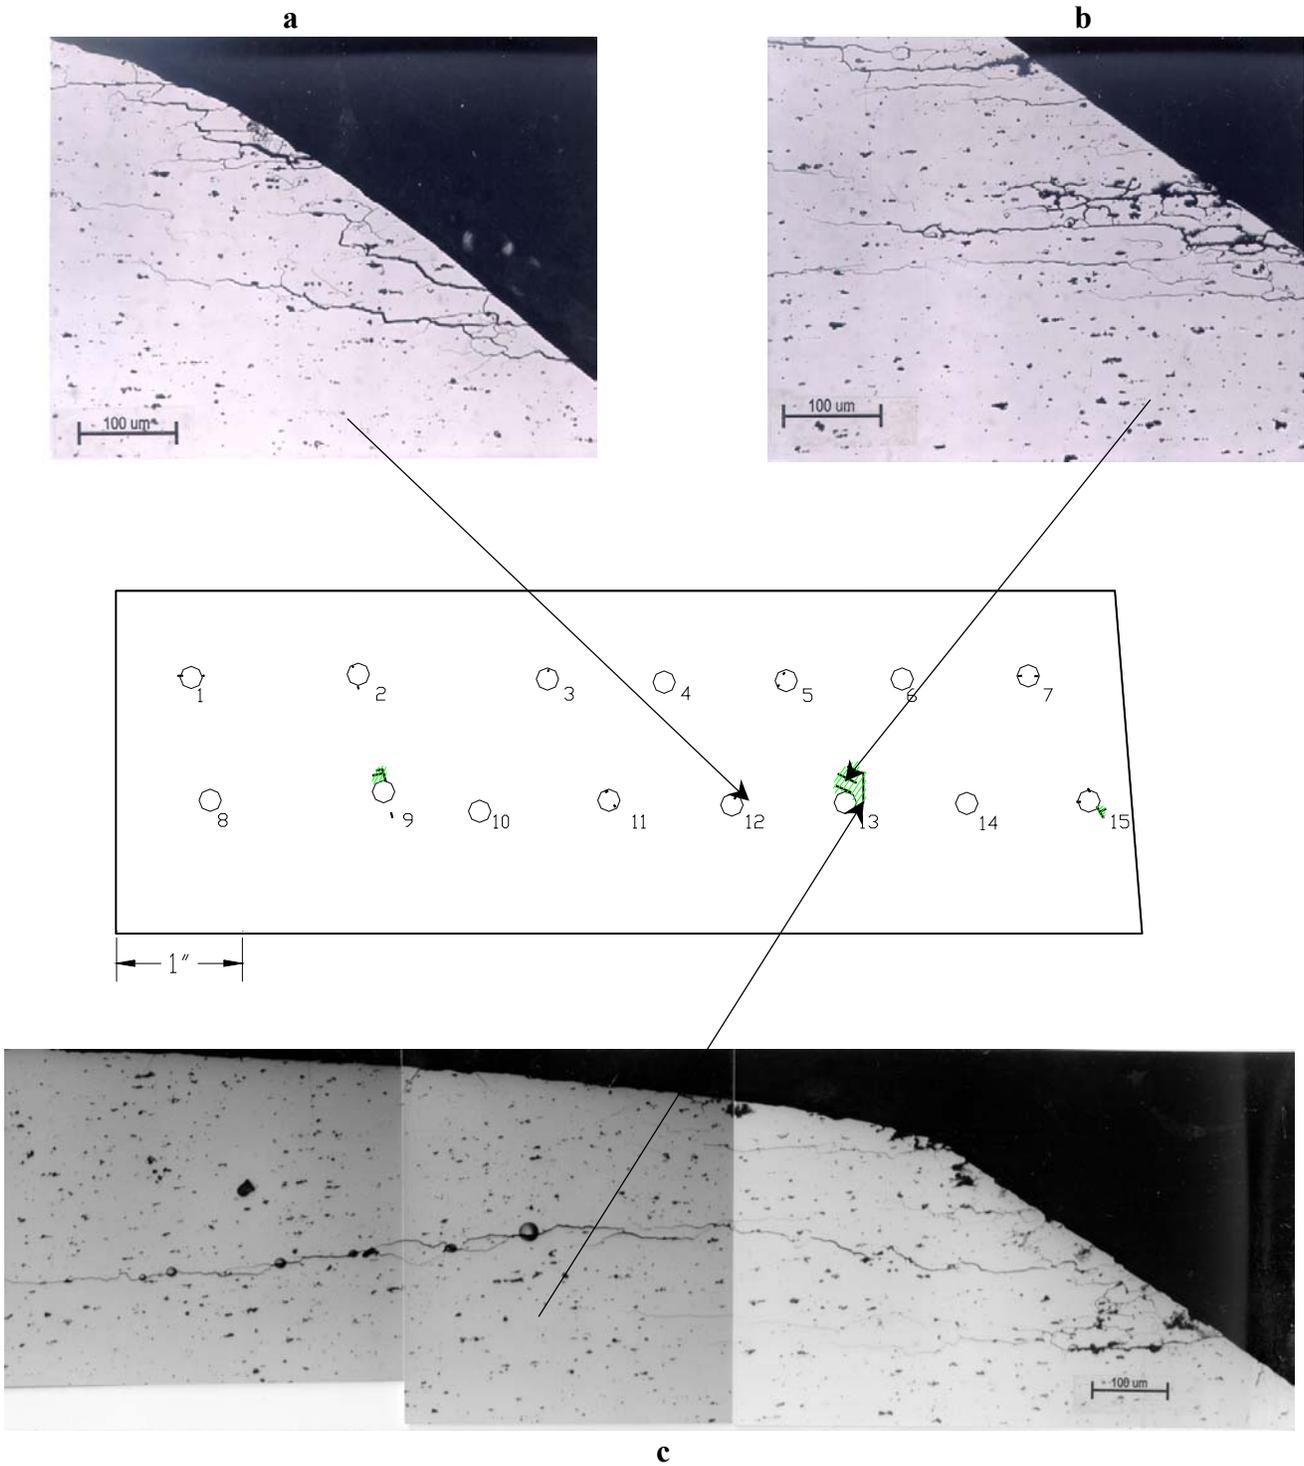
Although the outboard upper wing skin section lap joint did not show any sign of corrosion on the exterior and little corrosion on the faying surface, metallographic cross-sectioning revealed extensive exfoliation corrosion as well as pitting both at and in between the fastener holes. Figure 7 shows a schematic diagram of the exterior surface of the lap joint section and also optical of pitting and exfoliation corrosion in the areas indicated by arrows. Figure 8 shows a micrograph of a cross section through an area near fastener hole number 9 shown in Figure 7. Again pitting and exfoliation corrosion was found in the fastener hole walls and the top surface of the lap joint. The pitting corrosion showed some preferential dissolution that is characteristic for aluminum alloys (see Figure 9). Although the intergranular corrosion was extensive at some fastener holes, it appeared that little corrosion product had formed at the grain boundaries and, hence, the grains were not lifted. Because of the lack of corrosion product formation and grain exfoliation, detection, by any NDI technique, of this form of corrosion is expected to be difficult. The fact that intergranular attack was found under the grindout areas suggests that the NDI detection techniques following grindout had failed to find the corrosion damage. To gain insight in the morphology of the corrosion, three-dimensional montages were created by making perpendicular metallographic cross sections of the specimen. Examples of such three-dimensional montages in Figure 10 clearly demonstrate the fine nature of the intergranular corrosion and the lack of grain lifting or exfoliation. The micrographs further show that the corrosion was several grains deep in either direction, i.e., several 100 μm .

Figure 7. Schematic Diagram of Exterior Surface of Outboard Wing Lap Joint, Showing Areas of Exfoliation and Pitting Around the Fastener Holes

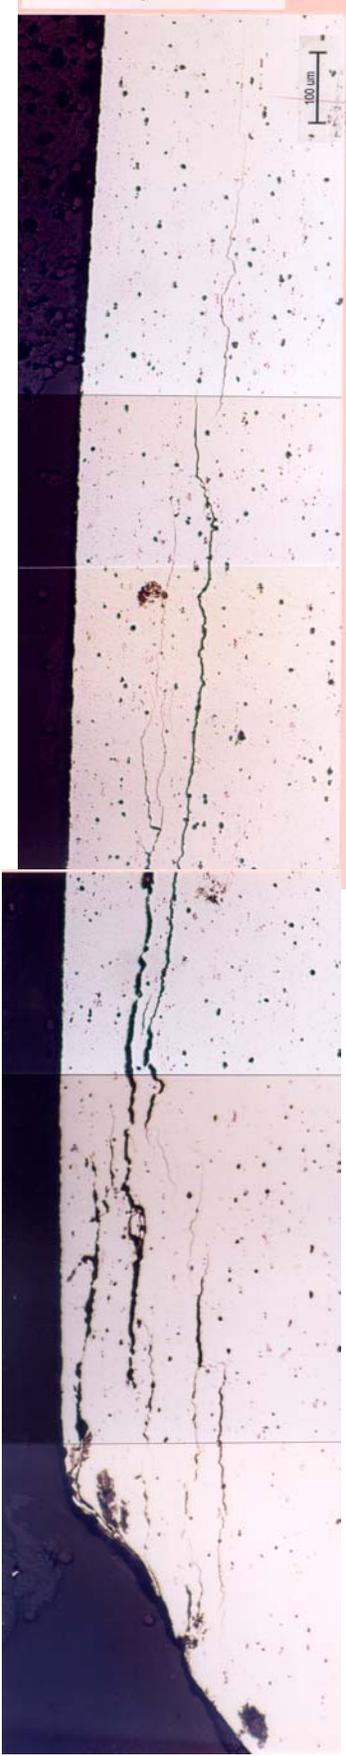
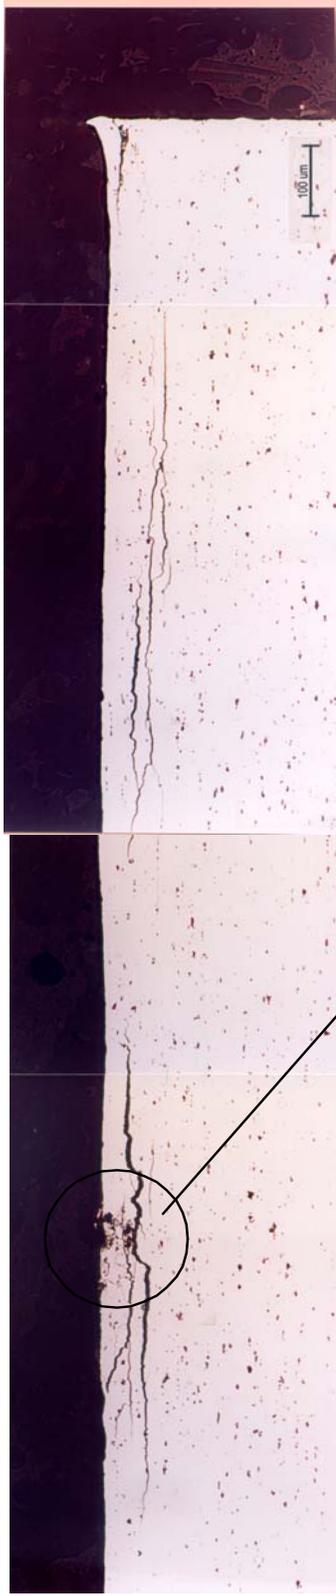
Figure 8. Optical Micrograph of Metallographic Cross Sections of Outboard Wing Lap Joint near Fastener Hole 9 in Figure 7

Exfoliation and pitting can be seen on the exterior of the upper wing skin.

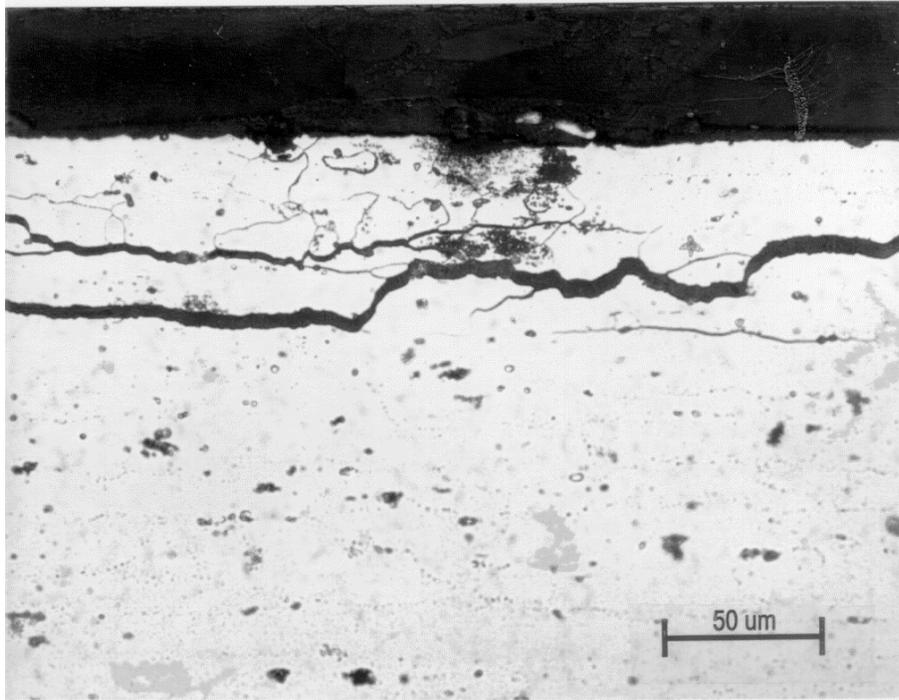
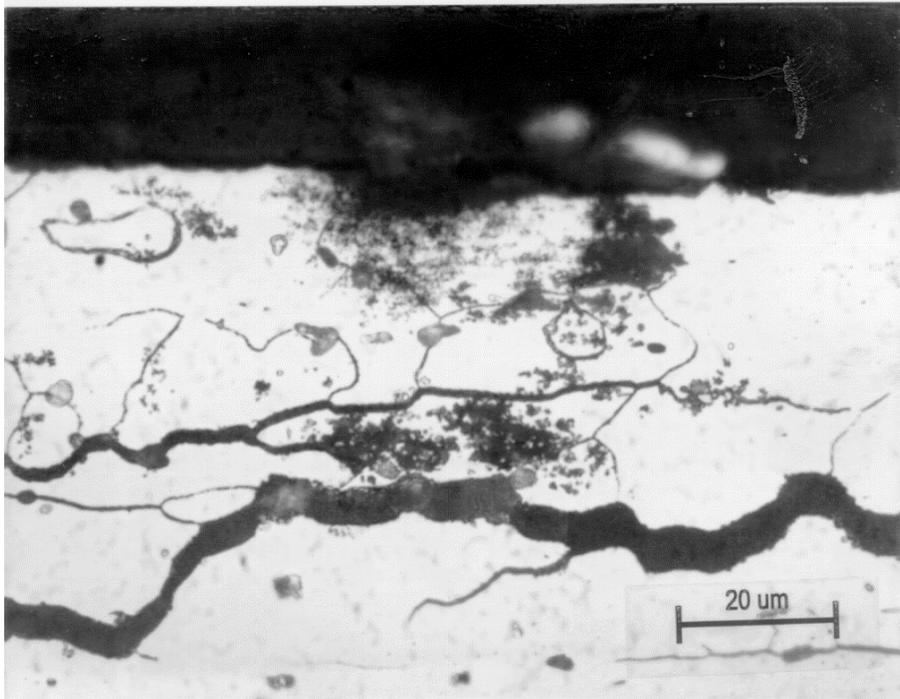
Figure 9. Details of the Pit Indicated in Figure 8

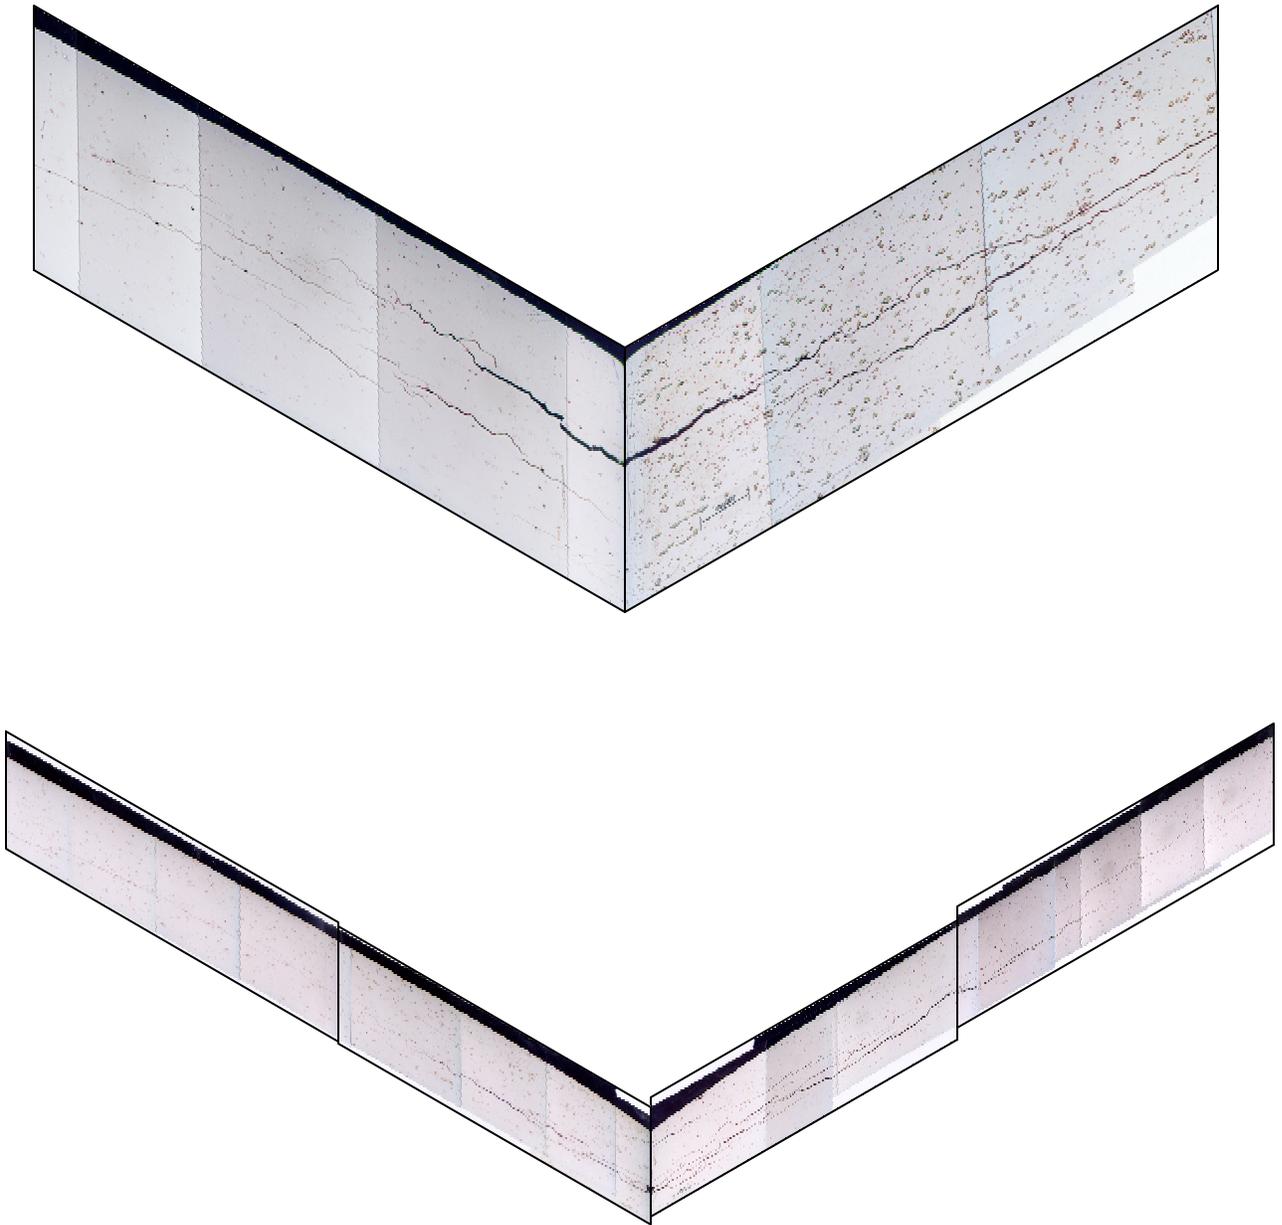
Figure 10. Three-Dimensional Images of Exfoliation Corrosion near Fastener Hole 13 in Figure 7

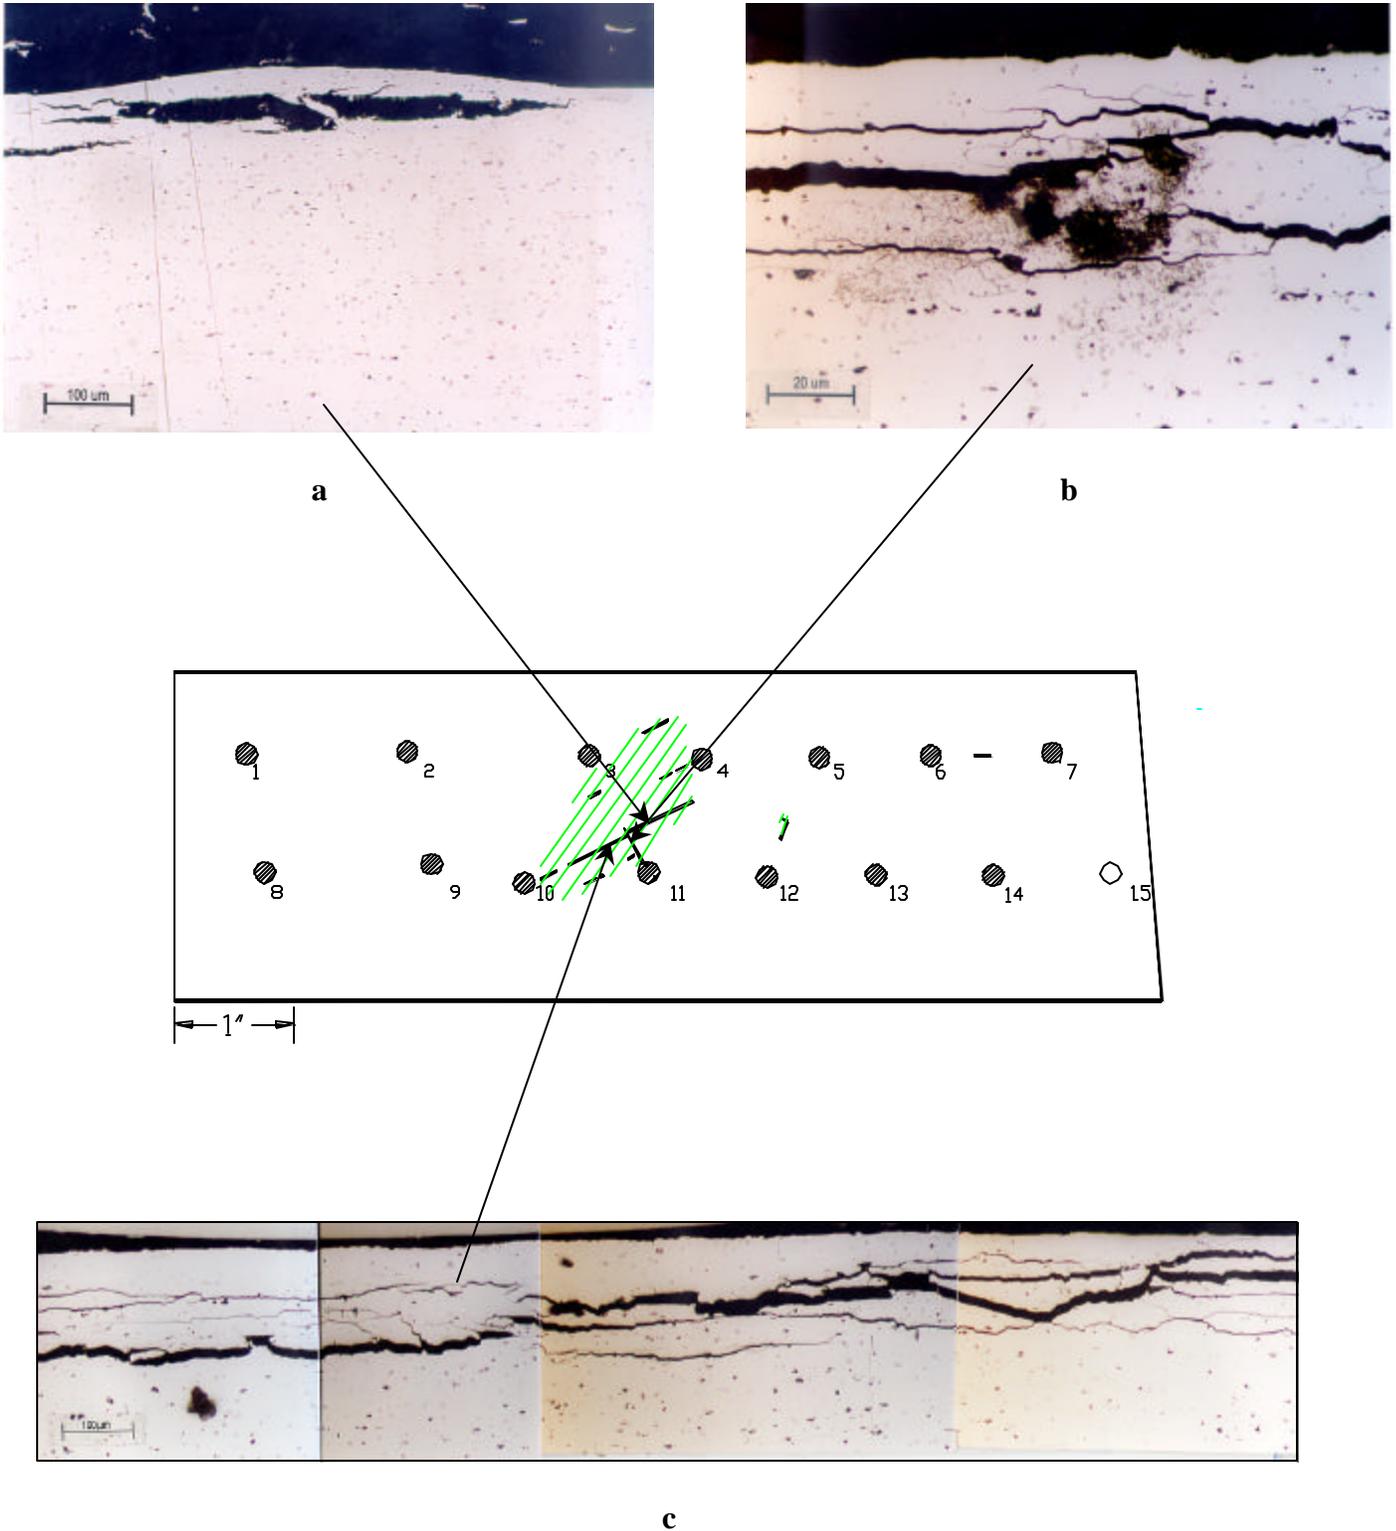
Figure 11 shows a schematic diagram of the faying surface of the lap joint, indicating that most of the corrosion occurred between the fastener holes. There was no evidence that the corrosion had originated from the fastener holes. When examining the corrosion on the faying surface, the morphology of the intergranular attack appears to be different from that observed near the exterior of the skin. The micrographs in Figure 11 show that voluminous corrosion products had formed along the grain boundaries, lifting up the grains and creating the so-called pillowing effect. Also, the micrograph in Figure 11b shows that after exfoliating, the grains continued to corrode by what appears to be a preferential dissolution process, forming the voluminous corrosion product ($\text{Al}(\text{OH})_3$). To examine the extent of the intergranular attack, several metallographic cross cuts were made. Figure 12, which is a collage of optical micrographs, shows the extent and severity of exfoliation corrosion on the faying surface. Three-dimensional montages, such as in Figure 13, created from the metallographic crosscuts also demonstrate the large extent of the corroded area as well as a uniform depth of the corrosion attack of about 100 microns. The optical micrographs in Figures 12 and 13 further show definite pillow formation due to severe exfoliation corrosion.

Figure 11. Schematic Diagram of Faying Surface of Outboard Wing Section, Showing Areas of Extensive Exfoliation Corrosion, Corrosion of the Exfoliated Grains and Pilling

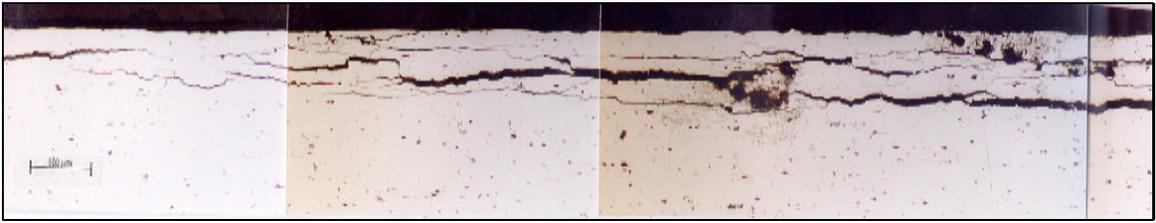
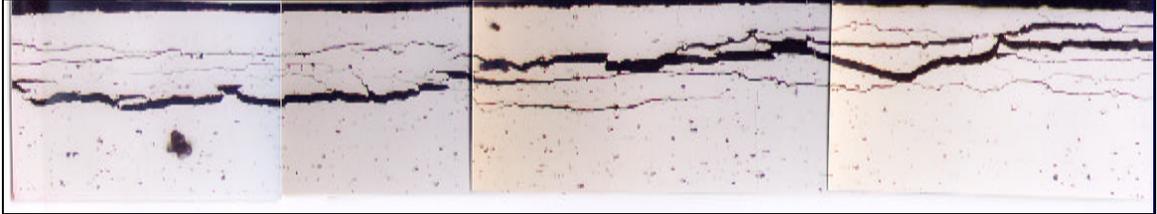
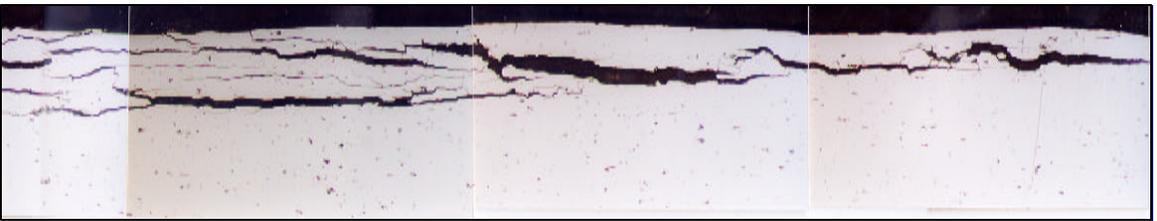
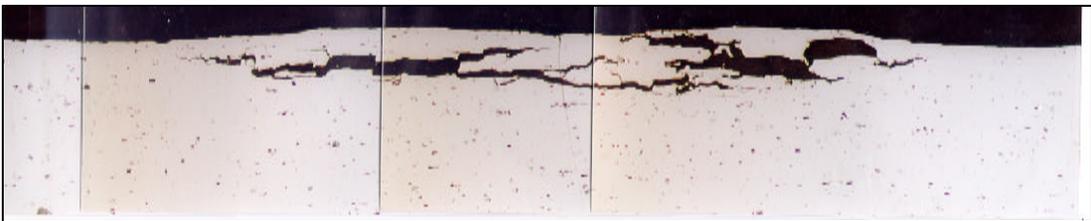
Figure 12. Optical Micrographs of Metallographic Cross Sections Through the Upper Wing Skin of the Outboard Wing Section, Showing Exfoliation and Blistering on the Faying Surface

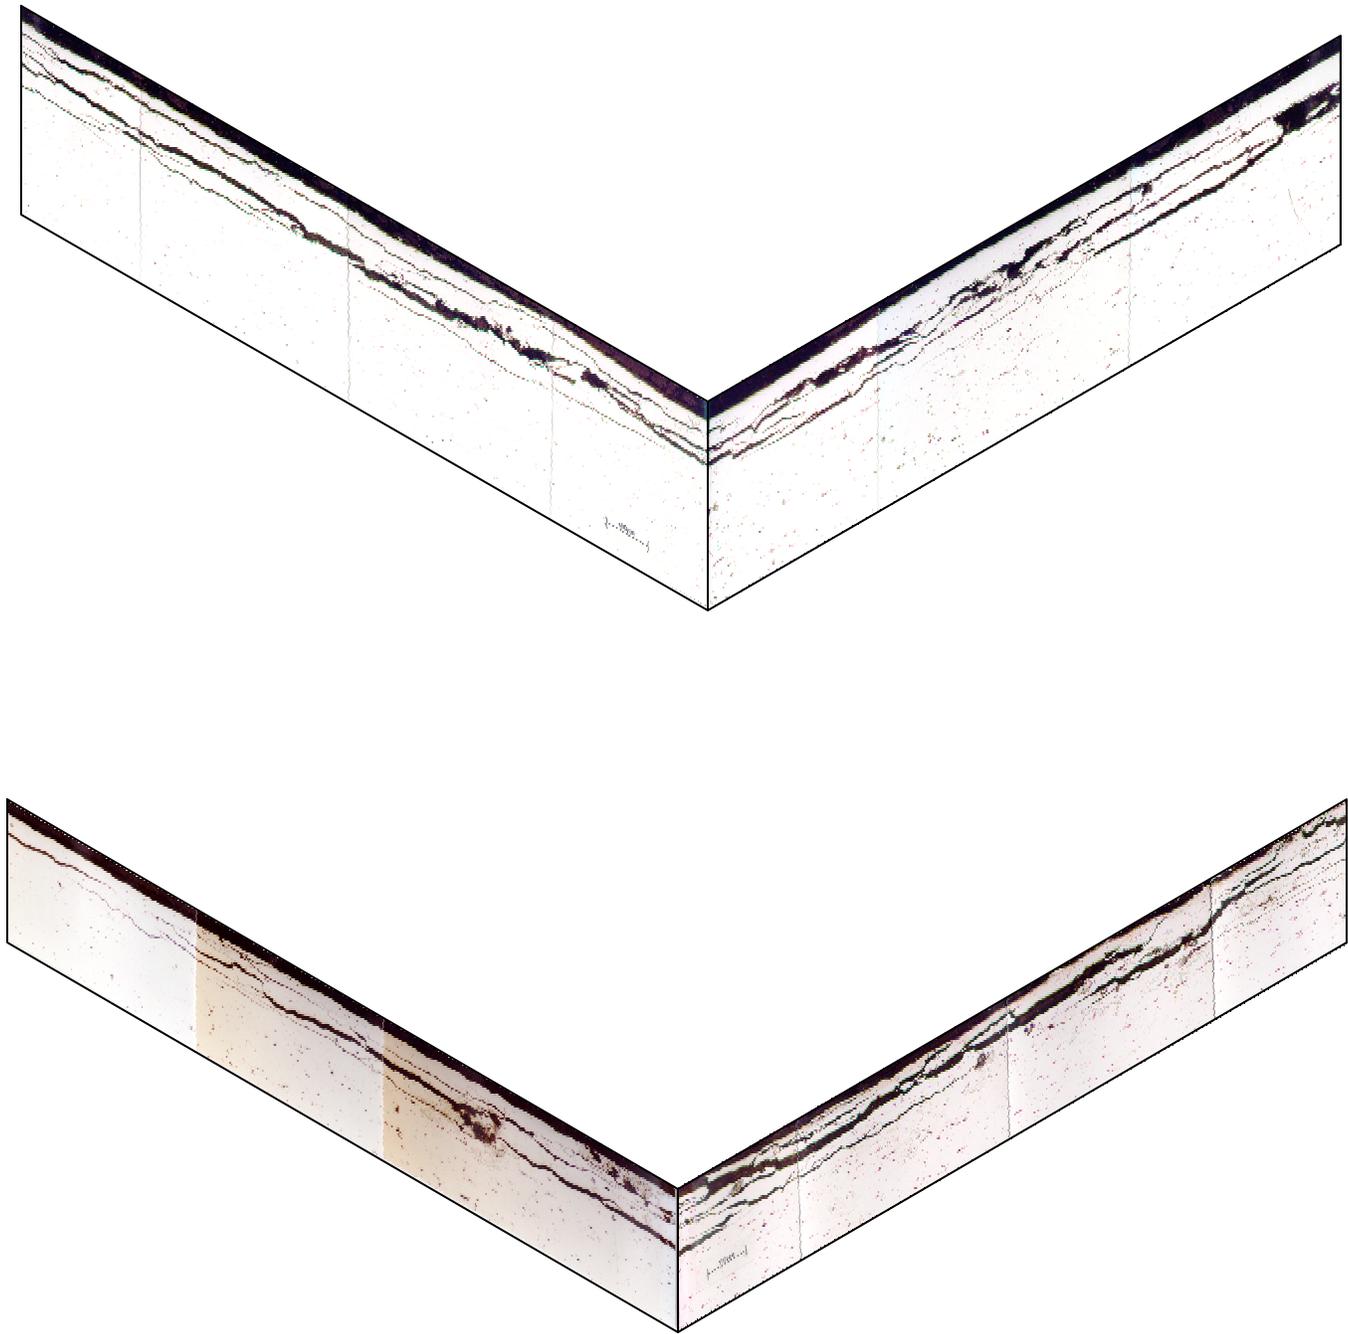
Figure 13. Three-Dimensional Images of Exfoliation Between Fastener Holes on the Faying Surface of the Outboard Wing Section, Showing Extensive Grain Lifting and Pillowing

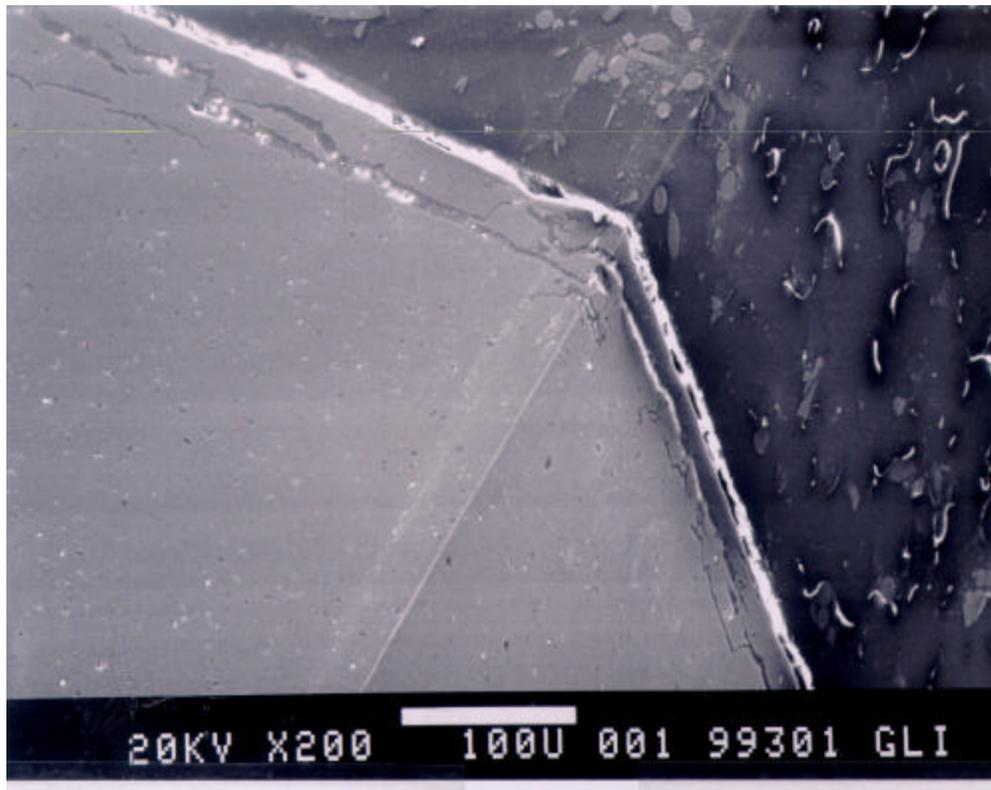
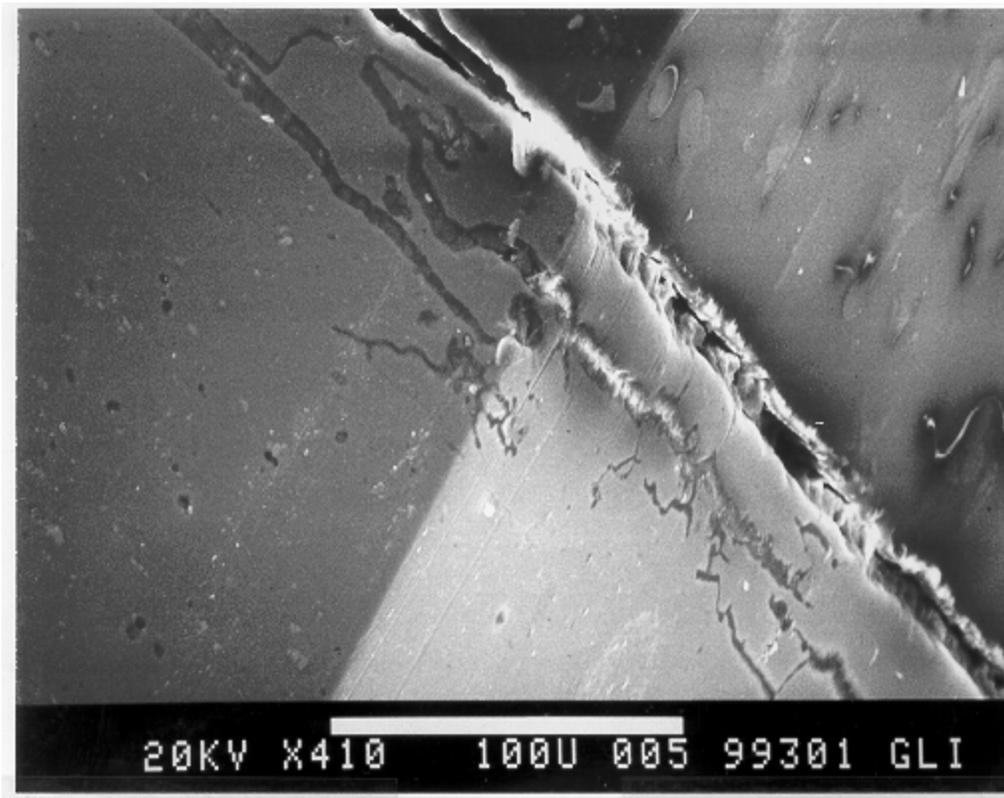
In addition to exfoliation corrosion, it was found that at specific locations, pockets of intergranular corrosion were found extending deeper into the material. An example of this form of corrosion attack is given in Figure 14, which shows scanning electron micrographs of perpendicular metallographically prepared surfaces. The micrographs show clearly the formation of localized intergranular corrosion under the general exfoliation attack.

Figure 14. Scanning Electron Micrograph of Two Perpendicular Metallographic Cross-Sections of Outboard Wing Section, Showing Exfoliation and Intergranular Attack

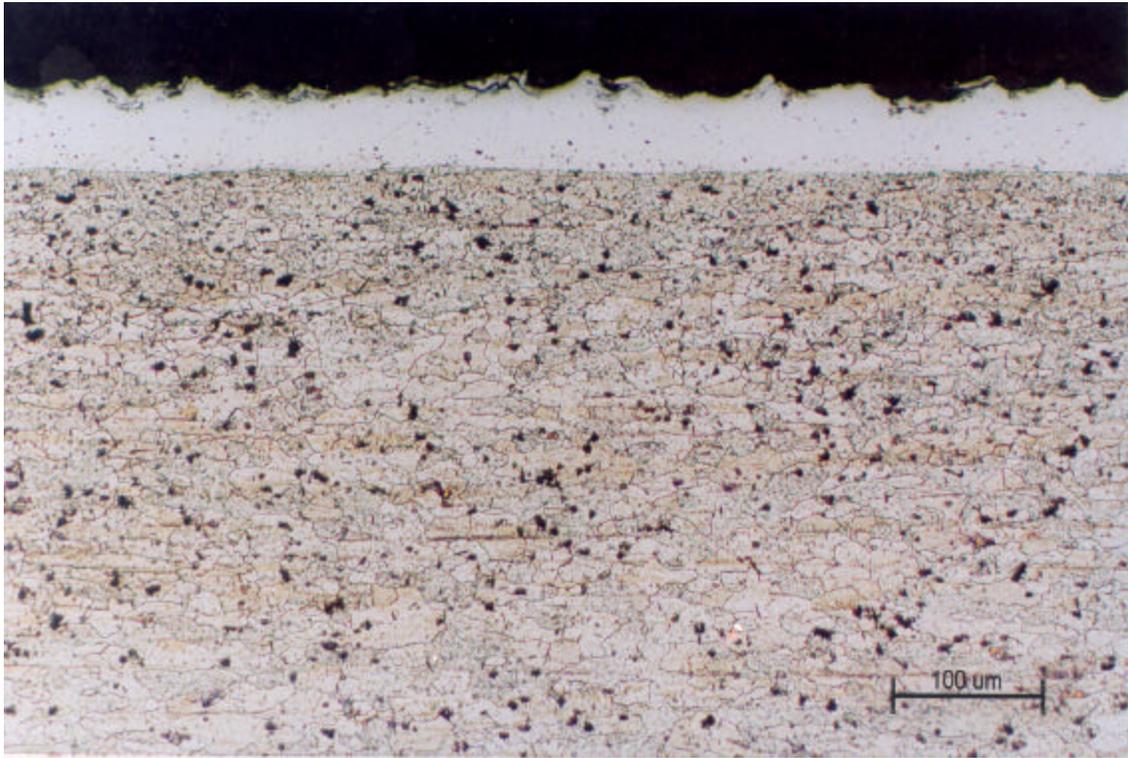
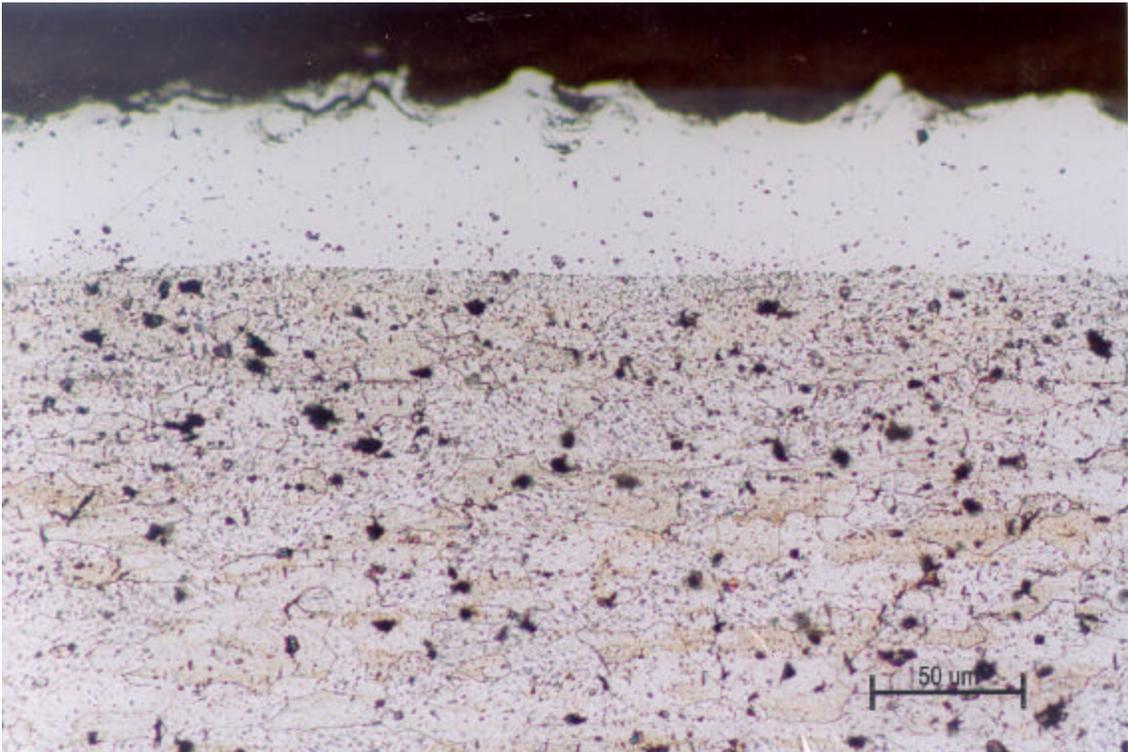
Figure 15. Optical Micrographs of Metallographic Cross Sections Through Aluminum Alloy 2024-T3 Fuselage Lap Joint, Showing Pitting on the Clad Faying Surface

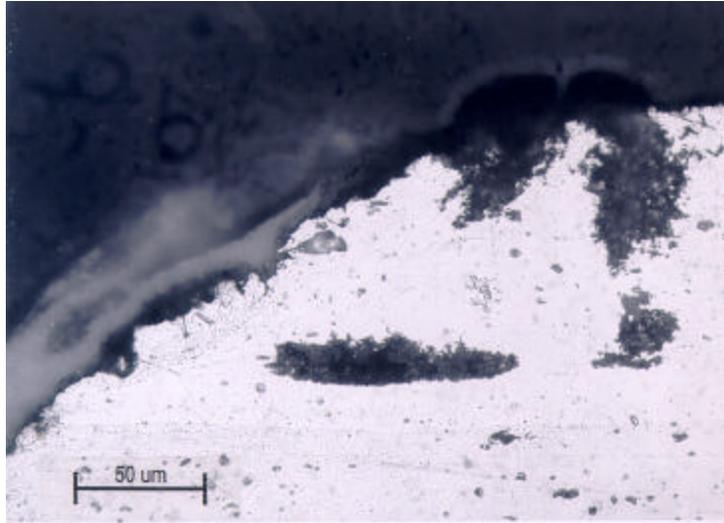
Photograph a shows pitting corrosion at a fastener hole on the outside surface.

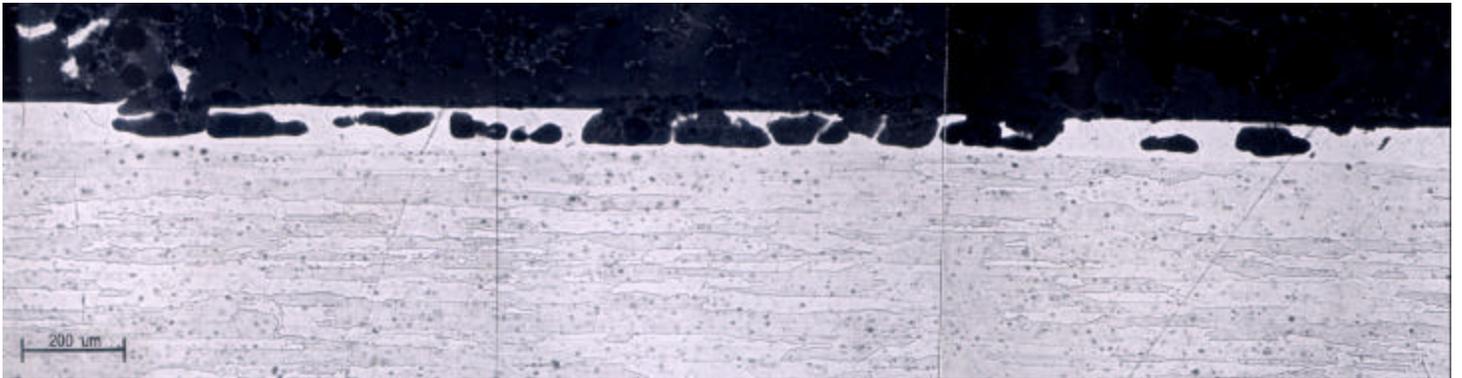
Photograph b shows corrosion of the clad layer on the outside surface. Photograph c shows pitting corrosion on the faying surface.
