AFRL-VA-WP-TR-2002-3032

**CORROSION MORPHOLOGY IN
LAP JOINTS**

JUNE 2000

Final Report for 01 April 1999 – 31 May 2000

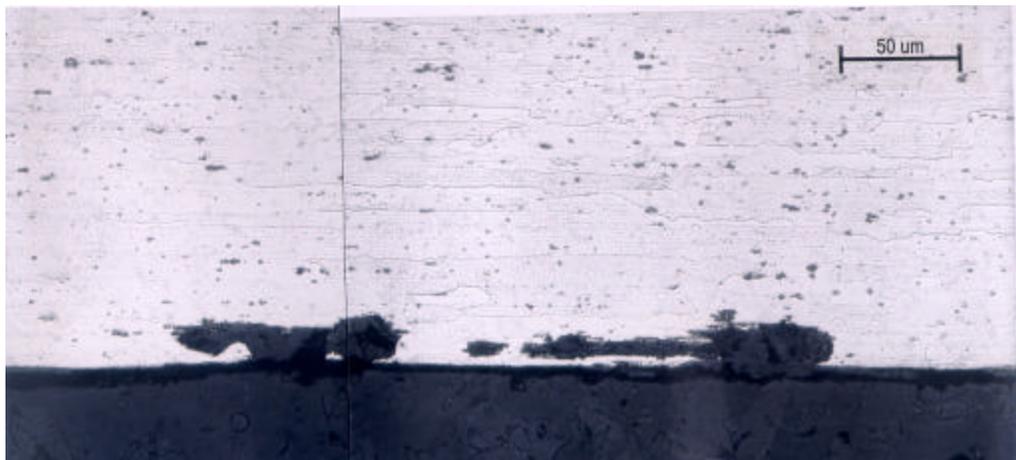
Minor corrosion was found on the faying surface in the form of shallow pitting (see Figure 12c). It should be noted that there was no clad on the faying surface.

Photograph b shows corrosion of the clad layer on the outside surface. Photograph c shows pitting corrosion on the faying surface.

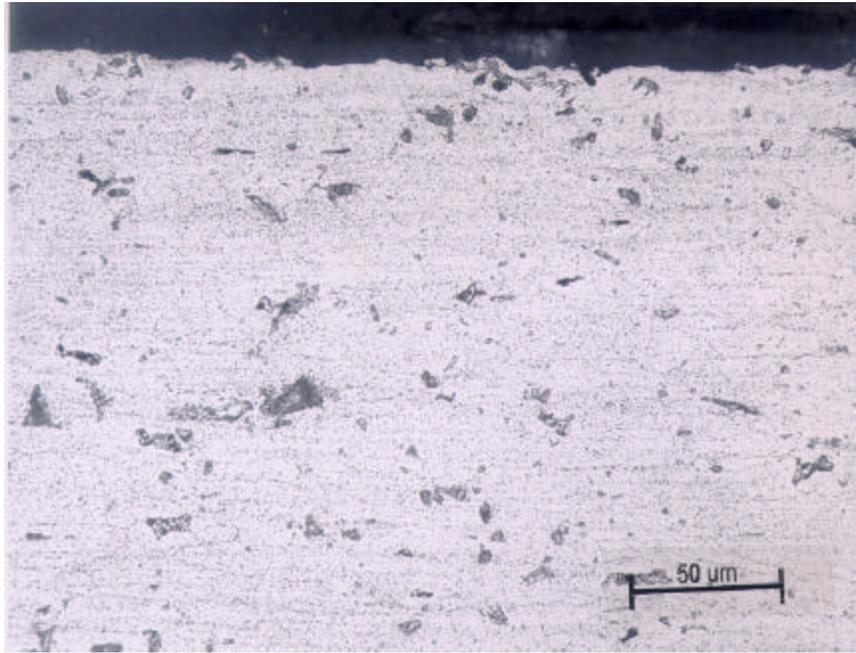
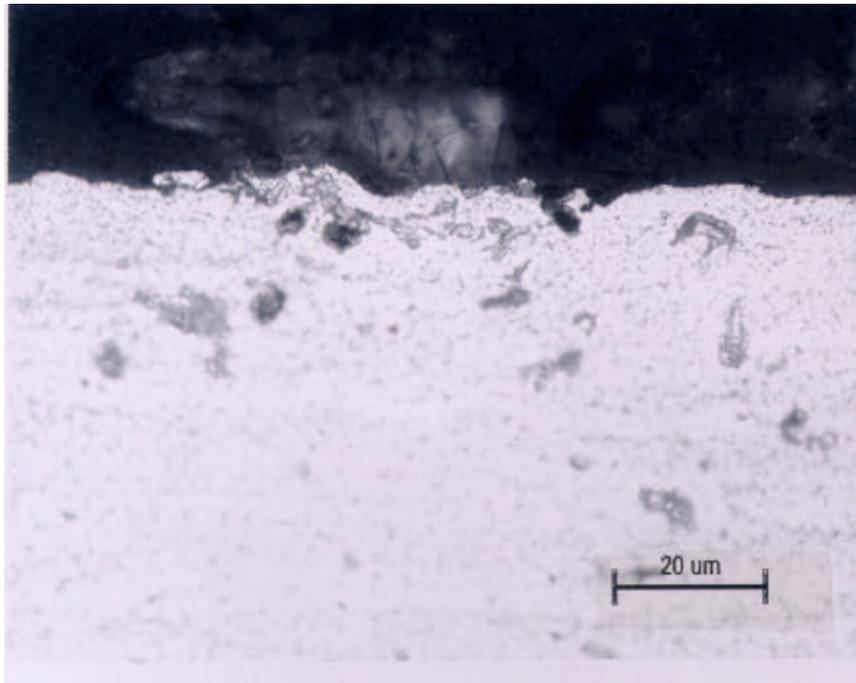
Figure 21. Optical Micrographs of Cross Section Through Alloy 7178-T6 after Potentiostatic Polarization at -780 mV Versus SCE, Showing Small Pits on the Surface

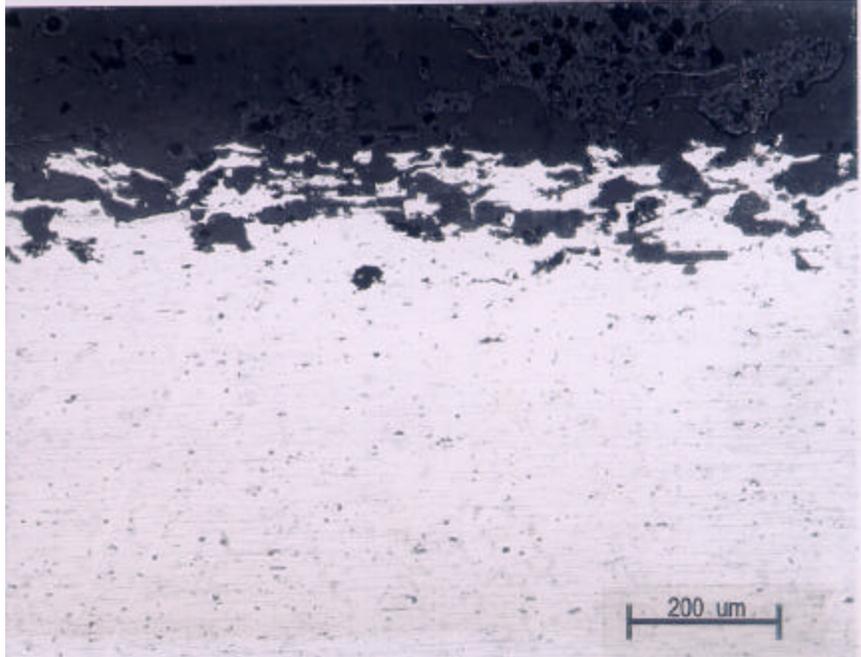
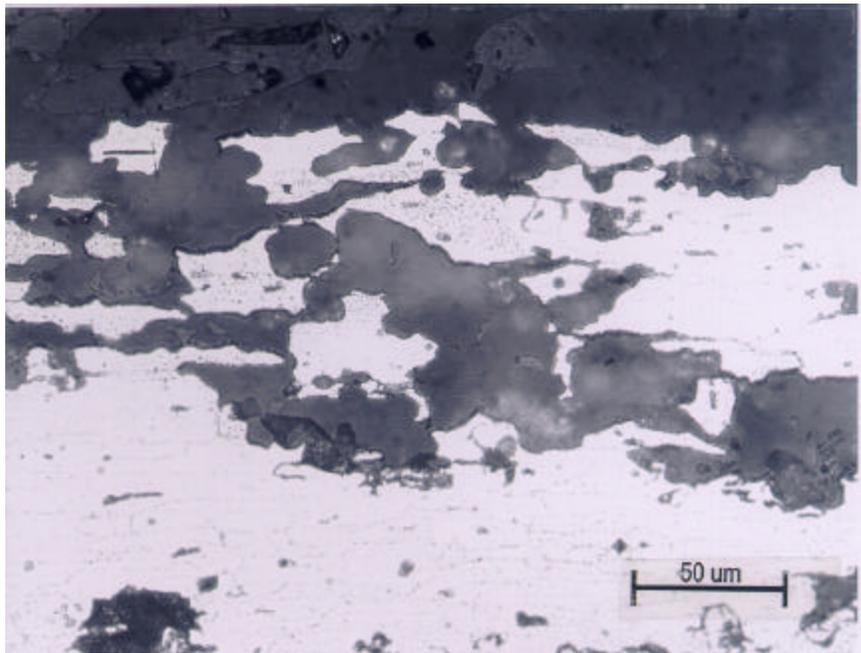
Figure 22. Optical Micrographs of Cross Section Through Alloy 7178-T6 after Potentiostatic Polarization at -700 mV Versus SCE, Showing Intergranular Corrosion at the Surface
