- *Title:* Technology Showcase: Integrated Monitoring, Diagnostics and Failure Prevention.
Proceedings of a Joint Conference, Mobile, Alabama, April 22-26, 1996.

METALLURGICAL EXAMINATION OF A FAILED SPIRAL BEVEL GEAR

Marc Pepi
U.S. Army Research Laboratory
Materials Directorate
Aberdeen Proving Ground, Maryland 21005

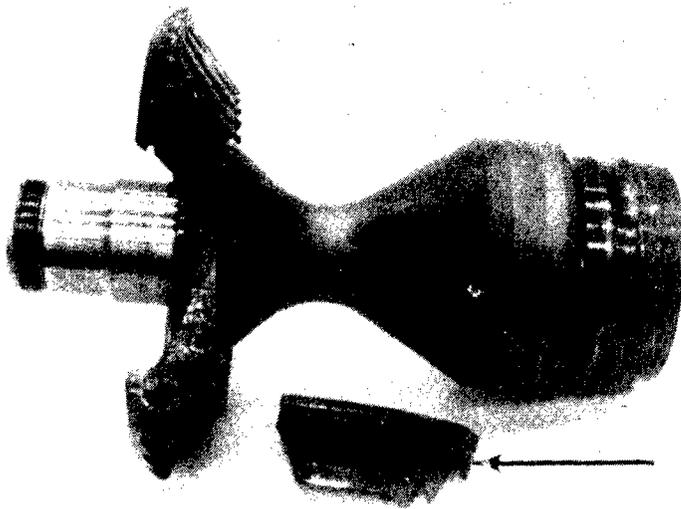
A spiral bevel transmission gear (Figure 1) from an Army cargo helicopter failed during a training flight leading to an immediate landing. Inspection of the number 2 engine transmission revealed that an 8-tooth segment (out of a 35-tooth gear) had fractured and penetrated the transmission housing. The failed component was fabricated from X-2M steel (a modified H11 tool steel), and

Figure 1 Optical Macrograph of the failed spiral bevel gear and the fractured eight-tooth segment (denoted by the arrow). Reduced 70%.

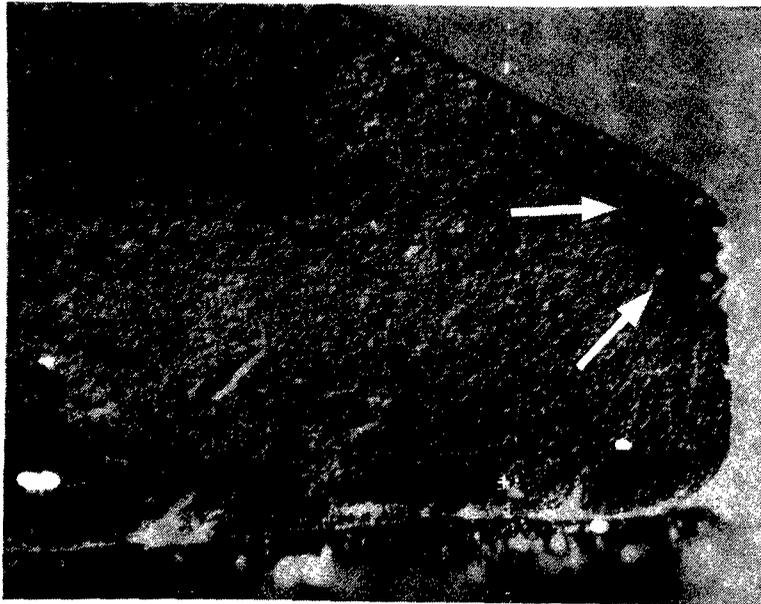
Figure 3 Magnified view of the processing defect at the origin. The grinding crack is denoted by arrows. Mag. 40x.

The extent of fatigue propagation observed on the fractured part was 1.65 inch followed by a ductile overload morphology. The fracture origin was located at a defect within the damping ring groove region. The defect was "half-moon" shaped and had a depth of approximately 0.005 inch and a surface length of approximately 0.015 inch. The defect had a darkened topography, and was considered evidence of a pre-existing crack opened to the surface during the manufacturing sequence of the gear.

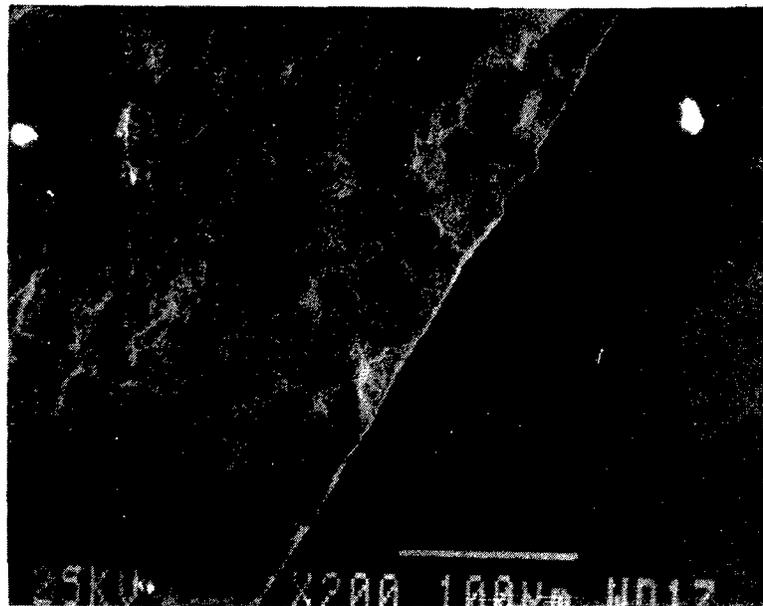
Fractographic examination of a secondary through-fracture revealed an intergranular morphology within the case of the damping ring groove area (see Figure 6). The remaining morphology consisted of ductile dimples, indicative of overload fracture. No evidence of fatigue was noted in this section. This finding was evidence that a grinding crack had propagated along the continuous carbide networks.

Figure 6 Secondary fracture sample from the damping ring groove area found to contain an intergranular morphology. A grinding crack most likely propagated along the carbide networks. Mag. 200x.
