David Taylor Research Center

DTRC/SHD-1315-01 January 1990

Departmental Report

PRELIMINARY RESULTS OF DD-963 MODEL TESTS IN BROKEN ICE FIELDS

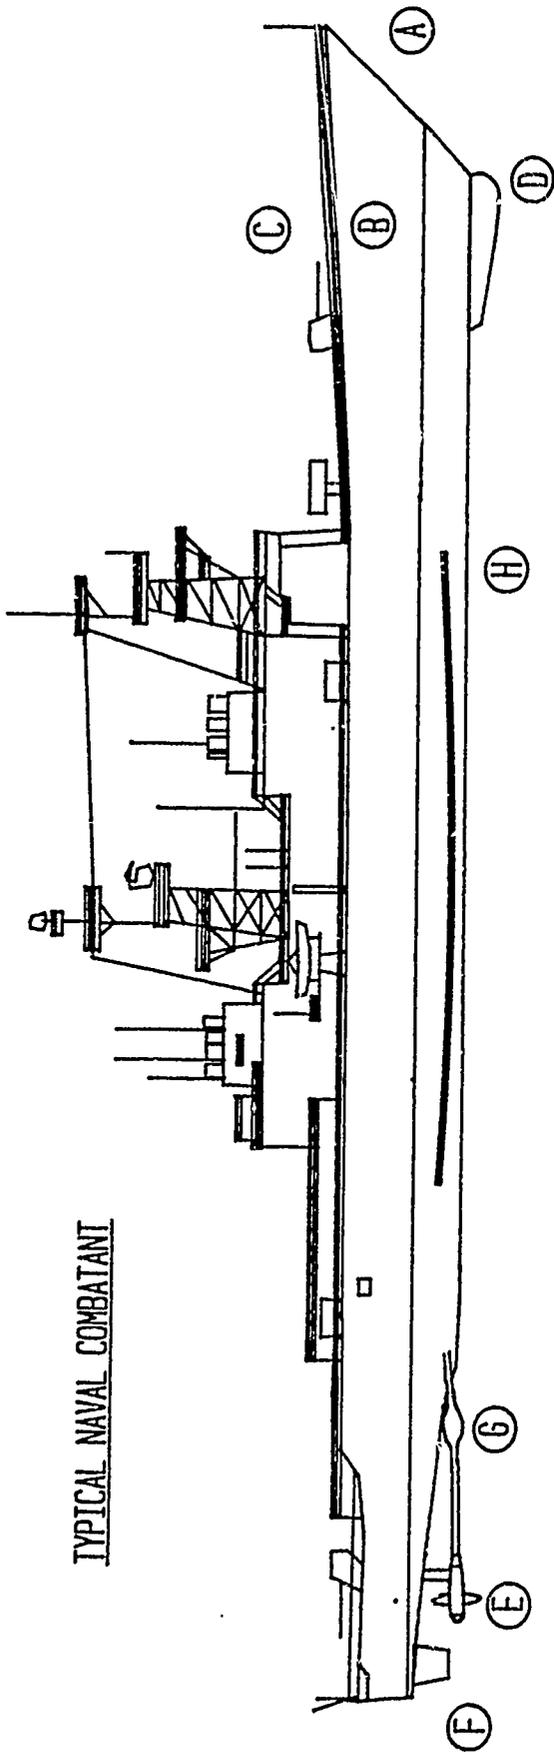
Fig. 1. Typical Surface Combatant

TYPICAL NAVAL COMBATANT

Potential Structural Inadequacies for Surface Combatants Operating in Ice or Extreme Cold Regions:

- A) Hull not configured for breaking ice.
- B) Hull shell structure not designed for ice loading (no icebelt)
- C) Low temperature steels not utilized.
- D) Sonar dome rubber window structure exposed to ice impact.
- E) Controllable pitch propeller not designed for ice milling.
- F) Balanced rudder subject to ice impact.
- G) Shafts and struts exposed to ice impact.
- H) Bilge keels subject to ice impact.

It is generally accepted in the Navy today that surface ships should not attempt to penetrate solid ice packs because of insufficient hull and appendage strength. In fact, the typical warship has a hull and appendages which are unsuitable for pack ice penetration. Some specific potential problem areas are shown and listed in Figure 1.
