# Oxidation and Hot Corrosion of Superalloys Rene 100 and X-40 at Temperatures of 1475°F to 2000°F

M. Levy, J. J. Falco, and F. Pettit

ARL-TR-87

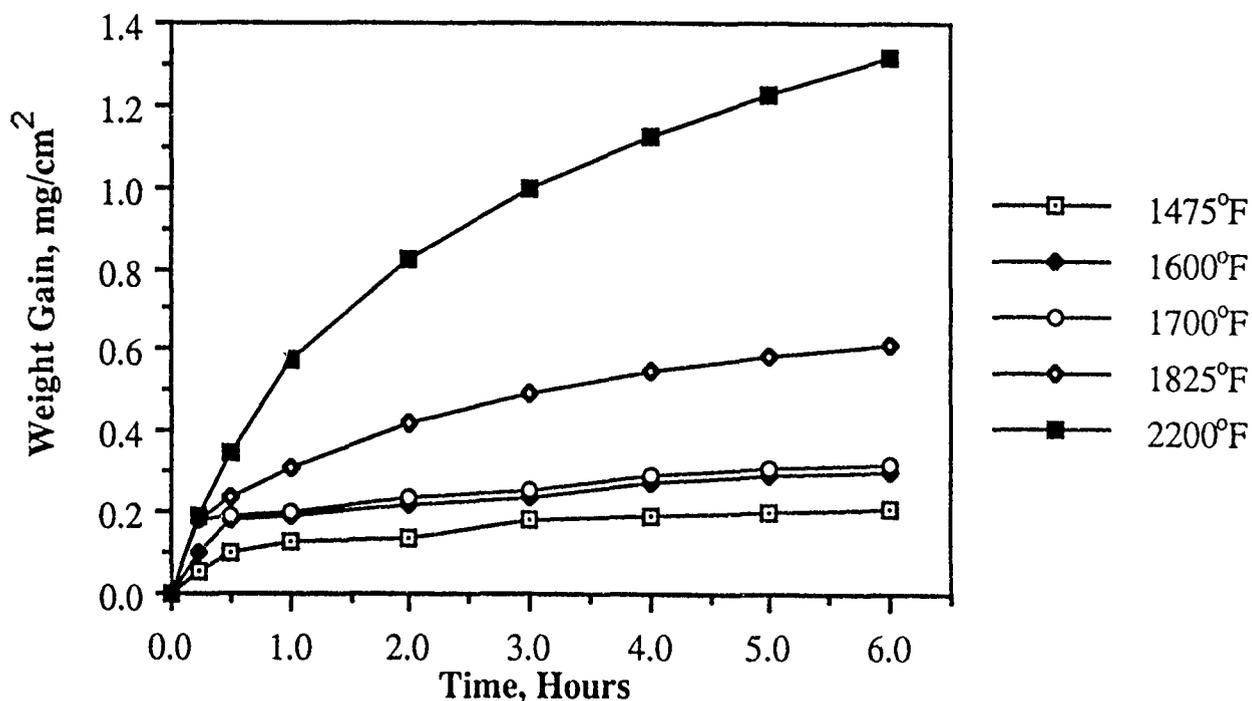
The data obtained for X-40 are presented in Figure 1 where weight changes as a function of time are presented for a number of temperatures between 1475°F to 2200°F. These data, with the exception of the 2200°F test, approximate a parabolic rate law with rate constants in reasonable agreement with those for growth of  $\text{Cr}_2\text{O}_3$  scales on alloys [9]. Parabolic kinetics are also followed at 2200°F, but the rate constant is significantly less than that for growth of  $\text{Cr}_2\text{O}_3$  and this may result from the formation of volatile products; i.e.,  $\text{CrO}_3$ , at this temperature.

Figure 1. Oxidation of X-40: Air Flow Rate = 57 cm/min, Pressure = 760 Torr.

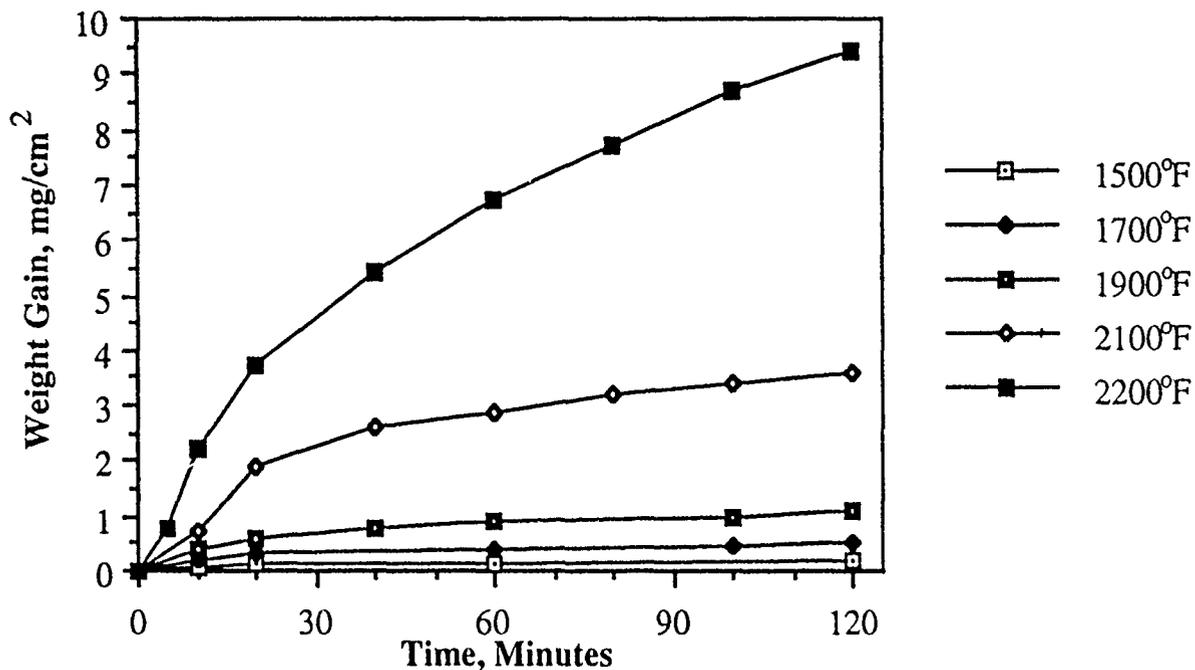
The oxidation behavior of Rene 100 (see Figure 2) was poor compared to that for X-40; this was especially the case at the higher temperatures. Examination of Figure 2 shows that the weight gains for Rene 100 after two hours were almost always greater than those for X-40 exposed to the same temperature for six hours. Moreover, the weight change/time plots for Rene 100 had shapes for 2100°F and 2200°F that indicated the oxide scales were cracking at the temperature of oxidation. These data conformed to a parabolic rate law; however, rate constants greater than those for the growth of nickel oxide scales were obtained. For example, at 2200°F a rate constant of  $10^{-8}$  ( $\text{g}^2/\text{m}^4\text{-s}$ ) was obtained for Rene 100. Inspection of the composition of Rene 100 suggest that  $\text{Al}_2\text{O}_3$  scales could be formed on this alloy but probably only after extensive amounts of transient oxidation during which oxides such as  $\text{NiO}$ ,  $\text{Cr}_2\text{O}_3$ ,  $\text{CoO}$ , and  $\text{TiO}_2$  are formed. The data which has been obtained indicates  $\text{Al}_2\text{O}_3$  scales may begin to develop but that cracking must render this process ineffective. The alloy, therefore, has poor oxidation resistance compared to X-40, especially at temperatures above 1900°F.

Figure 2. Oxidation of Rene 100: Air Flow Rate = 57 cm/min, Pressure = 760 Torr.

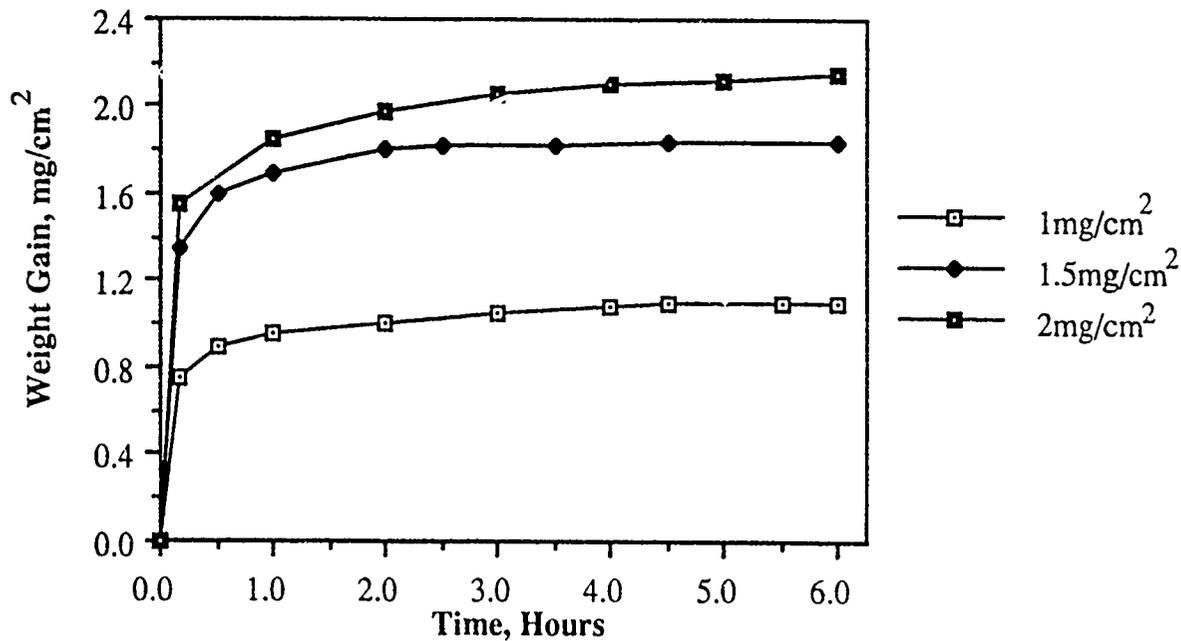
The weight change data for hot corrosion experiments must always be examined with care since gaseous products can be formed in addition to condensed phases at the surfaces of specimens. The weight change versus time curves for hot corrosion of X-40 always exhibited an initial rapid increase followed by a long period of very small weight changes (see Figure 3). The weight changes were always significantly larger than those for oxidation, as can be seen by comparing the data presented in Figures 1 and 3. Furthermore, the initial rapid increase in weight due to the presence of  $\text{Na}_2\text{SO}_4$  became greater as the amount of  $\text{Na}_2\text{SO}_4$  was increased (see Figure 3).

Figure 3. Hot corrosion versus  $\text{Na}_2\text{SO}_4$  concentration on X-40 at  $1600^\circ\text{F}$ . Air Flow Rate = 57 cm/min, Pressure = 760 Torr.

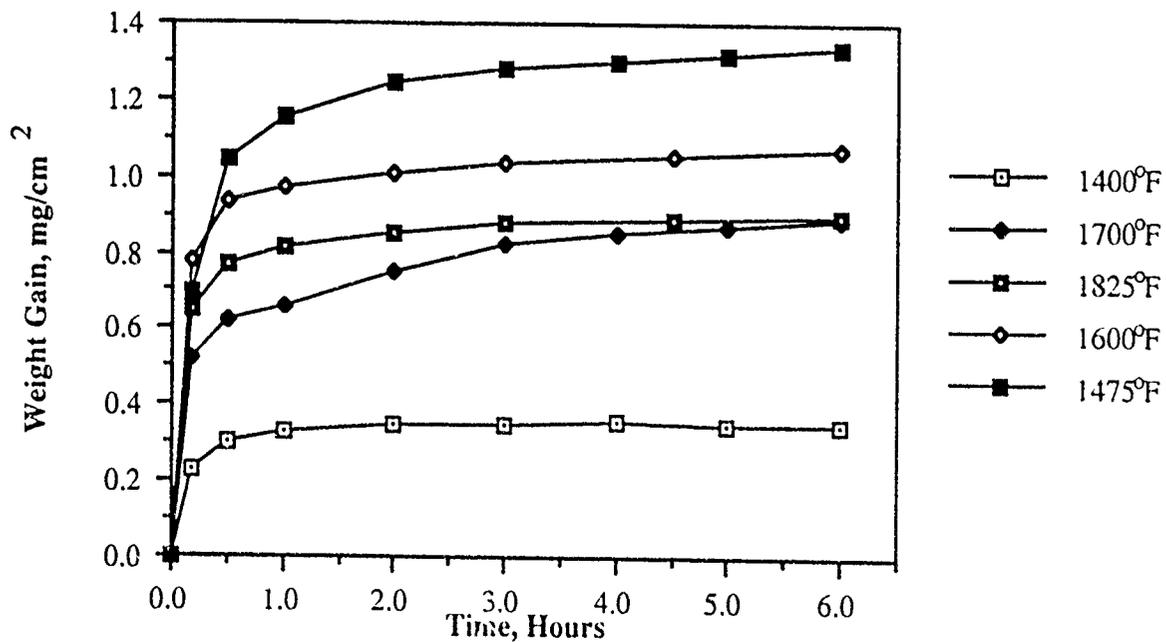
In Figures 4 and 5 weight change data for X-40 are presented for the two different procedures used in the hot corrosion tests. In the experiments involving the pre-treatment with argon,  $\text{SO}_2$  was identified (by a starch-iodate test) as an effluent which indicates that the  $\text{Na}_2\text{SO}_4$  may be decomposing according to the reaction.

Figure 4. Hot corrosion of X 40 with  $1 \text{ mg Na}_2\text{SO}_4/\text{cm}^2$  Air Flow Rate = 57 cm/min, Pressure = 760 Torr, Ar pretreated.

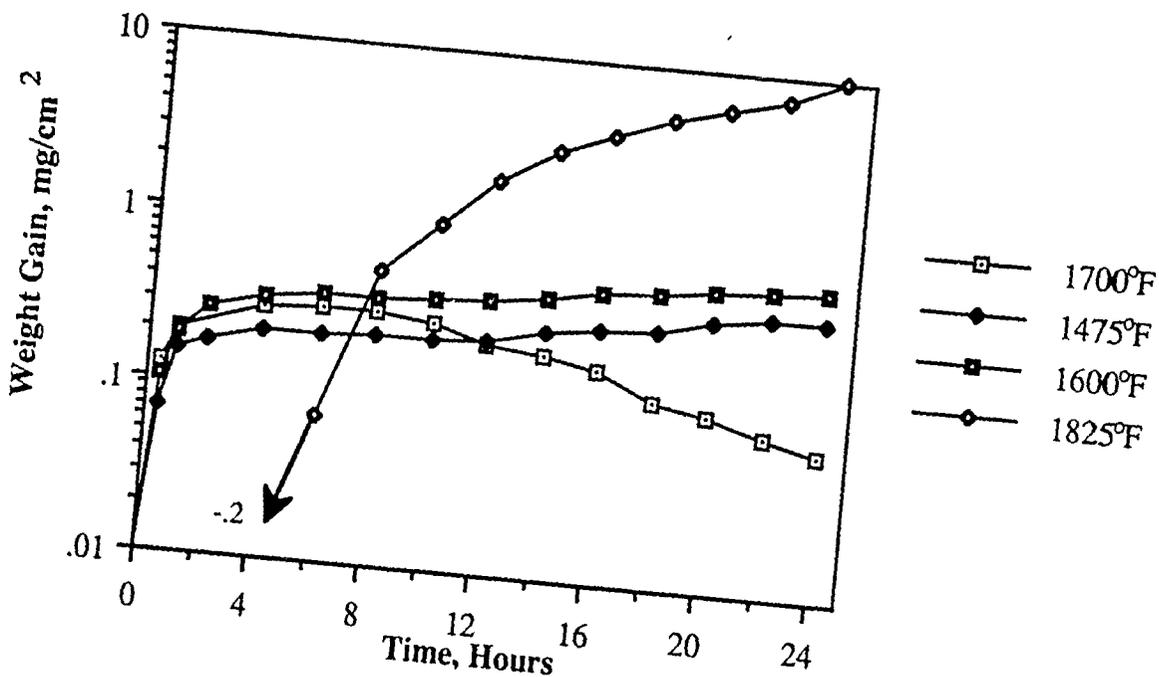
Figure 5. Hot corrosion of X-40 with 2 mg  $\text{Na}_2\text{SO}_4/\text{cm}^2$ . Air Flow Rate = 57 cm/min, Pressure = 760 Torr, No Ar pretreatment.

The weight change data obtained for the samples heated in air (see Figure 5) are influenced by the gradual increase in temperature of the specimen (the specimen was found to reach the test temperature after approximately 10 minutes), weight losses due to  $\text{SO}_2$  evolution from the  $\text{Na}_2\text{SO}_4$ , and the formation of corrosion products on the surfaces of the specimens. At temperatures between 1475°F to 1700°F the results are not much different from the argon pretreatments exhibiting an initial larger increase in weight followed by a leveling off of the corrosion rates. These data are believed to be less reliable than those obtained with the argon pretreated samples since, in the latter, the weight losses resulting from decomposition of  $\text{Na}_2\text{SO}_4$  occurred prior to the beginning of the weight change measurements. The results obtained with the X-40 specimen exposed to air and heated to 1825°F, however, show that very severe attack has occurred. In view of the relatively large

amount of tungsten in this alloy, it appears that oxides of tungsten must have been formed and reacted with the  $\text{Na}_2\text{SO}_4$  to produce an acidic melt that causes alloy-induced acidic fluxing to take place [5,9]. Such attack does not occur with the argon pretreatment since the  $\text{Na}_2\text{SO}_4$  decomposes and is not present during that part of the experiment where air is present.

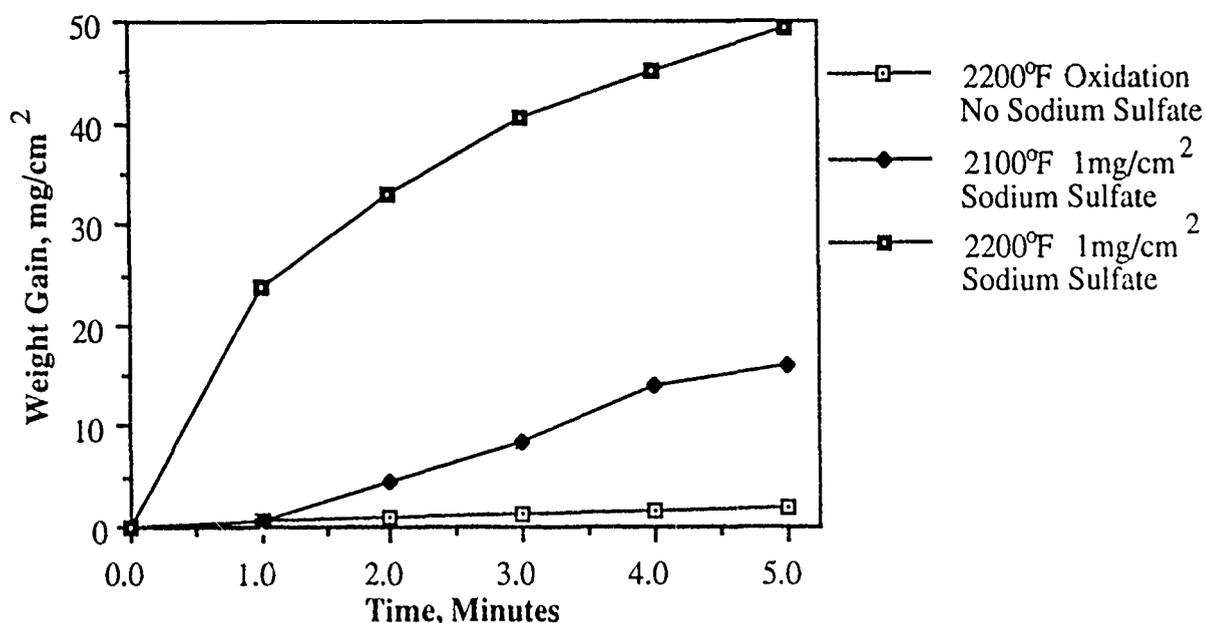
The hot corrosion of X-40 became more severe at temperatures of  $2100^\circ\text{F}$  and  $2200^\circ\text{F}$ , as shown in Figure 6. Attack was evident after a few minutes of exposure. The amount of degradation was much more than the amount of  $\text{Na}_2\text{SO}_4$ . Such results show that oxidation products must be sustaining the rapid degradation. This is consistent with alloy-induced acidic fluxing.

Figure 6. Comparison of oxidation and hot corrosion of X-40 at elevated temperatures

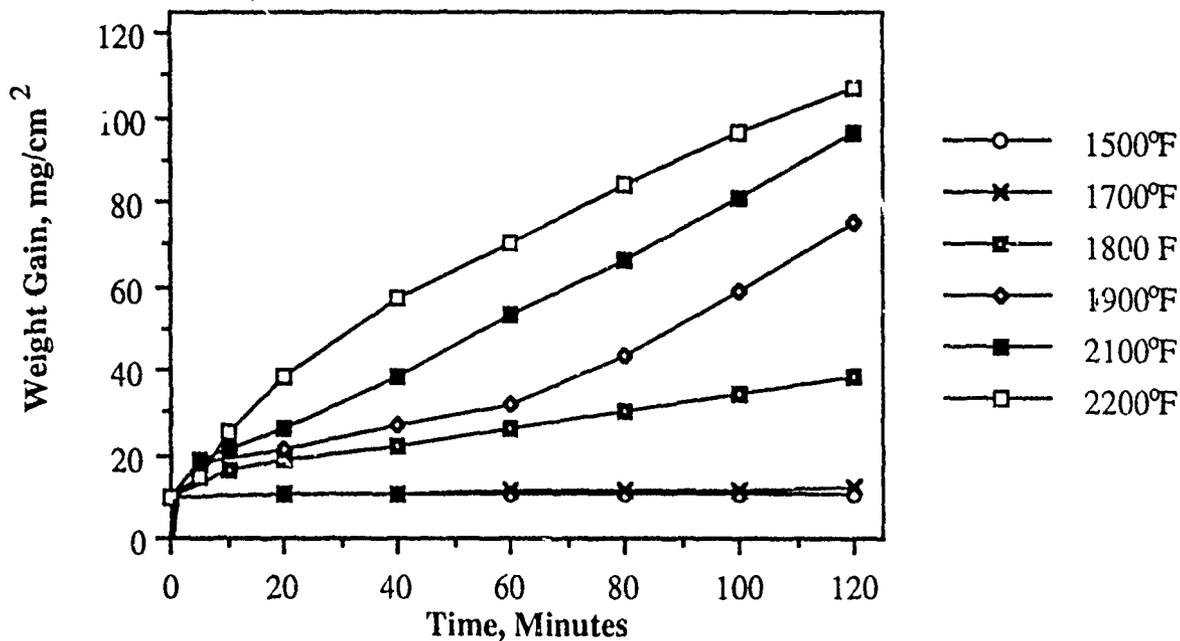
Results obtained from hot corrosion tests with Rene 100 are presented in Figure 7. Very severe attack is obvious upon comparison of the hot corrosion data with that for oxidation. The effects are especially severe at temperatures of  $1800^\circ\text{F}$  and above where the data again suggest degradation via an alloy-induced acidic fluxing process originating from the molybdenum and vanadium in Rene 100. Experiments were also performed where  $\text{Na}_2\text{SO}_4$ -coated specimens were exposed at  $1500^\circ\text{F}$  for two hours and then re-exposed at  $2100^\circ\text{F}$  without further addition of  $\text{Na}_2\text{SO}_4$ . The results are compared to hot corrosion and oxidation data obtained at  $2200^\circ\text{F}$  in Figure 8. It is evident that the exposure at  $1500^\circ\text{F}$  has caused the hot corrosion at  $2100^\circ\text{F}$  to be more severe. This probably has occurred by decreasing the time required to initiate the alloy-induced acidic fluxing at  $2100^\circ\text{F}$  and, hence, weight changes even greater than hot corrosion at  $2200^\circ\text{F}$  are observed.

Figure 7. Hot corrosion of Rene 100 with 1 mg Na<sub>2</sub>SO<sub>4</sub>/cm<sup>2</sup>: Air Flow Rate = 57 cm/min, Pressure = 760 Torr

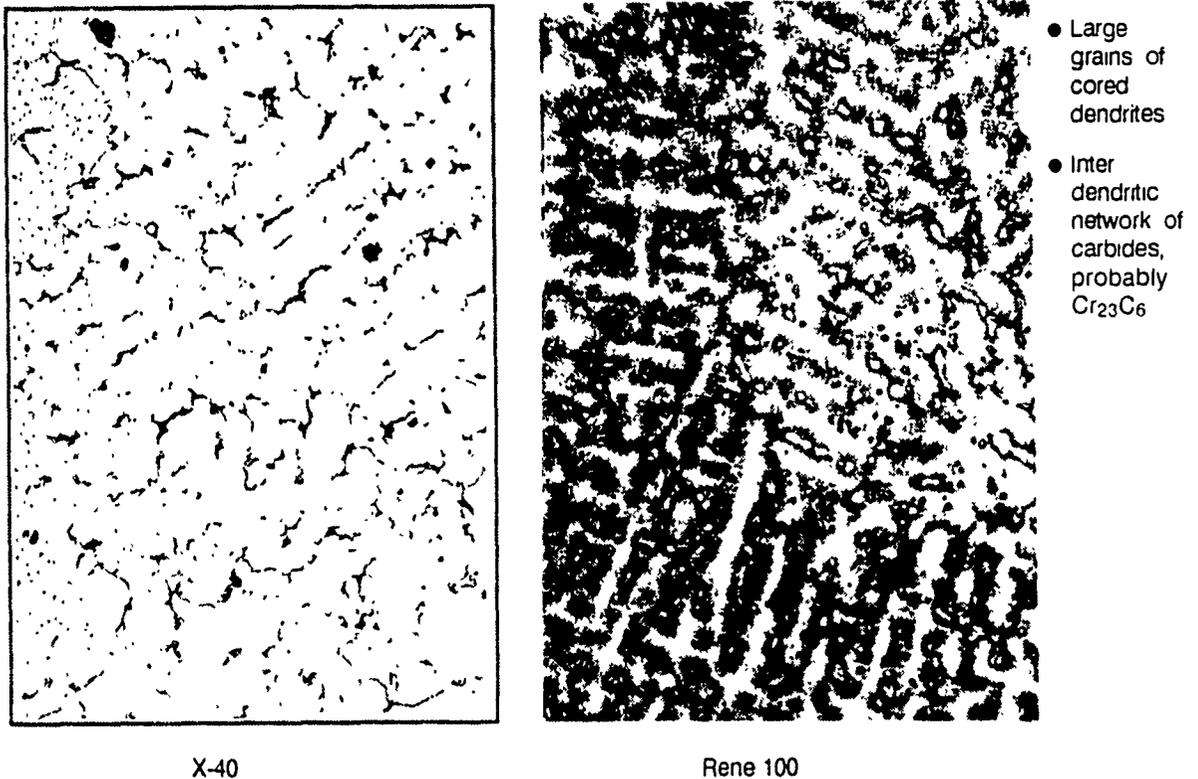
Results obtained from metallographic examination of specimens exposed to the hot corrosion tests were consistent with the weight change data. The microstructural features of the as-fabricated alloys are presented in Figure 9. Both alloys exhibit large grains composed of cored dendrites which are more readily seen in the nickel-base alloy. Carbides were evident as an interdendritic network distributed throughout both alloys. The major carbide in this network is believed to be  $\text{Cr}_{23}\text{C}_6$  in X-40 [10], and also probably in Rene 100 also.

Figure 9. As-cast condition. Mag. 100X

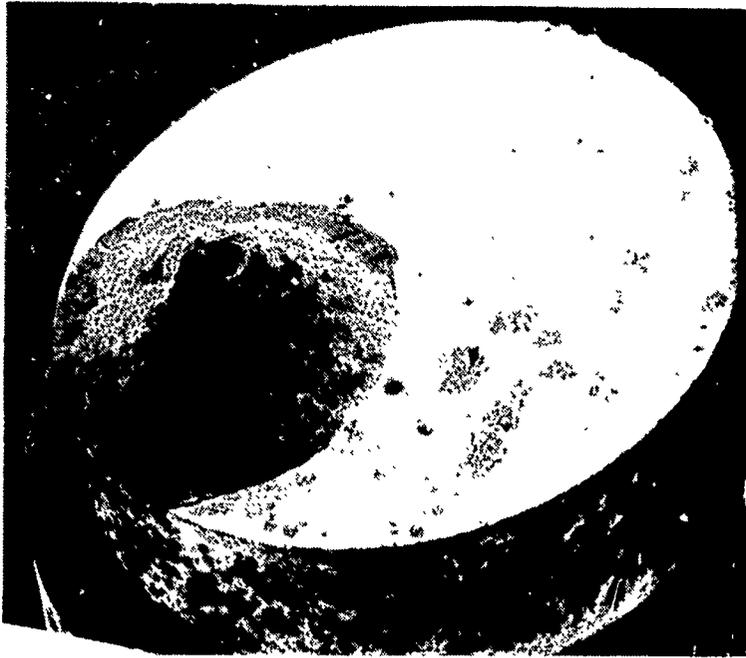
At 1600°F both single and multiple additions of Na<sub>2</sub>SO<sub>4</sub> resulted in visible coating failure after 50 hours at temperature. The attack usually was such that the coating was penetrated in localized areas (see Figure 14). After penetration of the coating substrate attack became evident as indicated by large amounts of corrosion products (see Figure 15).

Figure 14. Hot corrosion of Rene 100/CODEP B system after two applications of  $\text{Na}_2\text{SO}_4$  for 50 hours at  $1600^\circ\text{F}$ . Coating failure in localized areas. Mag. 7X
