WL-TR-93-4054

**X-RAY COMPUTED TOMOGRAPHY
FOR EMERGING AEROSPACE MATERIALS
AND PROCESSES DEVELOPMENT**

Boeing Defense & Space Group
P.O. Box 3999
Seattle, WA 98124-2499

Interim Report for Period September 1991 to May 1993

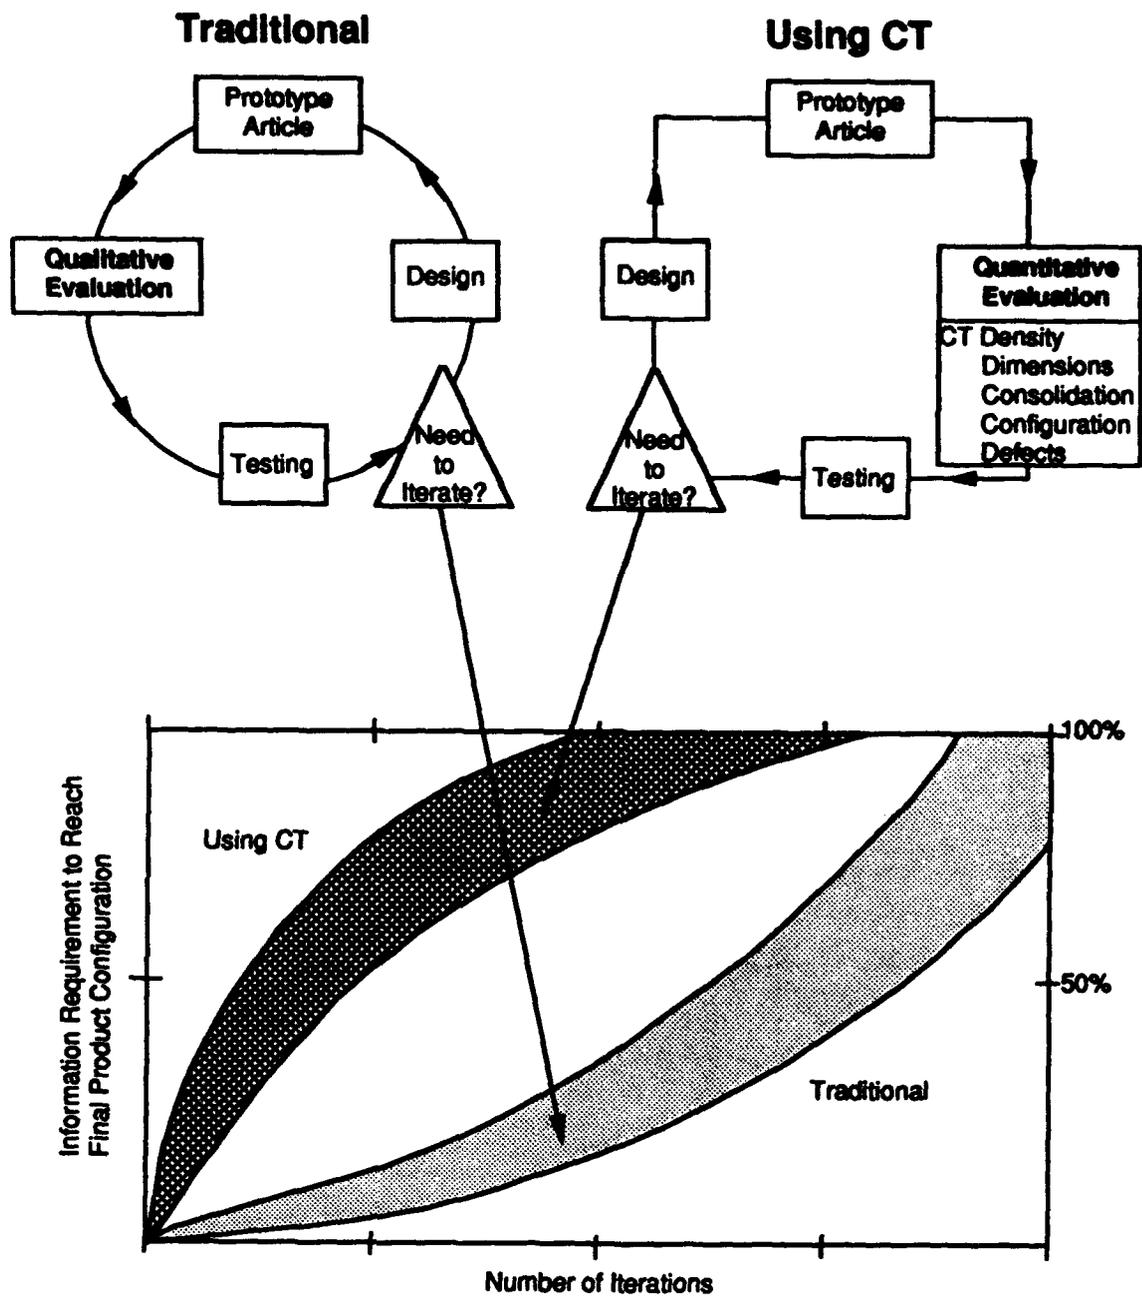
Figure 2.3-1 Diagram showing how CT measurements can contribute to the activity of emerging material and process development.

Based on the experience of the CTAD stories, it is possible to construct a general comparison of CT as an enabler of product development versus approaches that use traditional measurement techniques. Figure 2.3-1 shows graphically how CT can contribute to the activity of emerging material and process development. In this figure, the traditional approach requires a number iterations (design, prototyping, evaluation, testing, redesign, etc.) for the development team to arrive at sufficient information to establish the final product configuration (i.e. materials and processes) that provides the desired result. With CT, quantitative measures obtained nondestructively for features, consolidation, and dimensions within the product are available. This easily interpreted information allows informed decisions for product/process changes to rapidly define and achieve the desired final configuration and quality. The number of iterations to reach the necessary information level required for final product definition will be reduced. The graph of Figure 2.3-1 shows generalized curves for the relative effects of using CT versus the traditional (lack of quantitative nondestructive data) approach. By employing quantitative measurements, the overall product development schedule will be improved. The amount of improvement to the overall process, through the application of CT, will depend on the specific product.

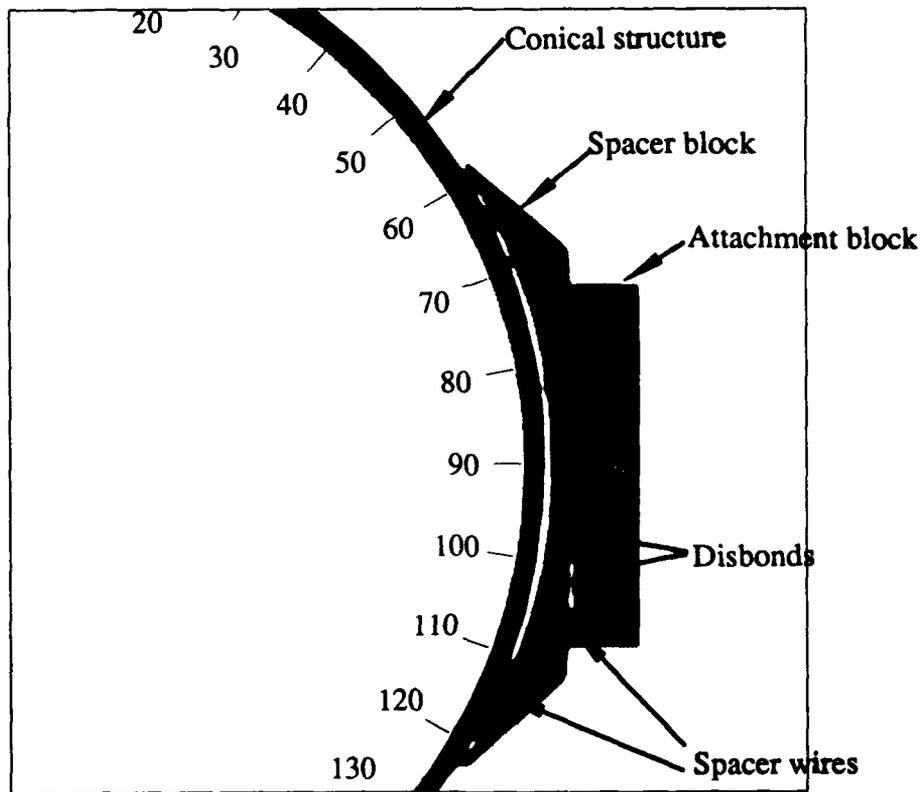
Figure 3.1.1-2 Enlarged area of interest from CT image of bonds.

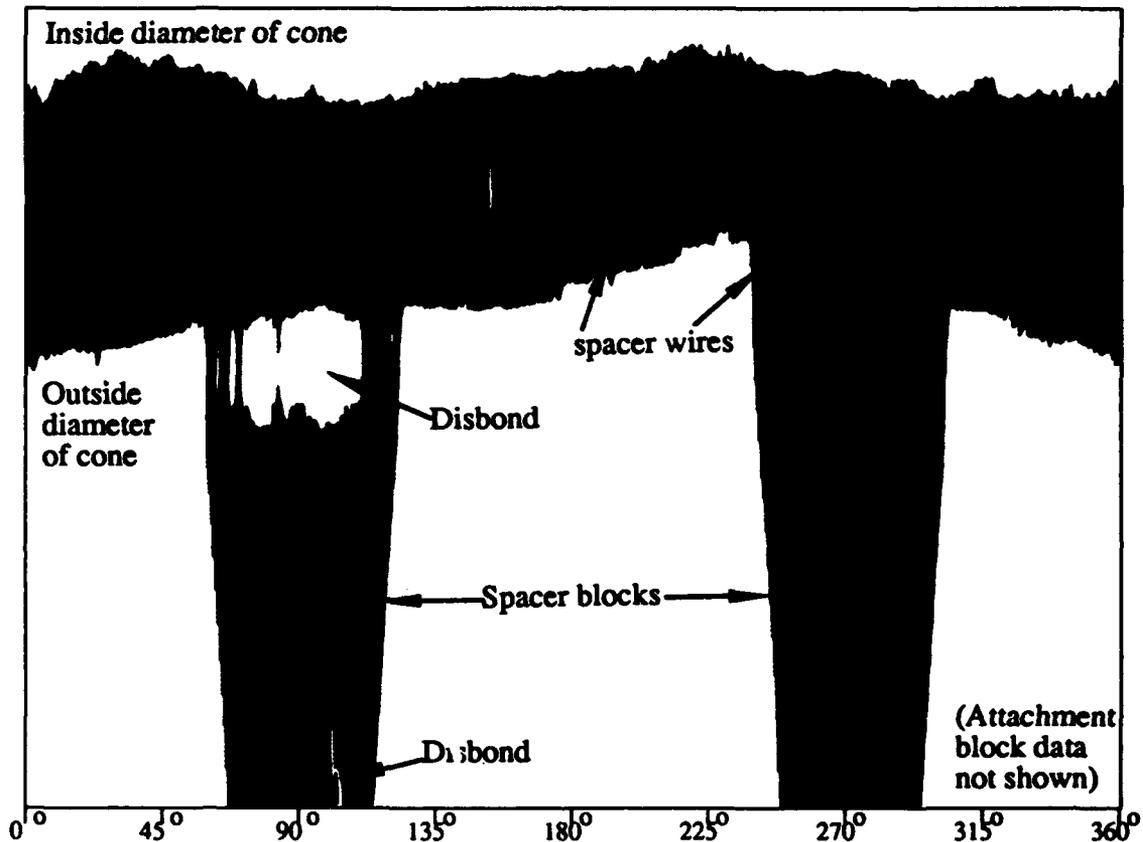
Figure 3.1.1-3 Cylindrical coordinate presentation of the CT slice data.

The data from this CT slice can be presented in a cylindrical (radius and theta) coordinate system mapped onto rectangular axes, as shown in Figure 3.1.1-3. The data is distorted in the r (radius) direction due to the magnification in that direction and "warping" of the inside wall of the cone when mapped onto the rectangular axis. The grayscale thresholds were set to make densities less than that of the composite material (e.g., air) appear white and those greater to appear black. The disbond is seen as the white area on the left hand portion of the figure, in the attachment region. The dark vertical lines in the gray area of the figure are the wires whose cross-sections have been "warped" into lines. Figures 3.1.1-2 and 3.1.1-3 indicate that the width of the disbond in the radial direction is roughly equal to the diameter of the inserted wires.

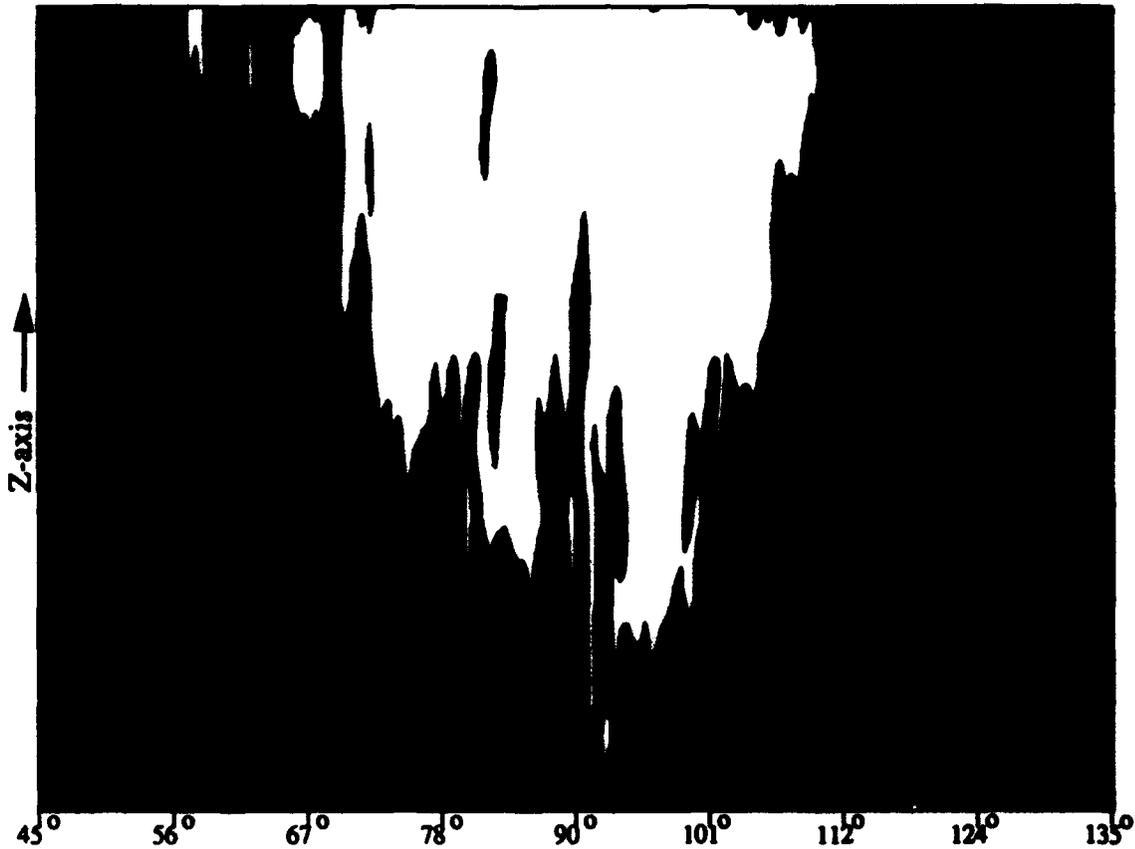
Figure 3.1.1-4 Map of the disbond from a set of 22 contiguous CT slices.

A series of 22 slices was taken at 2-mm intervals along the axis of the conical structure to create a volume data set. The data from these contiguous slices were processed to produce a "map" of the disbond in the vertical (z) and angular (theta) plane. By plotting the minimum through-thickness density for this plane from the volume CT data set, the disbond area will appear in the image as a function of angle and vertical height. The minimum CT density in the radial direction over the region of the bond is the disbond, i.e., the air in the disbond is seen as low density with CT. The plot is shown in Figure 3.1.1-4. This presentation of the composite data from all of the slices is essentially a map of the disbond and can be used to directly determine its area.

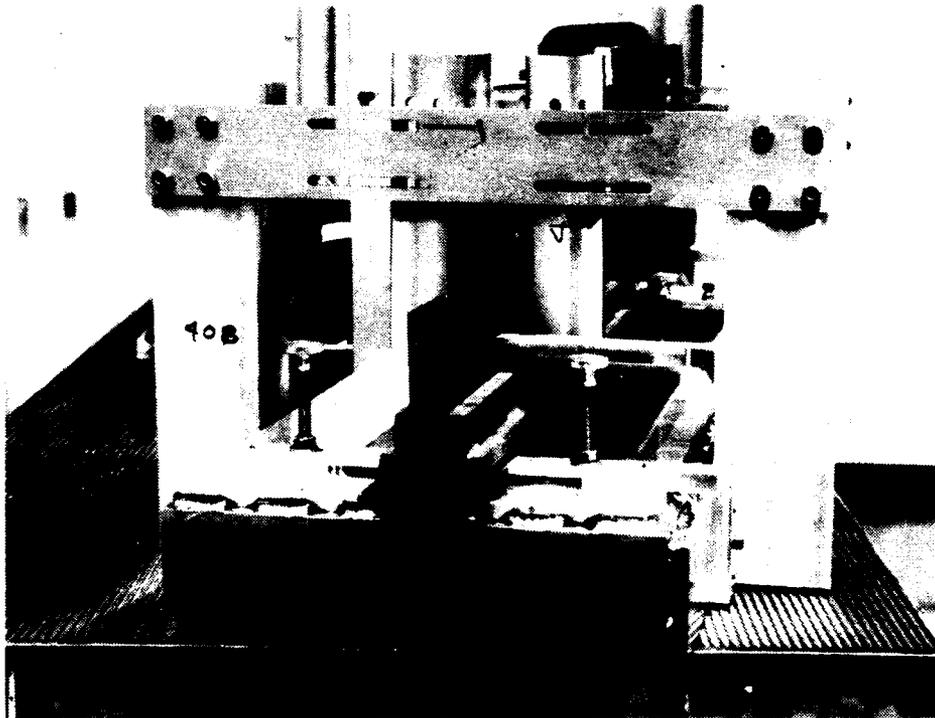
Figure 3.1.2-1 Photograph of bonding jig.

Figure 3.1.2-1 is a photograph of a bonded T-spar-to-skin section. The jig, constructed for demonstrating out-of-autoclave bonding is designed to allow adhesive bonding of 65-mm-wide composite "T" spars to 250-mm-wide skin sections.

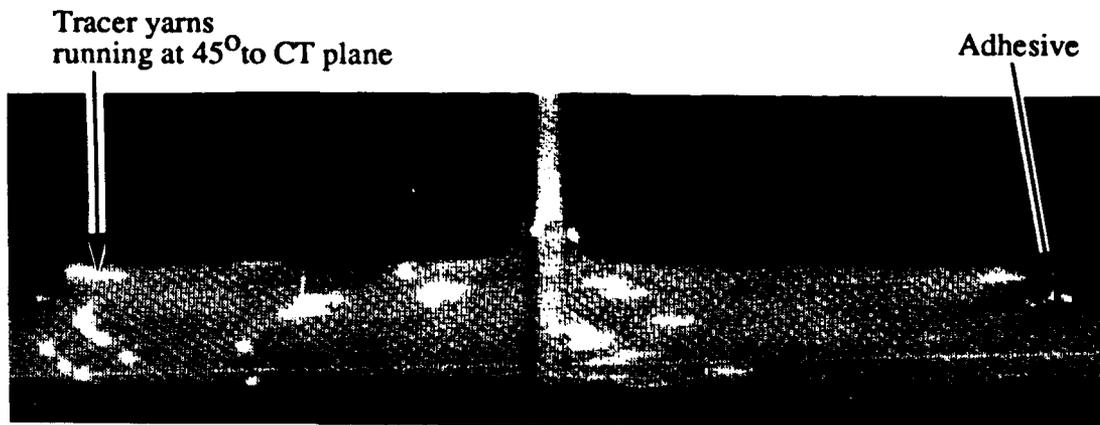
Figure 3.1.2-4 Example CT image from trial 3 showing no unbonds.

For the third bond trial, the controlling thermocouple was embedded in the bondline at the extreme end of the spar, and the thermocouple in the center of the spar was placed on top of the flange rather than in the bondline. This eliminated any potential bridging of the spar due to thermocouple wires in the central section of the spar. The CT results indicated a good contact along the bondline. An example is Figure 3.1.2-4.

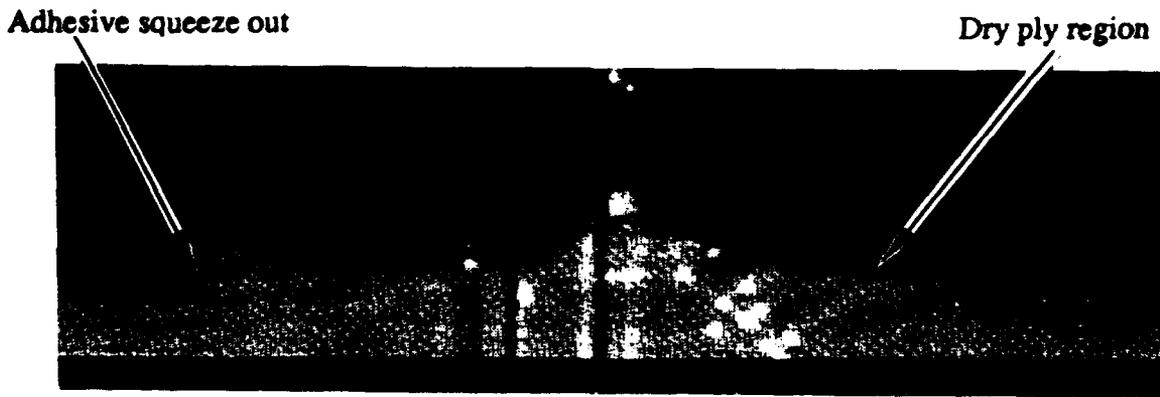
Figure 3.1.2-5 Example CT image from trial 4 showing dry ply region but no unbonds.

The fourth bond trial was run with a single adhesive film, nominally 0.2 mm (0.008 inches) thick, and an increase in air pressure in the elastomeric (65 psi). The purpose of these changes was to determine if a good bond could be made with less adhesive but more pressure. The CT results indicated a good contact all along the entire length of the bondline. However, a dry ply indication was identified along most of the length of the spar on one side of the flange which can be seen in the CT image of Figure 3.1.2-5.

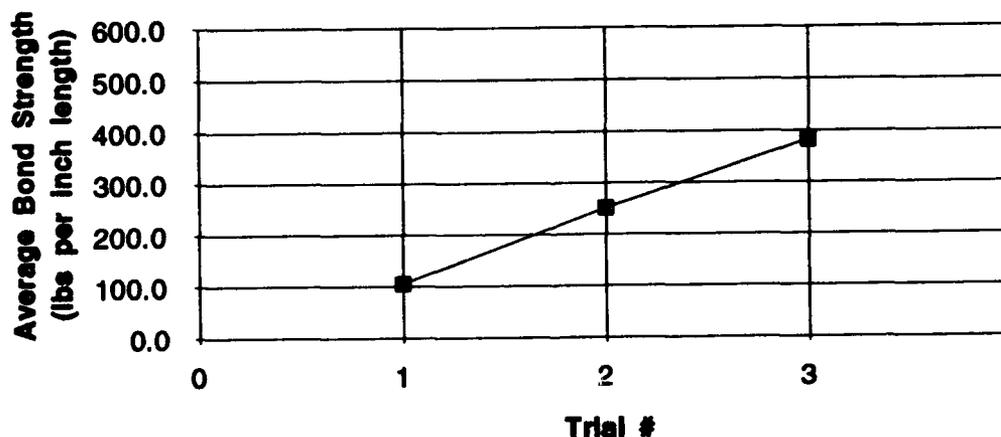
Figure 3.1.2-7 Average pull off strength versus trial number.

The pull-off results reflected the progressive improvement of the bonding technique from trial 1 to trial 3 that was indicated by the CT analysis. Trial 4 contained dry plies which caused the part to fail before the bondline failed. Figure 3.1.2-7 is a graph of the average pull-off strength versus test number for three of the four spar/skin tests. This graph illustrates that the out-of-autoclave bonding process can be controlled and improved. This result was predicted based upon the CT data.

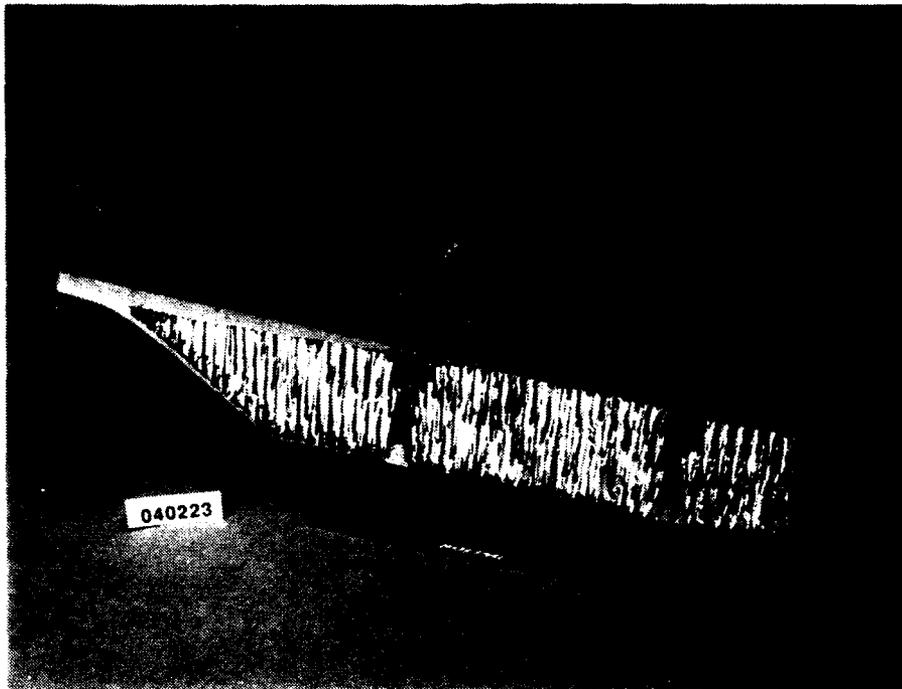
Figure 3.1.3-1 Photograph of a test section of a honeycomb composite enclosure.

It is often quite difficult to successfully detect defects on the interior wall of thick-walled honeycomb structures using normal NDE methods because the interior wall is inaccessible or the honeycomb is too dispersive for modalities such as ultrasonics. If the structure is of a suitable size for mounting on a CT system, it is possible to use CT to evaluate features of the internal bond surface. Figure 3.1.3-1 shows a photograph of a section of a honeycomb composite enclosure. The enclosure itself is curved, as is shown in the figure, and is slightly more than 50 mm (2 inches) thick. On the photograph a disbond is indicated whose extent has been mapped thermographically.

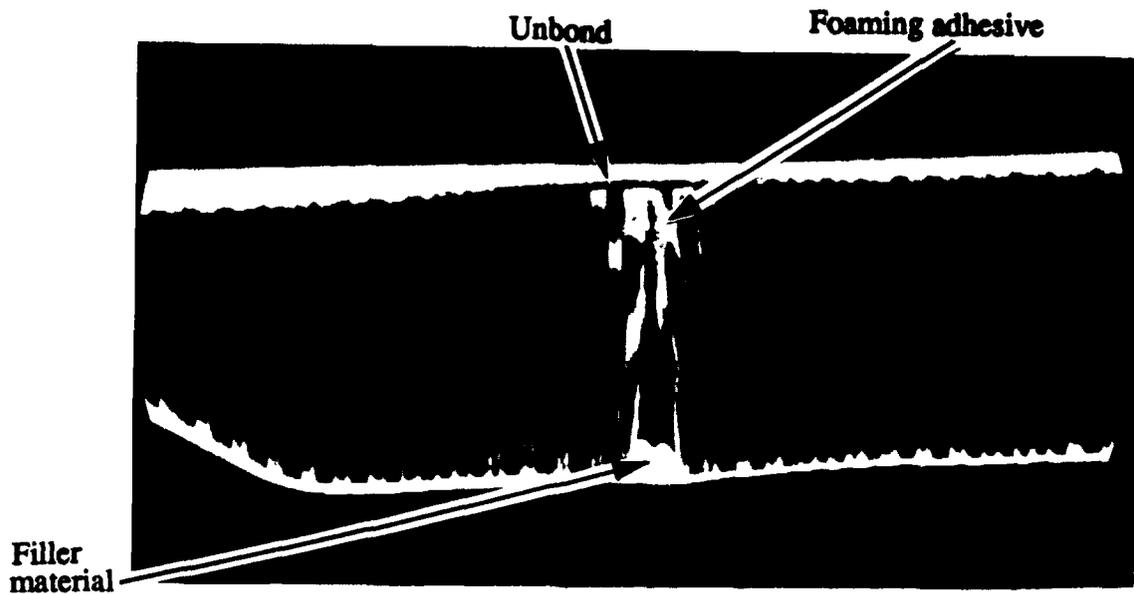
Figure 3.1.3-2 CT slice taken below the edge in the foreground of the photograph.

CT scans of the defect were taken in two mutually perpendicular planes, each normal to the surface underwhich the disbond exists. If the entire enclosure were present, rather than just a section, the CT slices could have been made in precisely the same way, provided the scanner and part size were matched. Figure 3.1.3-2 is a CT slice taken below the edge in the foreground of the photograph. The slice indicates the disbond, as well as foaming adhesive in the top of the vertical void and some filler material in the bottom of the void.

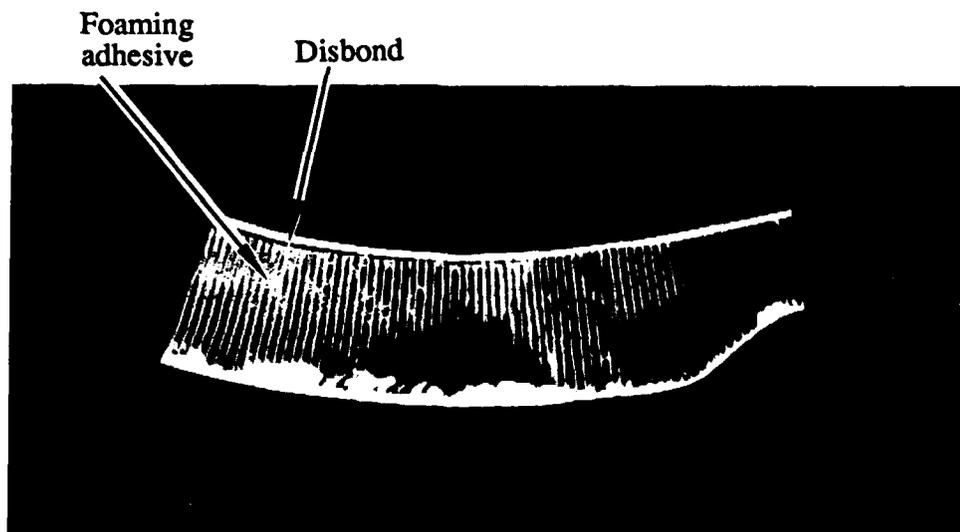
Figure 3.1.3-3 CT slice taken perpendicular to the Figure 3.1.3-2 image.

Figure 3.1.3-3 is a CT slice taken through the curved section perpendicular to the CT slice in Figure 3.1.3-2. From this slice it is easy to see that the disbond extends more than halfway across the section; whereas, thermographic mapping indicated an extent of less than one quarter of the way across. This information can be critically important to the successful development of processing techniques and monitoring measurement results from alternative methods.

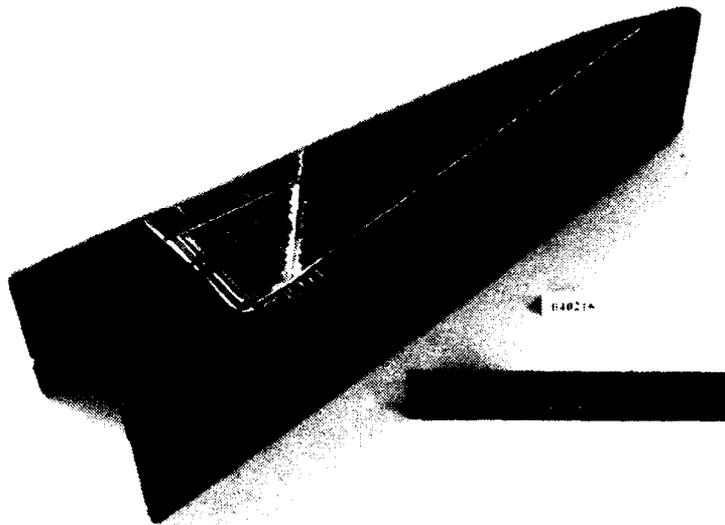
Figure 3.2.1-1 Photograph of a section of a leading edge.

One example is a leading edge made from a nomex honeycomb core bonded to a fiberglass skin. The core contains several internal septa, including one with a copper layer, to which the honeycomb material is bonded. A section of this leading edge is shown in Figure 3.2.1-1, illustrating the composite skin, honeycomb core and the various septa. The section includes a hole normal to its axis. The complexity of the geometries, as well as the number of different materials, limits the applicability of traditional NDI methods such as UT or ET.

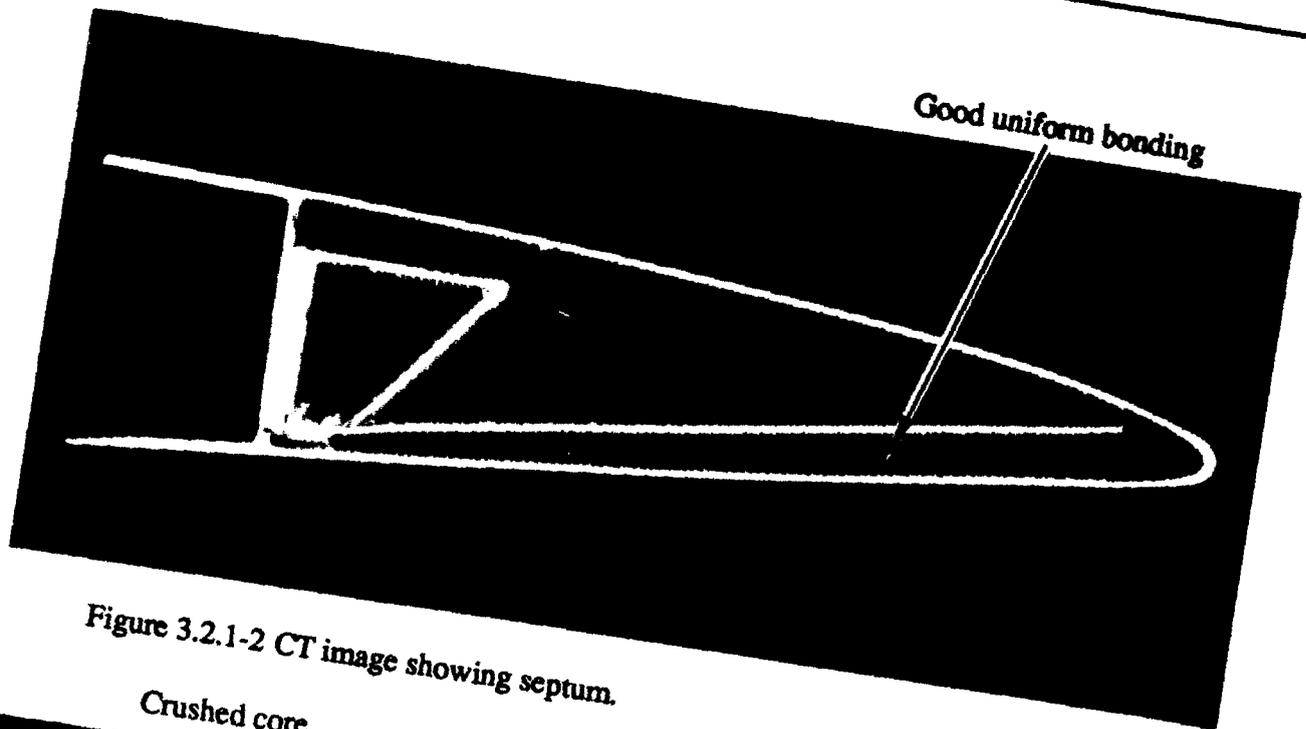
Figure 3.2.1-2 CT image showing septum.

Several CT slices of the section were taken to evaluate the quality of the adhesive bond between the septa and the honeycomb material, and to check for internal damage to the honeycomb material itself. One slice, whose image was displayed for two different values of density window width and density window level, revealed useful information regarding both the adhesive bond and the honeycomb condition. As shown in Figure 3.2.1-2, the bonding is uniform on the interface between the septa and the honeycomb material. Decreasing the density-window width and level revealed core damage to the interior of the honeycomb, in the triangular region bounded by the septa and the composite stiffener. This is shown in Figure 3.2.1-3. The black horizontal streak running near the upper surface is an image artifact, and not indicative of any condition of the material.

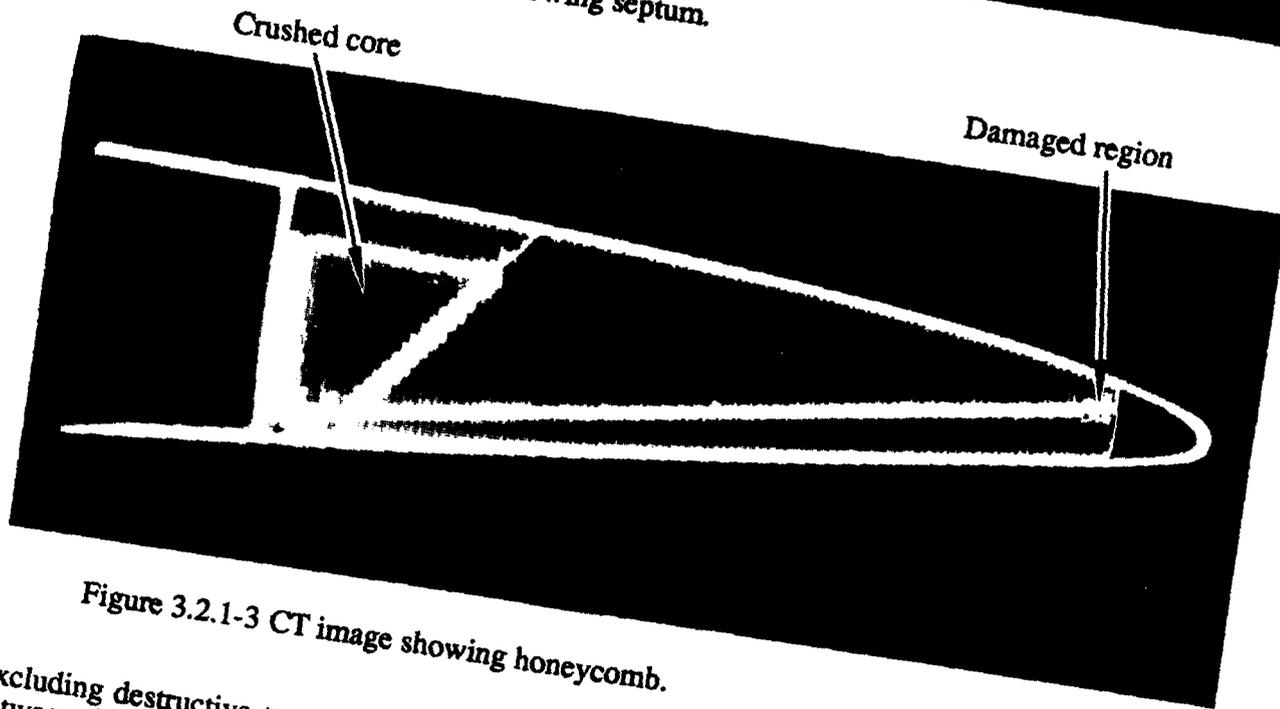
Figure 3.2.1-3 CT image showing honeycomb.

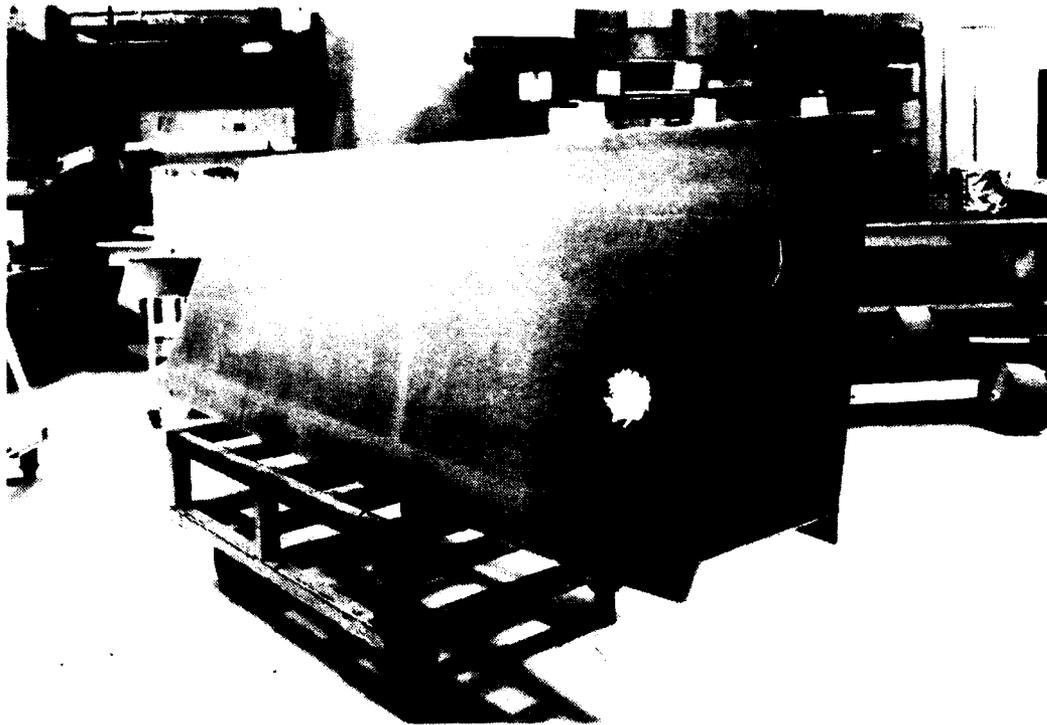
Figure 3.2.1-4 Photograph of a honeycomb trailing edge.

Another example of a honeycomb core composite with internal septa is the trailing edge made with a nomex core and a fiberglass/epoxy skin. A photograph of this rather large component (approximately 2.4 x 0.9 x 0.6 m (94 x 35 x 24 inches)) is shown in Figure 3.2.1-4. The trailing edge was made from several honeycomb sections, cut at angles to one another, and bonded together with a foaming adhesive. A good bond between cores, with minimal spreading of the adhesive, is important at these locations. An internal septum along the length was formed by bonding two halves together. This was done by placing a layer of prepreg cloth between layers of film adhesive bonded to each half.

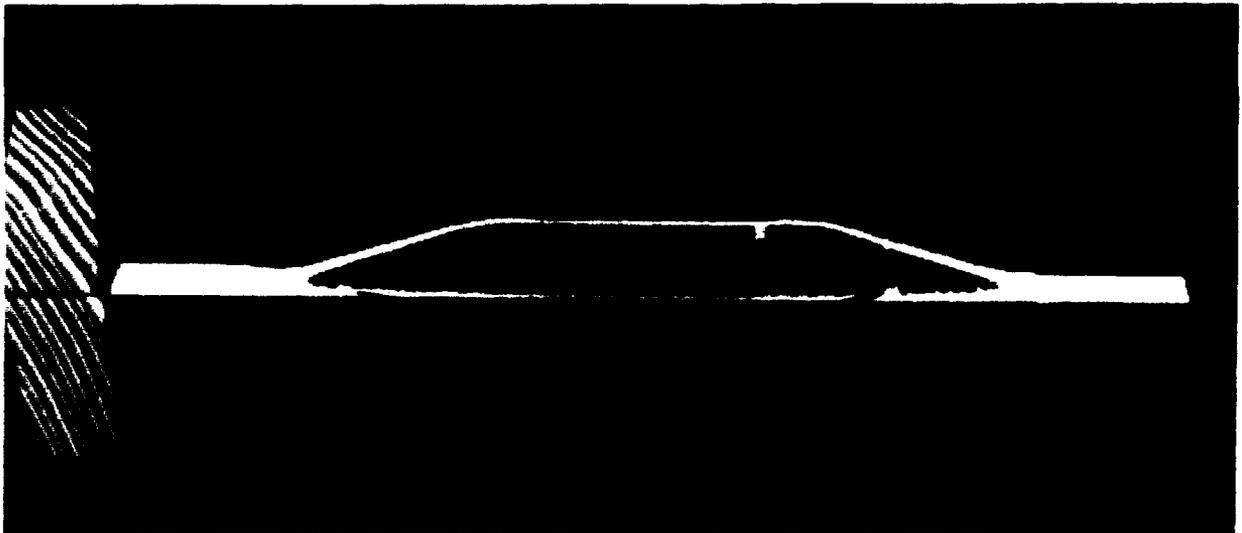
Figure 3.2.2-2 CT image showing water distribution in the honeycomb structure.

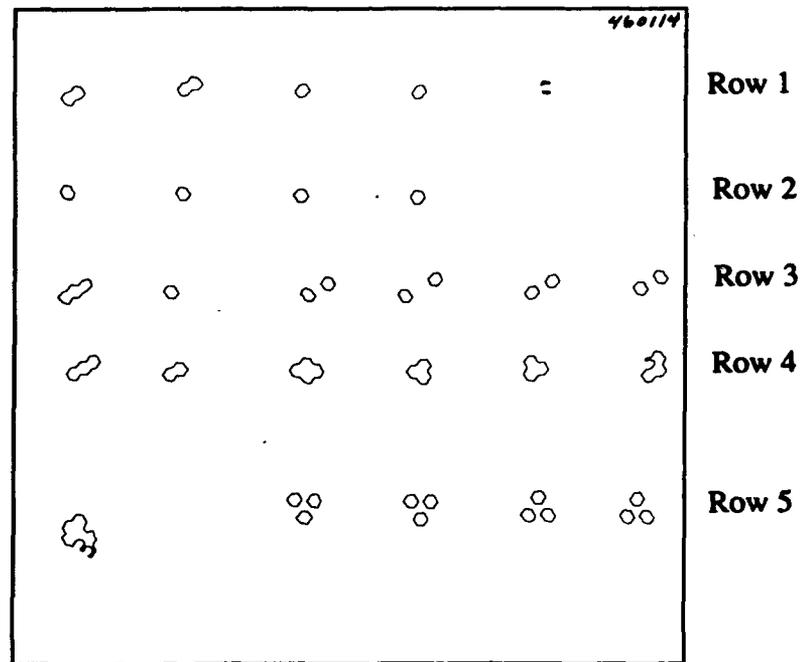
Figure 3.2.2-6 CT image of panel 2 showing water distribution in cells at 1.5 mm (0.06 inches) above the bottom preenvironmental cycling test.

A series of CT slices were taken with the panels mounted in the horizontal position to quantify the amount of water in the panels by obtaining a volume data set. By orienting the panels horizontally, the number of CT slices to cover the 20-mm-thick panel is minimized. These slices were taken both before and after the thermal cycling. The data was processed to threshold the water in each CT slice, creating contours which define the location of the water. The area of the image contours was calculated for each slice. Since the number of slices and their spacing are known, the total volume of water can be calculated. The CT slices taken near the top and bottom of the series were partially volumed by the panel sheets and the adhesive of the honeycomb. For panel 2, the volume of water was determined to be 4.8 cm³ pre- and 4.4 cm³ post-environmental test. The pretest value was very close to the estimate of the injected quantity of water. Because the water was migrating under the environmental test, some of the water ended up in cells at such a low level that it was impossible to distinguish from the interference with the adhesive layer bonding the honeycomb to the panel substrate, resulting in a lower volume measurement in the postcondition. Figures 3.2.2-6 and 3.2.2-7 are slices taken in panel 2 in the pre- and post-conditions, respectively. Figure 3.2.2-6 is a slice taken at approximately 1.5 mm (0.06 inches) above the bottom of the panel, and Figure 3.2.2-7 is a slice taken at approximately 2 mm (0.08 inches) above the bottom. It is again easy to see the net migration of the water.

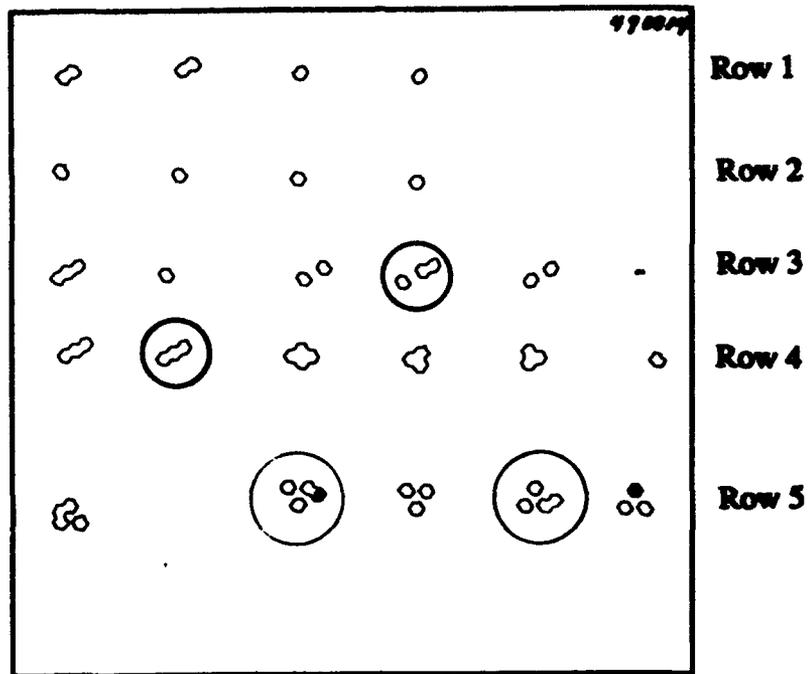
Figure 3.2.2-7 CT image of panel 2 showing water distribution in cells at 2 mm (0.08 inches) above the bottom postenvironmental cycling test.

The observed migration in panel 2 could possibly be attributed to a leak caused by the drilling process used to inject water for the thermal cycling test. A CT slice taken with panel 2 in the vertical position appears in Figure 3.2.2-8. It indicates a damaged cell, which is in the column 4, row 3 water containing cell cluster of Figure 3.2.2-7.

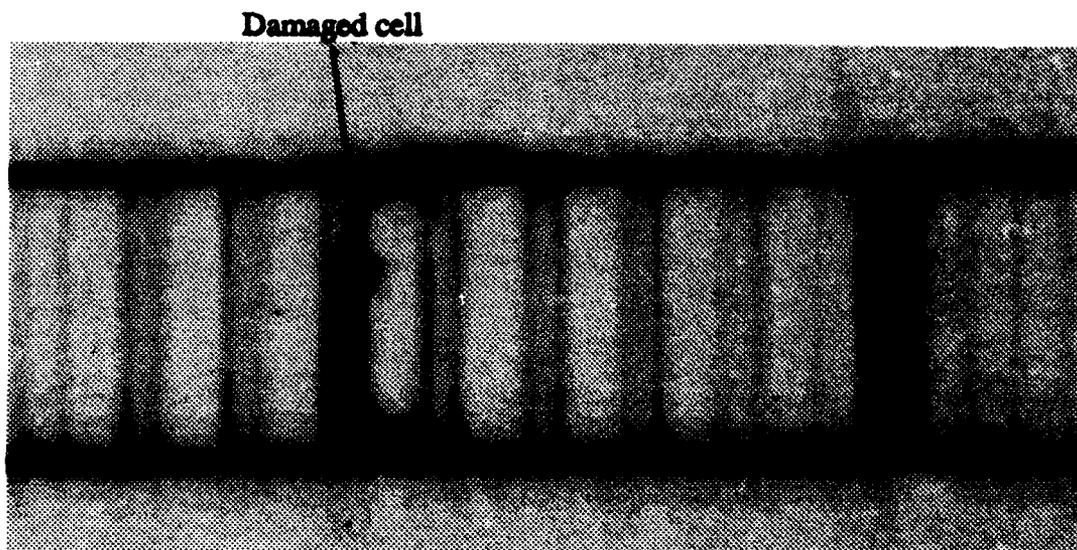
Figure 3.2.2-8 CT image across cells of panel 2 showing damaged cell.

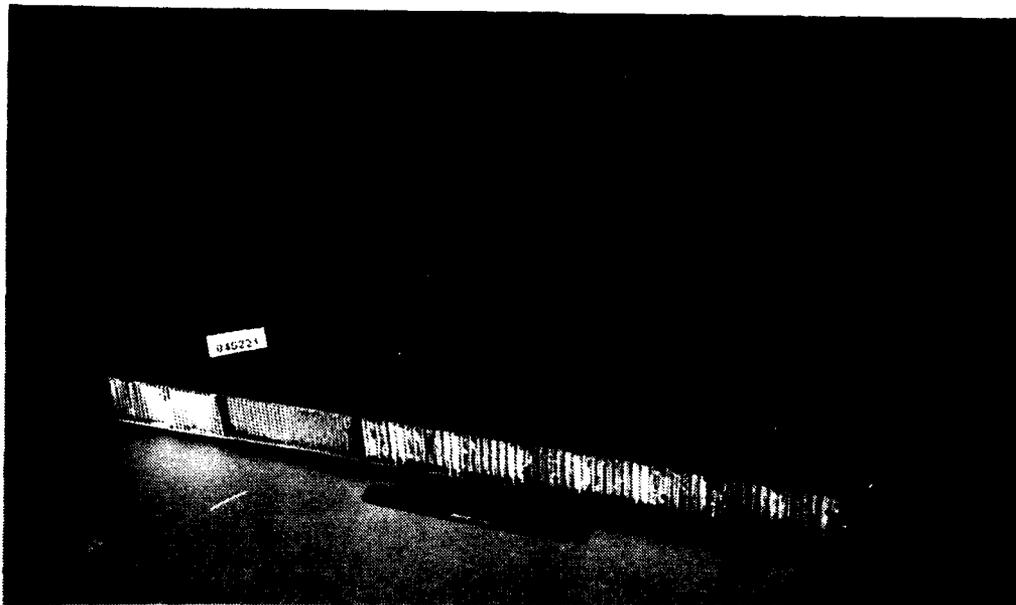
Figure 3.2.3-1 Photograph of a composite test panel.

Honeycomb structures will often be inspected by large area NDI techniques. Test specimens must be fabricated to establish the sensitivity of the NDI method. CT can provide information on the test specimens to show that they are fabricated correctly, with suitable features for the NDI evaluation. A photograph of a test panel is shown in Figure 3.2.3-1. The panel is approximately 600 mm (24 inches) square and 50 mm (2 inches) thick. The aluminum core has sections of three different densities and is comprised of sections of two differing thicknesses. The panel contains a number of features intentionally engineered into the honeycomb interior, allowing it to be used as a standard for thermographic NDI. These features include depressions machined into both of the surfaces of the aluminum core, crushed portions of core material, various types of adhesives between the core and the panel skins, and several repair regions.

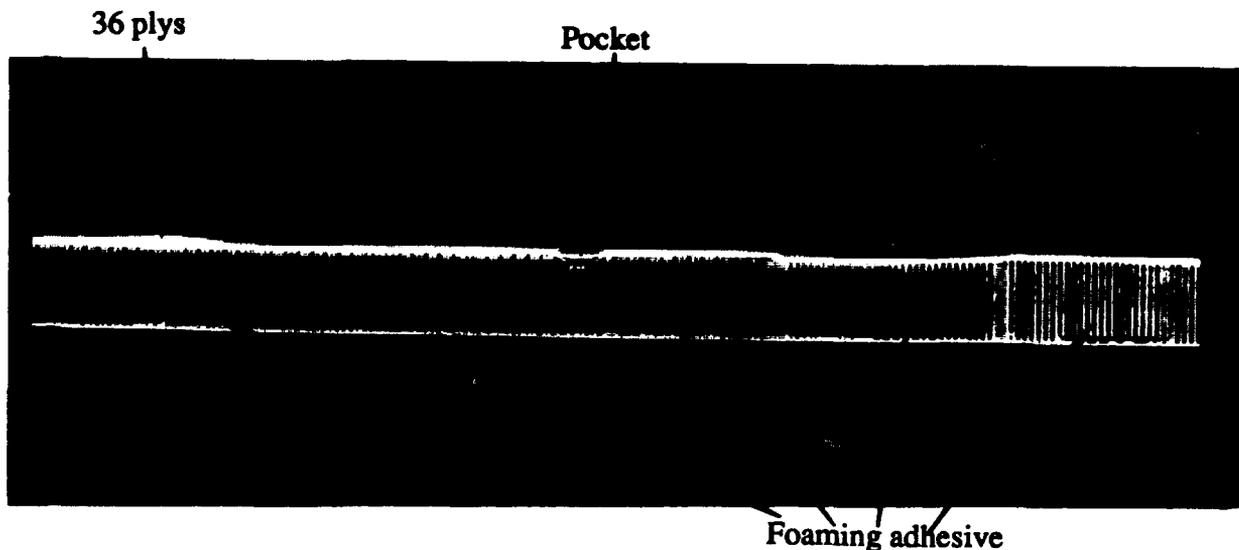
Figure 3.2.3-2 CT image of panel.

An image of one CT slice is shown in Figure 3.2.3-2. The upper skin in this figure contains a portion of 36 plies on the left-hand end. In roughly the center of the upper skin, there is a pocket machined into the honeycomb core. An adhesive layer is seen to be sagging slightly into this layer. The core itself is least dense, 0.24 g/cm^3 (3.1 lb/ft^3) over the left hand two thirds, then a section which is more dense, 0.47 g/cm^3 (6.1 lb/ft^3) over approximately the next sixth, and finally a section which is much more dense, 1.7 g/cm^3 (22.1 lb/ft^3) of the same width appears on the right. The medium density section is slightly less thick, as can be evidenced by observing the depression in the upper skin covering that portion of the panel. The upper skin was laid up and cured on the core. At four places along the bottom, just above the skin, foaming adhesive is seen. This adhesive was introduced into four "pockets" machined into the lower surface of the various sections of the core.

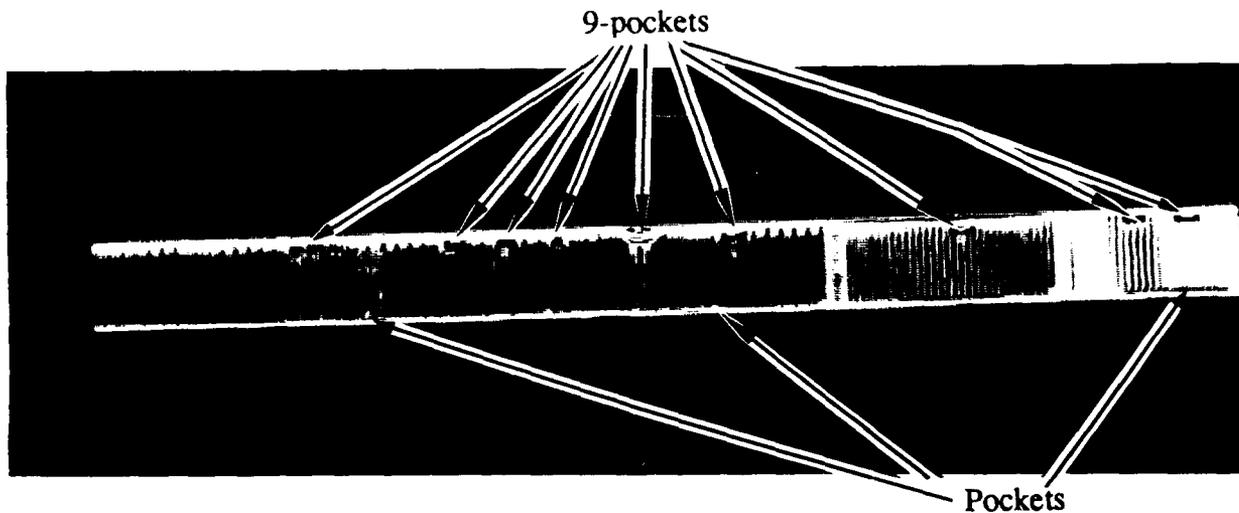
Figure 3.2.3-4 CT image of panel.

Figure 3.2.3-4 is an image of another CT slice taken about 75 mm (3 inches) away from the CT slice shown in Figure 3.2.3-2, but skewed slightly relative to the panel edge. This figure shows nine "pockets" machined into the upper surface of the various honeycomb sections. The dimensions of these pockets can be easily confirmed as per drawing. Also, there are four pockets similar to those on the lower surface of Figure 3.2.3-2, but in this case, there is no foaming adhesive. Those pockets in the light density core area (the left-hand two-thirds of the panel) are more difficult to see than those in the medium and high-density areas because the density difference in these latter two areas is greater.

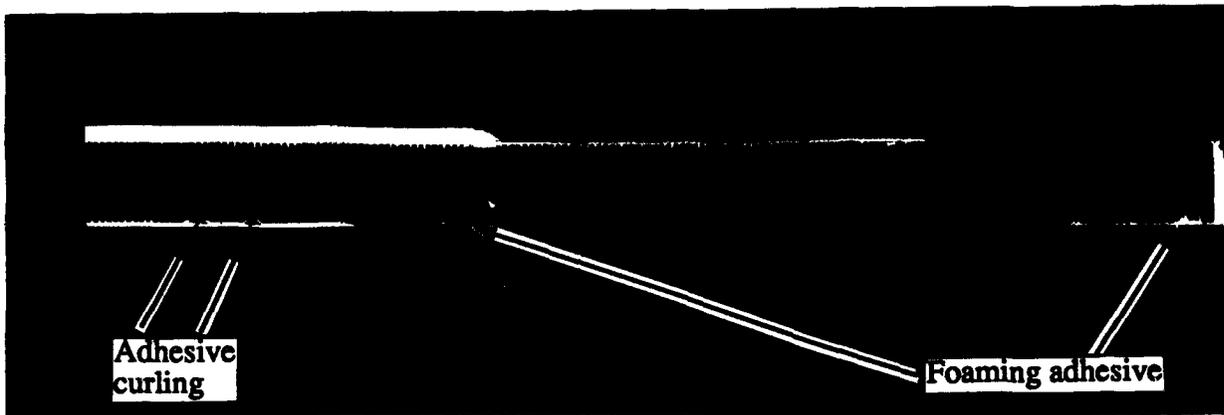
Figure 3.2.3-5 CT image across panel.

Figure 3.2.3-5 is an image of a CT slice taken across the panel perpendicular to the CT slices in Figures 3.2.3-2 through 3.2.3-4, cutting through the region containing only the light density core material. In several places, foaming adhesive is evident. The upper skin has sections of 36 plies on the left, tapering to 9 plies in the center, and finally to 3 plies on the right. The lower skin starts at 10 plies on the left then tapers to 4 plies for the remainder of the panel. Adhesive curling is seen on the bottom skin/core interface near the left end of the panel. Careful observation of the image on the CT system monitor showed some porosity in the 36-ply section on the upper left.

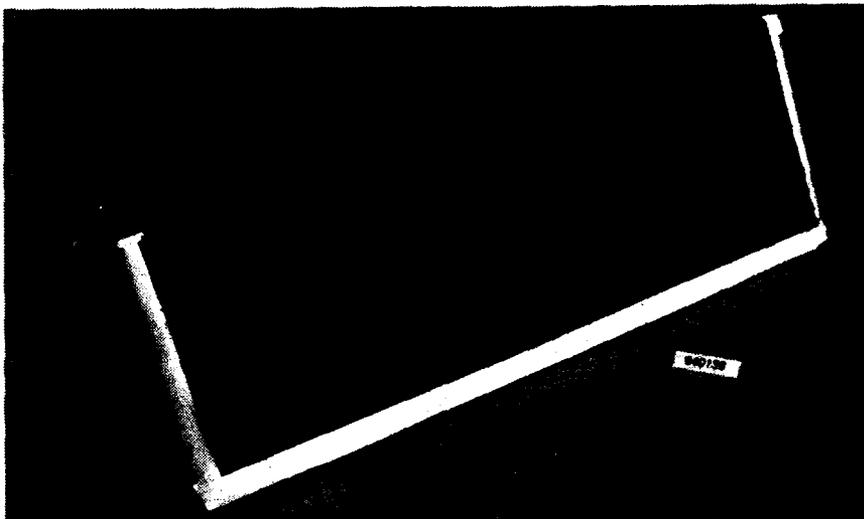
Figure 3.3.1-1 Photograph of "V" shaped composite test panel.

The aft boom fairing on the F-22 ties the vertical tail into the upper aft skin and is an example of developing a difficult-to-manufacture geometry. As part of the subscale testing of the chosen concept, layup of the graphite/BMI over a tight radius (0.5 mm (0.02 inches)) was required. Several parts were fabricated for the purpose of determining if the tight radius could be made while maintaining a good quality part. Figure 3.3.1-1 is a photograph of a test piece. While UT was sufficient for evaluating the flat areas of the parts, the very tight radius could not be adequately evaluated with this or any other conventional NDE method. CT was successfully used for examining the material at the radius of several parts.

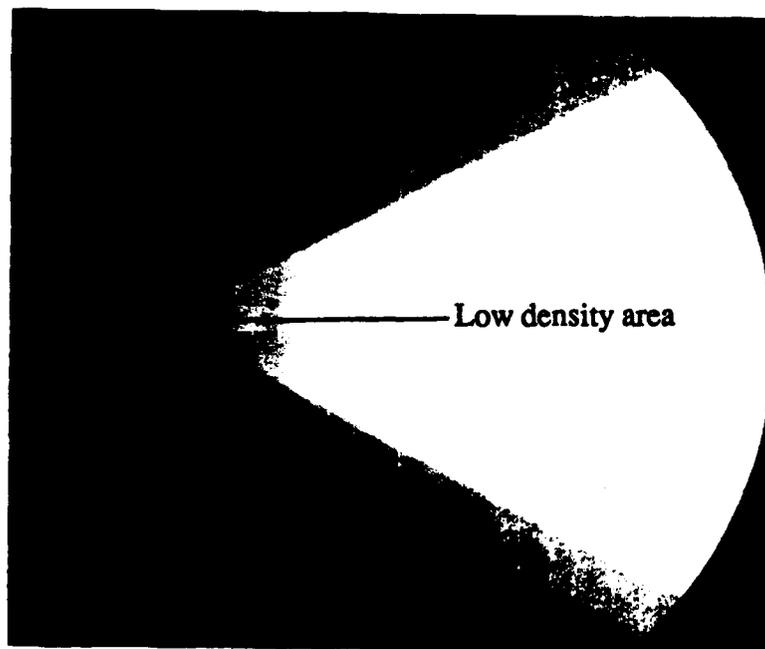
Figure 3.3.1-3 CT image of "V" section using bolus to reduce artifacts for article 1.

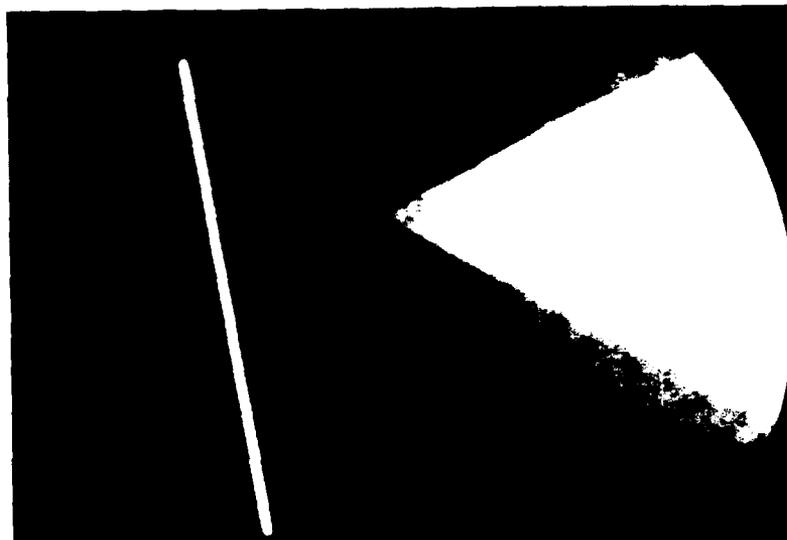
Figure 3.3.1-4 CT image of "V" section for article 2.

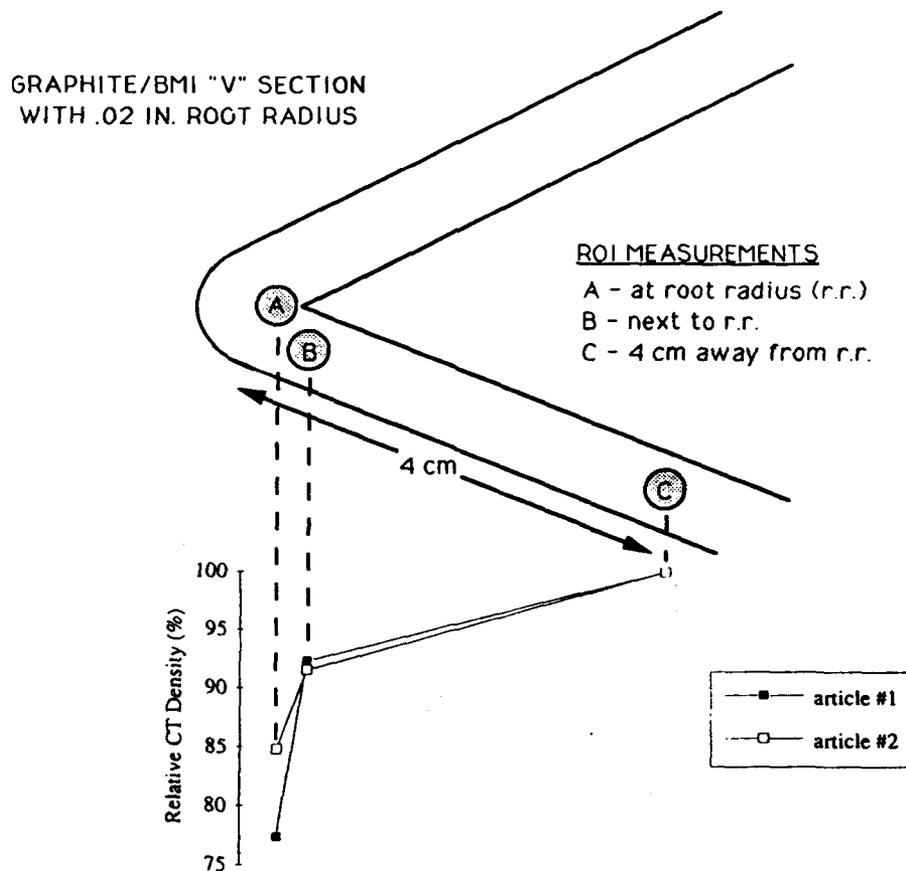
Figure 3.3.1-5 Drawing showing region of interest and CT measurement results.
