WL-TR-93-4054

**X-RAY COMPUTED TOMOGRAPHY
FOR EMERGING AEROSPACE MATERIALS
AND PROCESSES DEVELOPMENT**

Boeing Defense & Space Group
P.O. Box 3999
Seattle, WA 98124-2499

Interim Report for Period September 1991 to May 1993

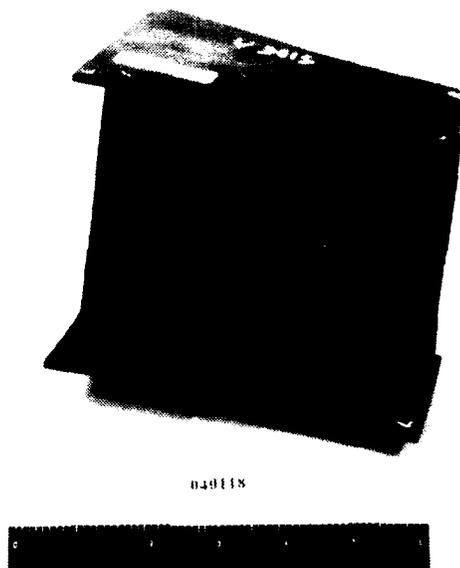
Figure 3.3.2-1 Photograph of a test section of a sinewave spar.

While it may not replace UT for general inspection of sinewave spars, CT appears to have potential as an evaluation tool for the web/flange intersections. An earlier CTAD report on CT for composites indicated just that [4]. In order to assess the defect detection capabilities of CT at these intersections, a thermoplastic sinewave spar was evaluated on a medium resolution CT system. Figure 3.3.2-1 is a photograph of a section of a spar. Previous CT scanning with a medical system had indicated that flaws were present in critical areas [4], but the resolution of the medical CT images was not sufficient to actually characterize the defects.

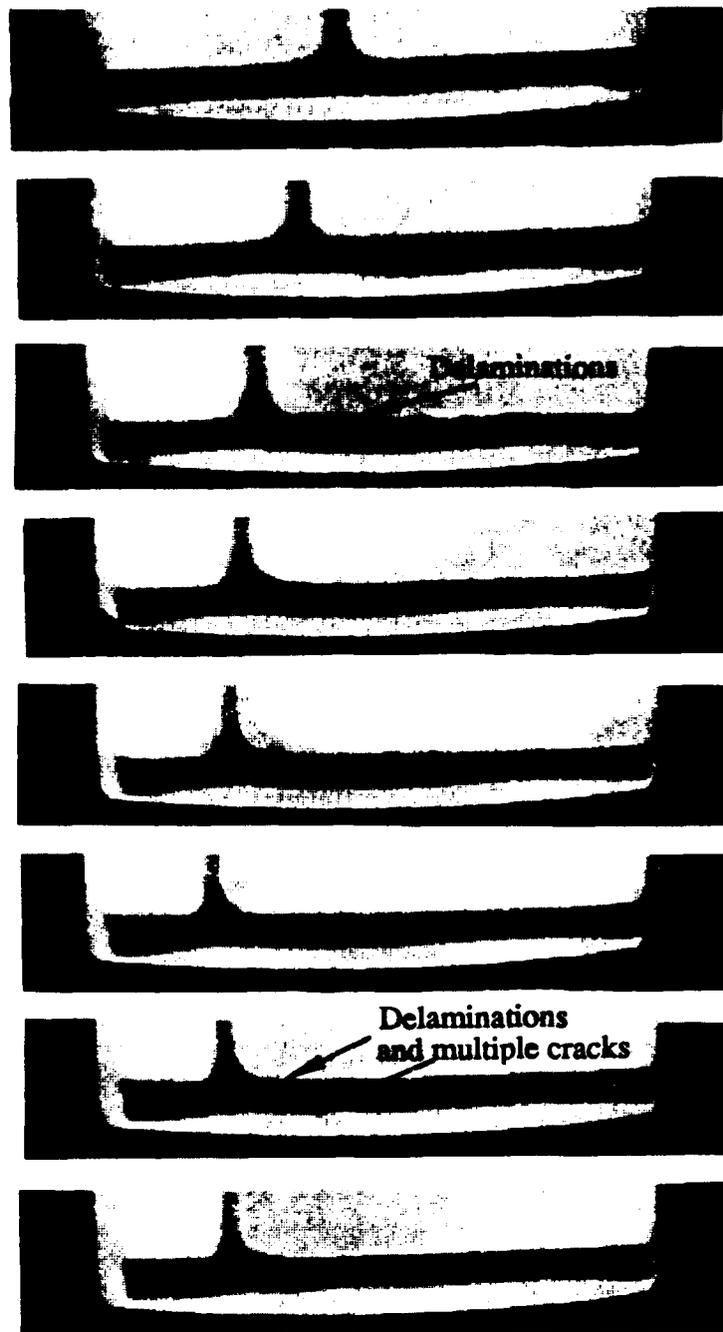
Figure 3.3.2-3 CT image series of a sinewave spar showing flange cracks and delaminations.

Delaminations and cracks that connect delaminations were found near one end of the spar section at the web/flange intersections. A series of contiguous slices were then taken in this region in order to more fully characterize the flaws. Thirty-one slices 1 mm (0.04 inches) apart were taken over a 3-cm (1.2 inch) length to produce a 3-D data set of the area. Part of the series of slices (every fourth image) is shown in Figure 3.3.2-3, where the right web/flange intersection is isolated. The shape, size, and relative location of the cracks and delaminations are clearly defined within the spar cross section.

The defects in this spar are relatively large. Not all cracks or delaminations that must be identified will be this significant. However, it is clear from the definition in these scans that smaller defects can be imaged. The CT data provides spatial characterization of the flaws, which can be used to make informed decisions about needed process modifications, and to predict part performance. At the same time, the CT data can provide a complete dimensional measure of the spar at any chosen location. If CT were to be used as a defect detection tool for the web/flange intersections, required dimensional measurements could be made simultaneously and

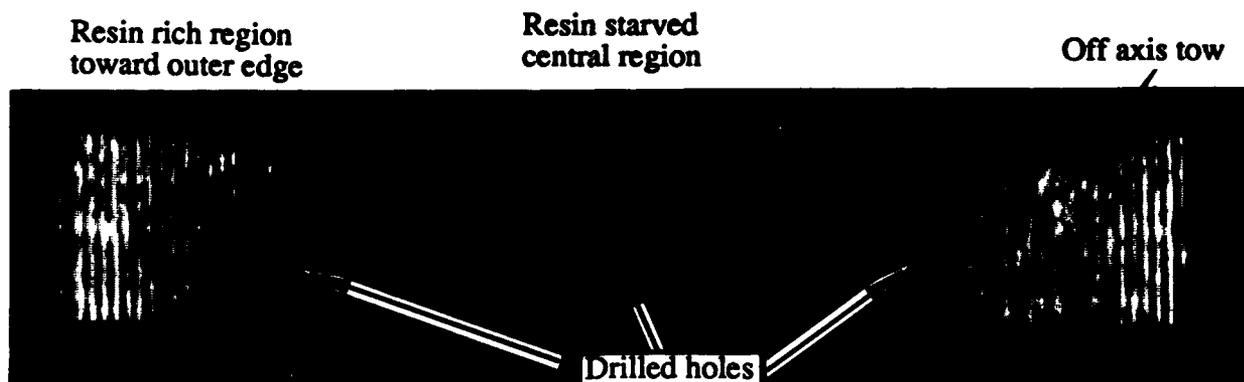
Figure 3.4.1-3 MPR reconstructed CT image of the composite beam at 3.9 mm (0.15 inch) from surface.

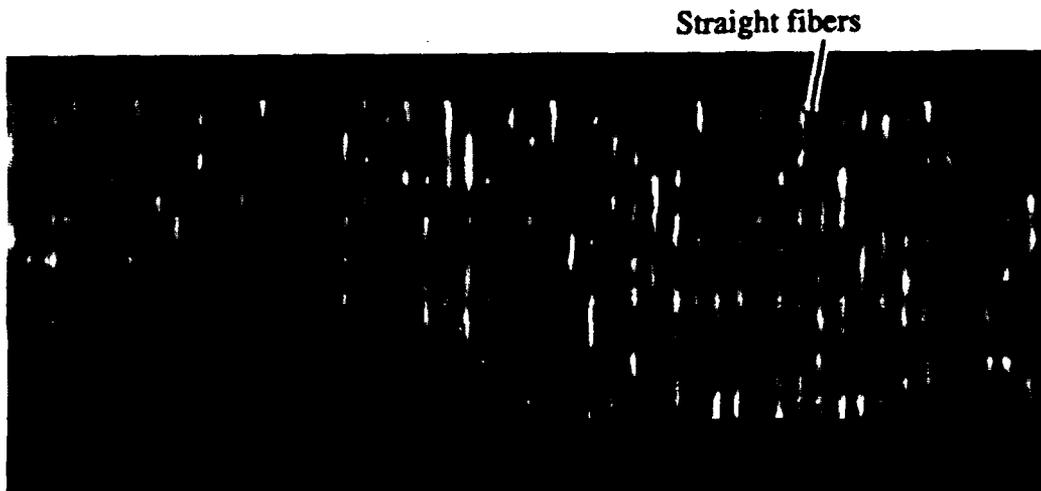
Figure 3.4.1-4 MPR reconstructed CT image of the composite beam at 10.8 mm (0.43 inch) from surface.

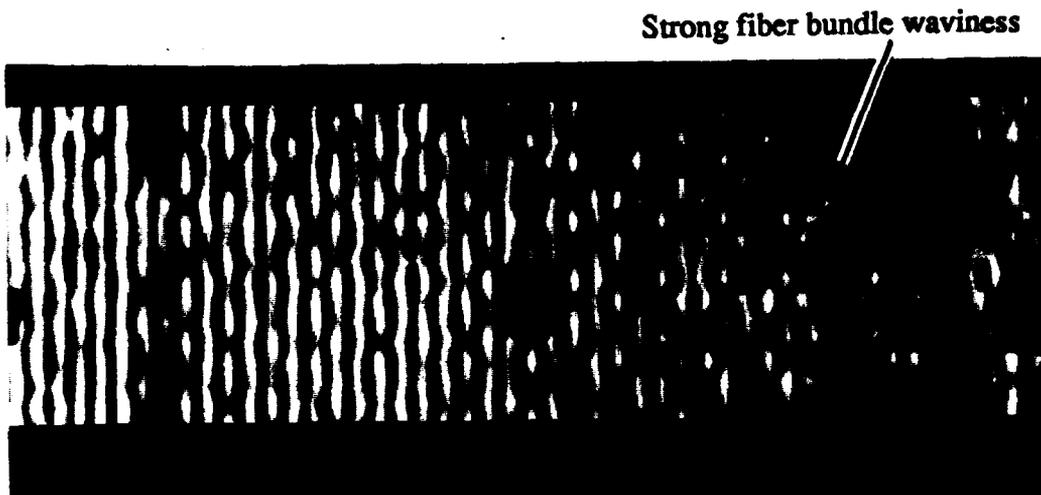
Figure 3.4.1-5 MPR reconstructed CT image of the composite beam at 4.1 mm (0.16 inch) from surface.

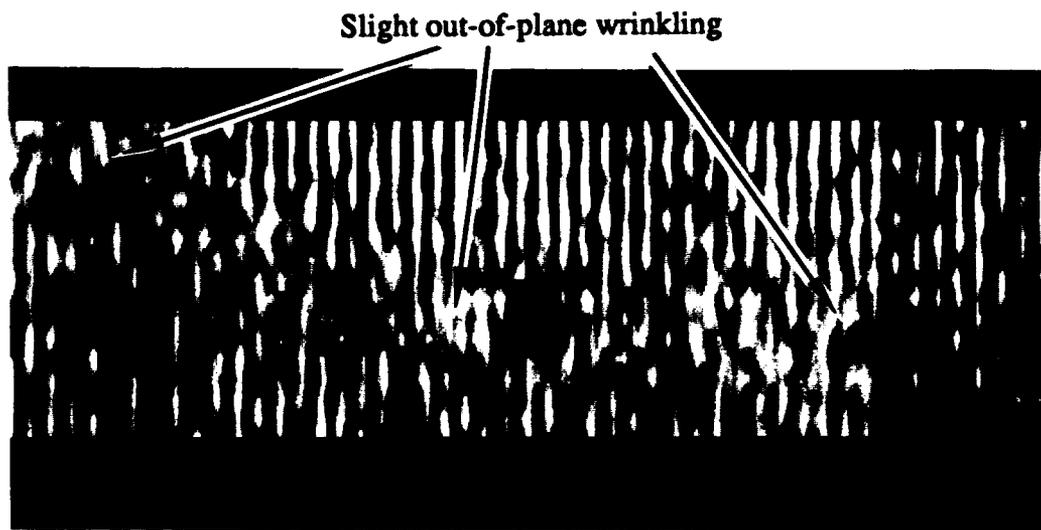
Figure 3.4.1-6 MPR reconstructed CT image of the composite beam at 9.4 mm (0.37 inches) from surface.

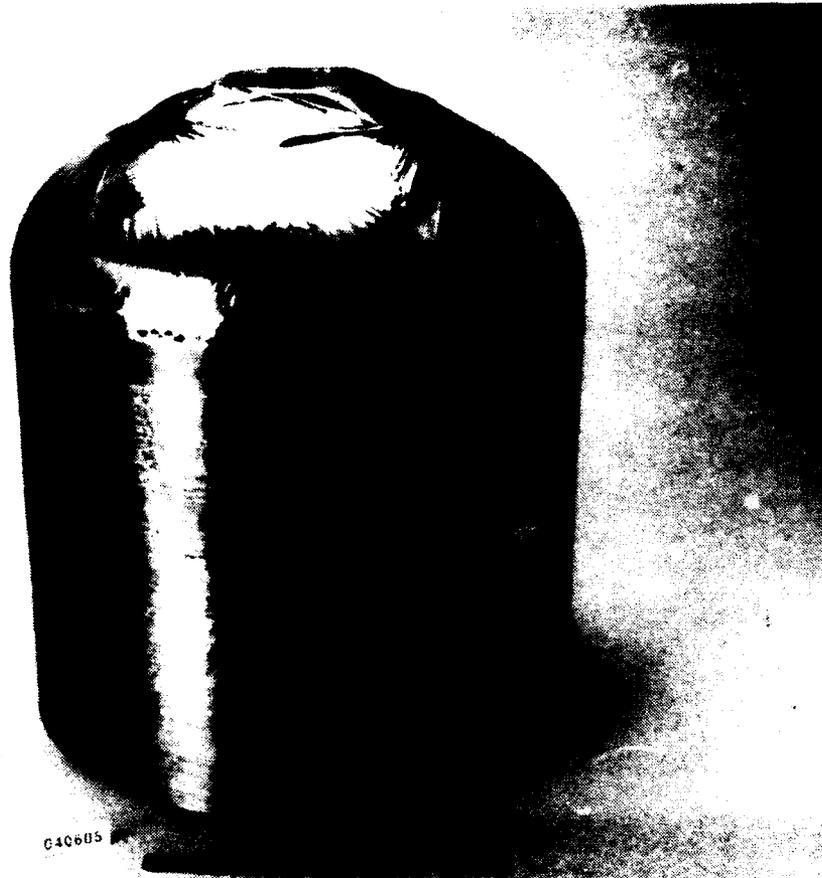
Figure 3.4.2-1 Composite filament wound bottle with a foam core.

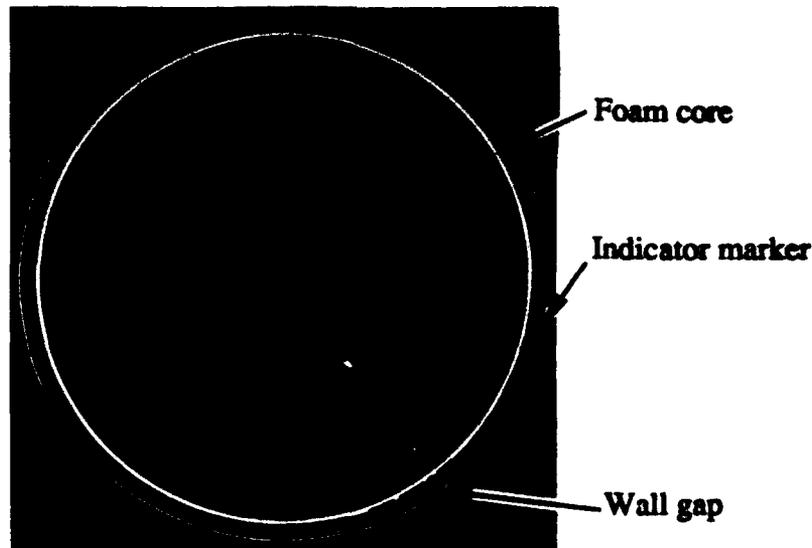
Figure 3.4.2-2 CT slice of the bottle.

Several slices of the bottle were made to investigate potential disbonds and the condition of the foam core material. Figure 3.4.2-2 is a CT slice taken through the region of the bottle including the butt joint and sleeve. The foam core material is seen in this figure, along with an indicator marker just below "3 o'clock" in the figure. At about "5 o'clock" a gap in the wall material is indicated. This gap is too far away from the inner surface of the bottle to be the bond between the wall and the sleeve. It is a gap in the inner wall itself. Adjusting the window level to omit the lighter density materials, such as the core foam and the sleeve, permits further detail as to the condition of the inner wall itself. Figure 3.4.2-3 is the same slice with the window level increased to show only the denser materials in the figure. The wall gap, revealed in the previous figure, is seen to be more extensive, at "4 o'clock and 5 o'clock," with further indications at "10 o'clock" and just above "3 o'clock." No other NDE method is capable of giving this information on an enclosed structure such as this.

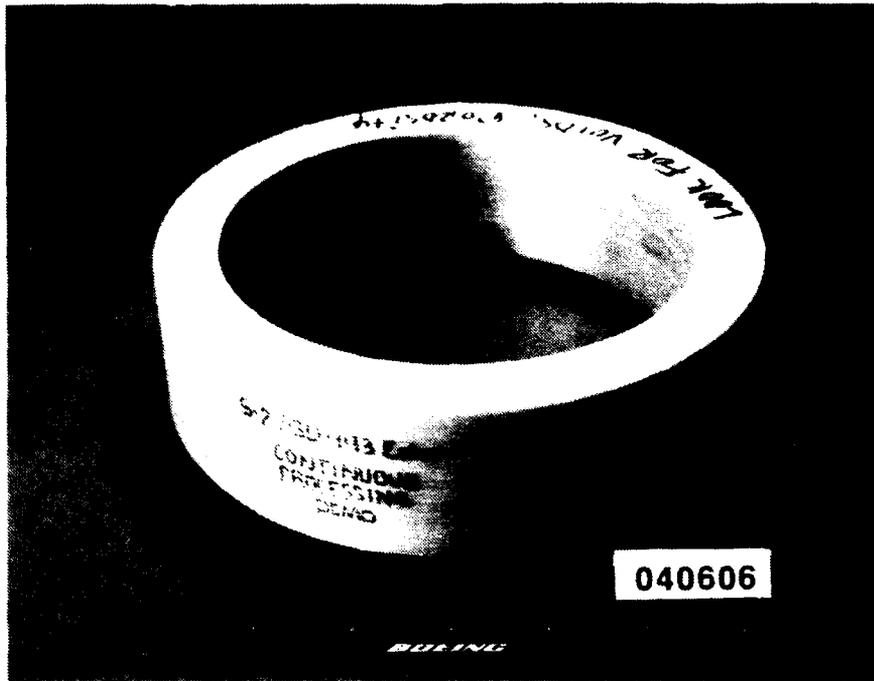
Figure 3.4.3-1 Photograph of fiberglass ring.

A second example of a wound component is a fiberglass composite ring, 156 mm (6 inches) in diameter and a 15-mm- (0.6-inch-) thick wall. The ring was examined for voids and general condition of the composite. A photograph of the ring is shown in Figure 3.4.3-1. Several CT slices of the ring were made. One is shown in Figure 3.4.3-2. This slice indicated voids between windings near the outer surface of the ring at about "6 o'clock" and "8 o'clock." The image also shows a number of low-density indications. In addition, the inner most portion of the ring is considerably less dense than the remainder of the ring. These features are quickly detected with CT, and give much more detail concerning the general condition of the ring and process effects than any other NDE method.

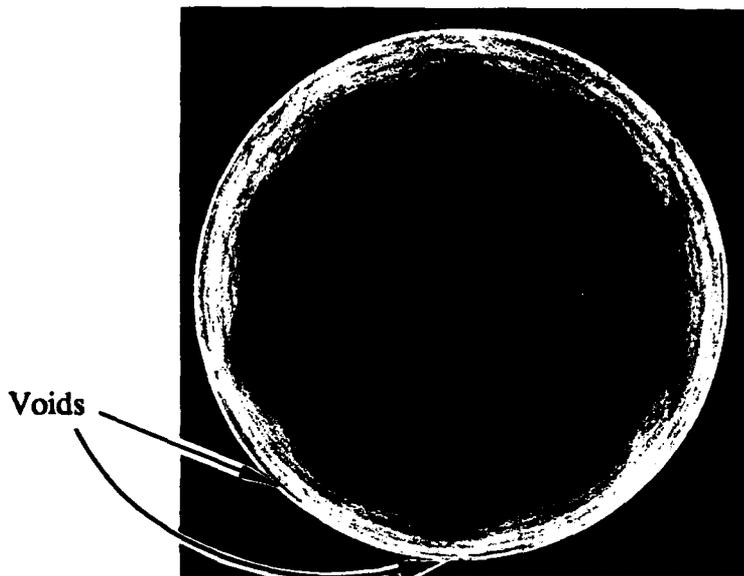
Figure 3.4.3-2 CT image of the ring showing voids in the windings.

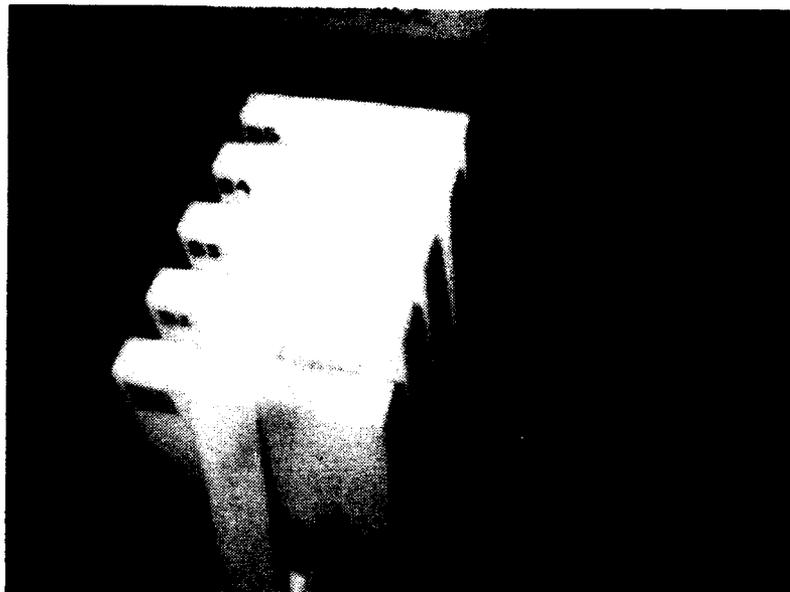
Figure 3.5.1-1 Photograph of the five green specimens mounted for CT examination.

Evaluation of test foam was performed on rectangular samples in two conditions: "green" and thermoformed. The thermoformed specimens are representative of those to be installed in the spar. Five green specimens, labelled B1 through B5, and six thermoformed specimens, labelled A1 through A6, were examined by CT. A photograph of the five green specimens mounted for CT scanning appears as Figure 3.5.1-1. As shown in the figure, all five of the green specimens were scanned simultaneously, as were the six thermoformed specimens.

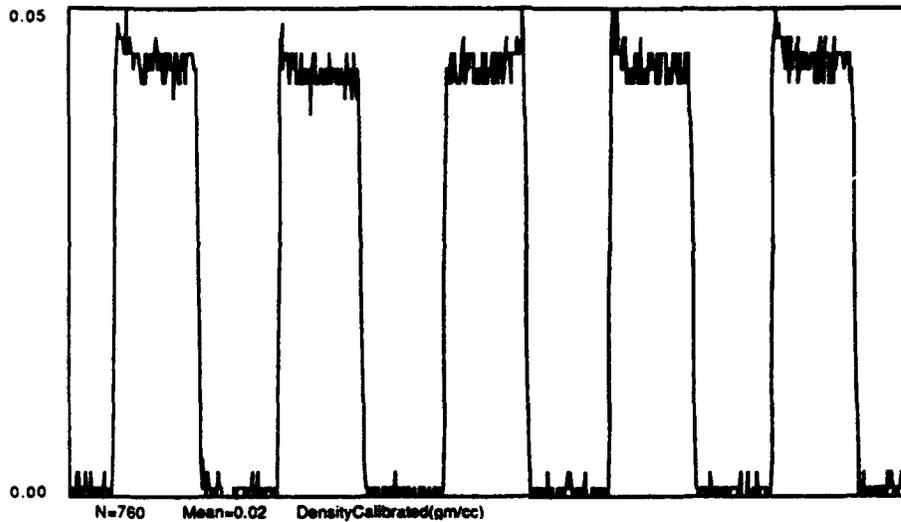
Figure 3.5.1-4 Density plots of "green" foam specimens.

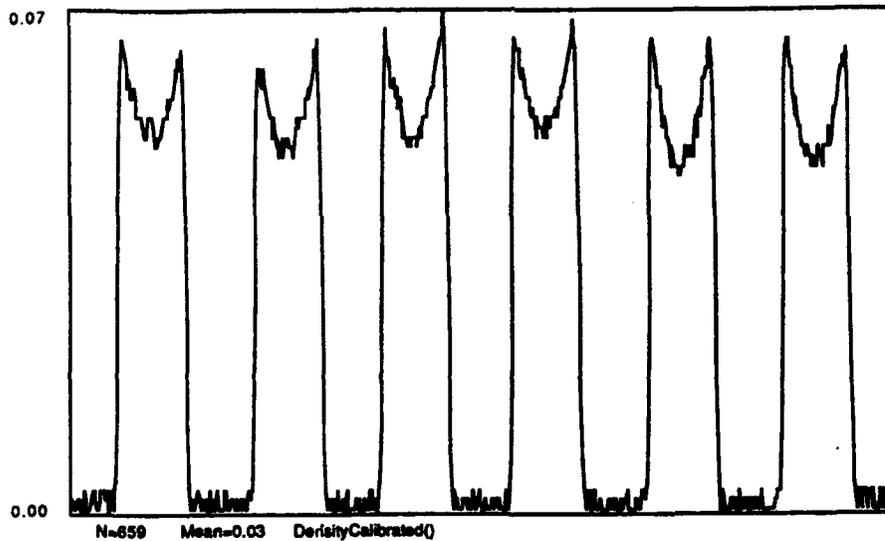
Figure 3.5.1-5 Density plots for thermoformed foam specimens

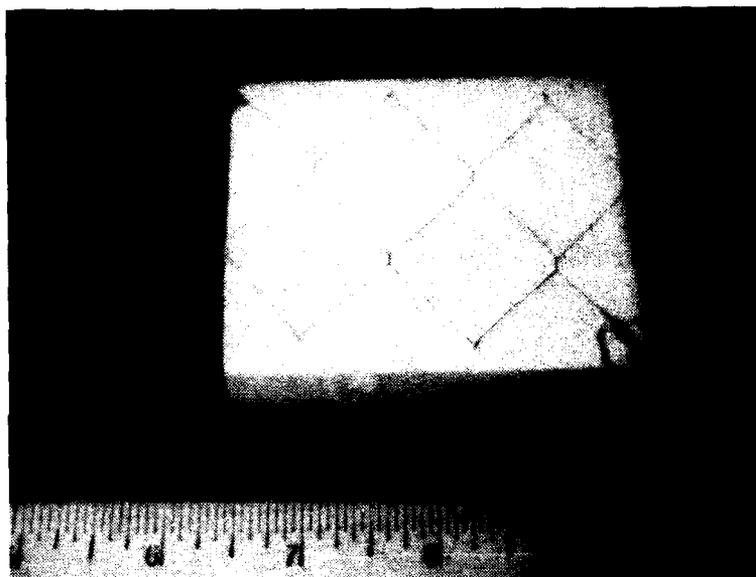
Figure 3.5.2-1 Photograph of fibrous ceramic tile.

CT was used to determine if the ceramic had completely flowed into the holes contained in the Ti honeycomb. When the part was scanned with the CT slice parallel to the surface shown in Figure 3.5.2-1, the crisscross pattern of the titanium could be seen within the ceramic interior. Figure 3.5.2-2 is an example of one of these images. Voids as well as the density distribution of the ceramic were easily imaged. However, the streak artifacts caused by the titanium eliminated the possibility of measuring the density in the holes. A series of slices were taken (five slices, 4 mm (0.16 inches) apart), the last of which just missed the titanium, going just below it, as shown in Figure 3.5.2-3. This slice indicates the density variation of the fibrous ceramic near the titanium. Apparently, the flow characteristics close to the titanium reduces the fiber concentration just below the grid.

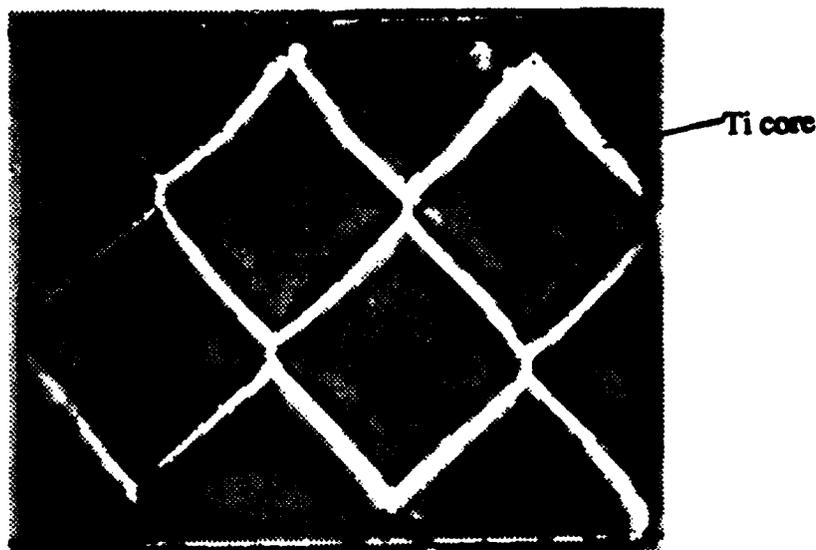
Figure 3.5.2-2 CT image in fibrous ceramic tile.

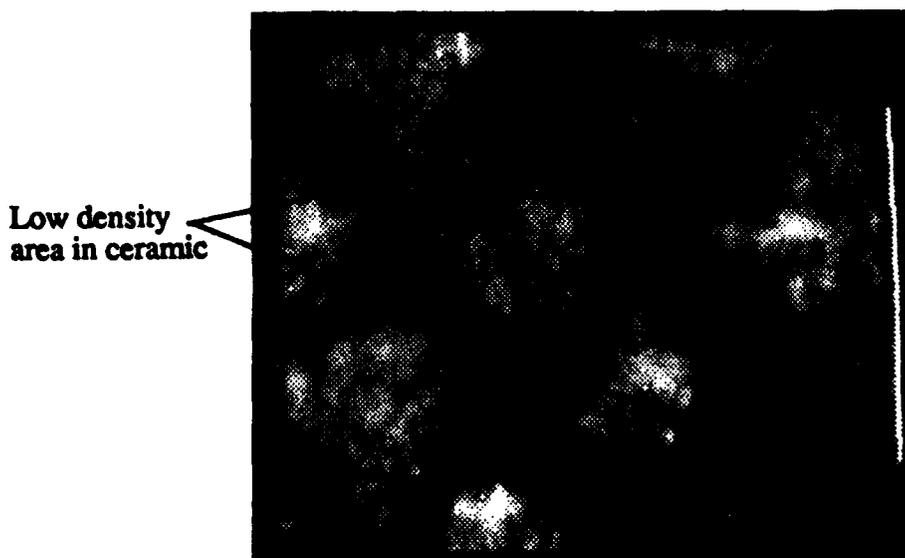
Figure 3.5.2-3 CT image in fibrous ceramic tile.

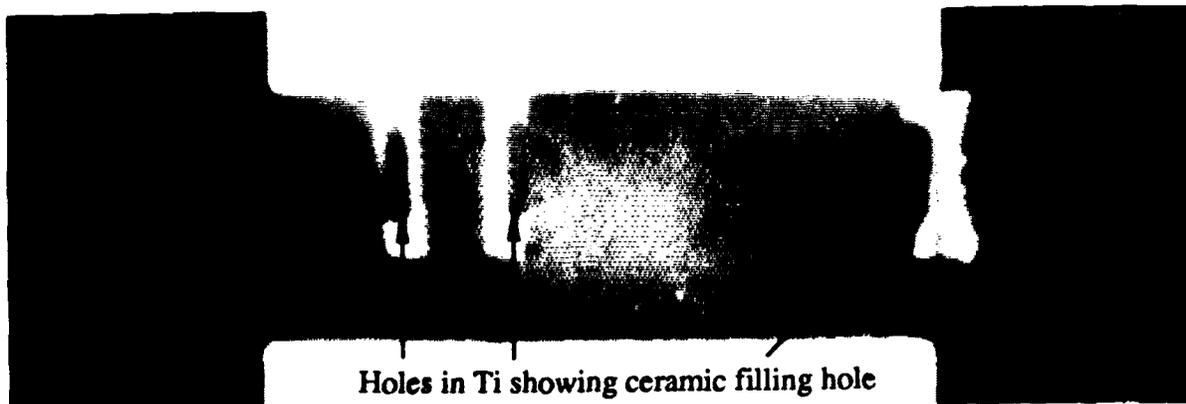
Figure 3.5.2-4 CT image in fibrous ceramic tile.

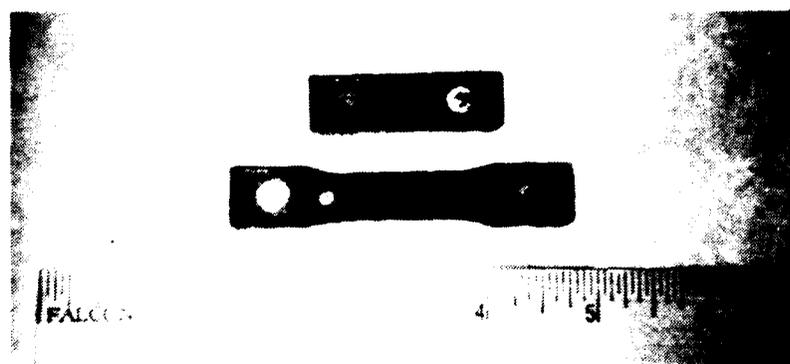
Figure 3.5.3-1 Photograph of two of the coated specimens.

Figure 3.5.3-2 is a CT slice taken through the two specimens shown in Figure 3.5.3-1. The larger specimen (specimen A) contains two thermocouple attachment points. Oxidation damage can be seen clearly around the left point (which had been subjected to 25 cycles), and is barely visible near the right attachment point (which had been subjected to 45 cycles). Figure 3.5.3-3 is a CT slice taken perpendicular to Figure 3.5.3-2 just below the coating of specimen A. This slice reveals the amount of oxidation around the thermocouple attachment points. The left end of sample A contains a previous attachment point that failed under initial thermal cycling, but was "repaired" by removing and filling the oxidized area with an alumina paste. The repair was not successful, as leakage paths around the paste allowed further oxidation upon subsequent thermal cycling.

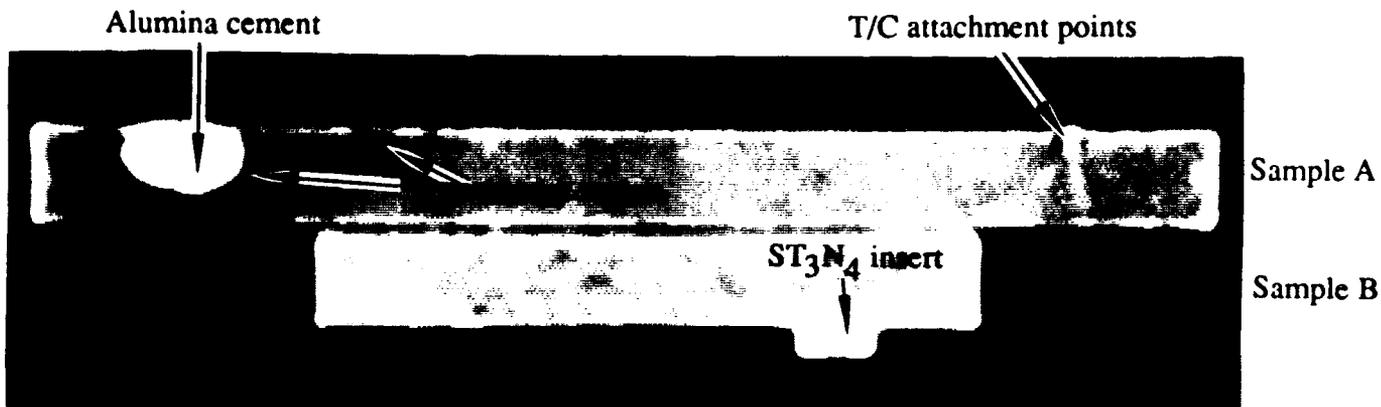
Figure 3.5.3-2 CT image of specimens shown in Figure 3.5.3-1.

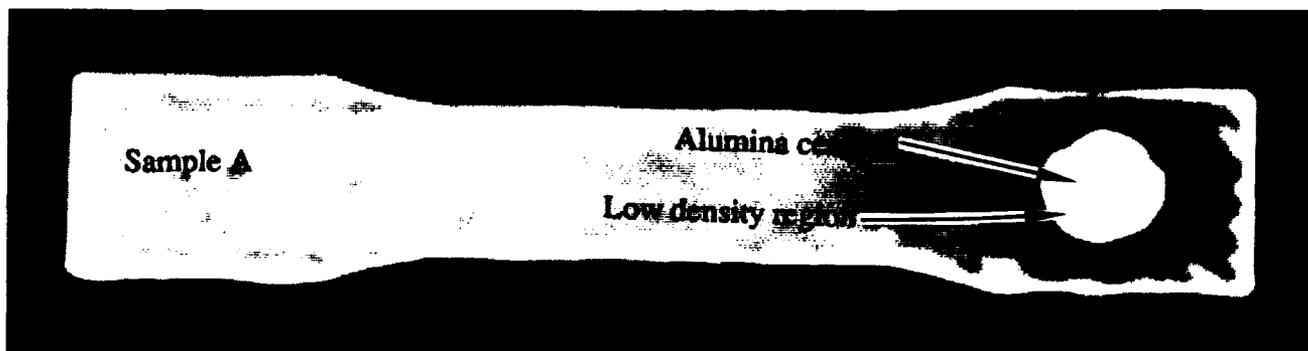
Figure 3.5.3-3 CT image taken perpendicular to Figure 3.5.3-2.

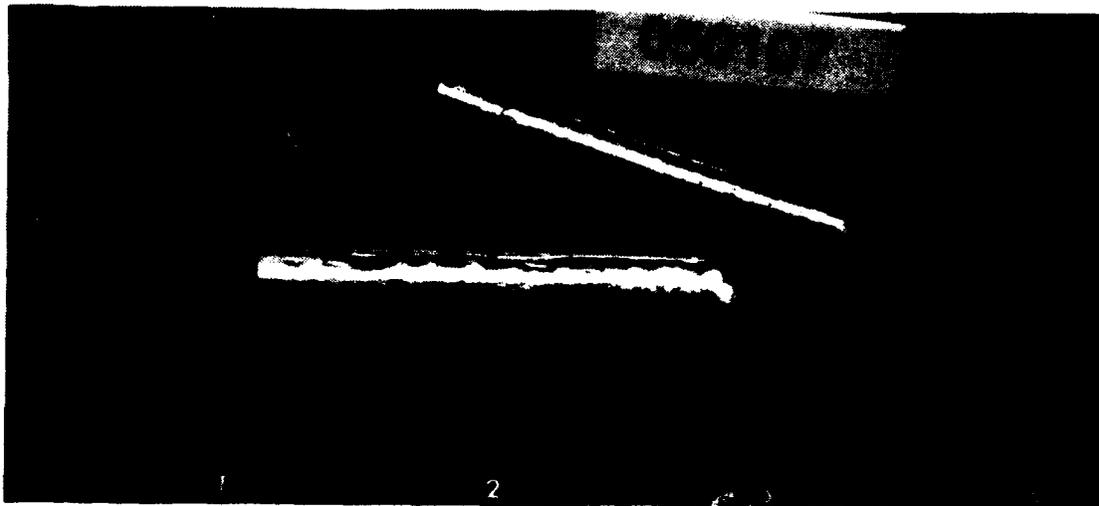
Figure 3.5.4-1 Photograph of Al MMC rods.
