AFRL-VA-WP-TR-2002-3032

**CORROSION MORPHOLOGY IN
LAP JOINTS**

JUNE 2000

Final Report for 01 April 1999 – 31 May 2000

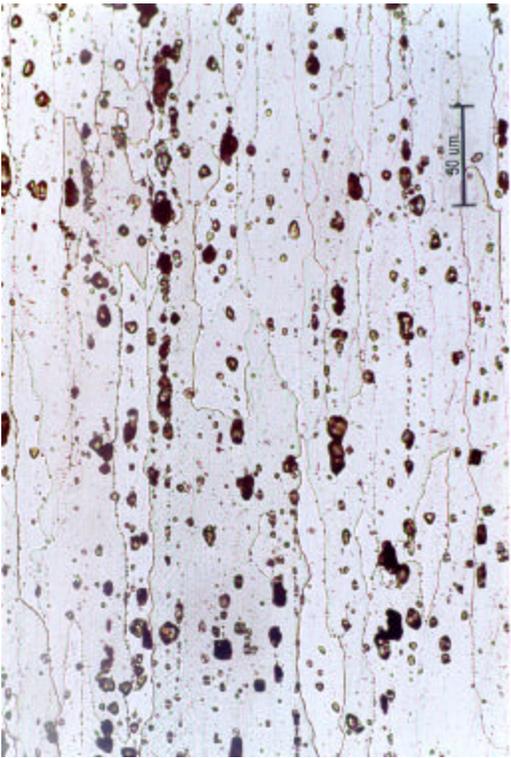
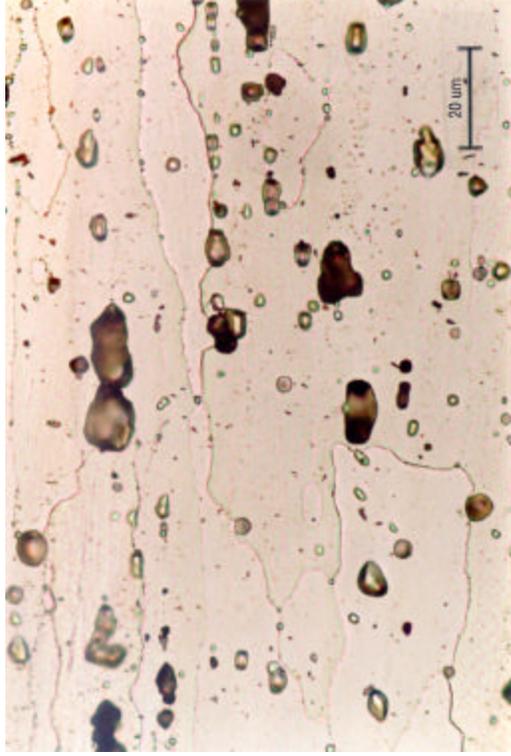
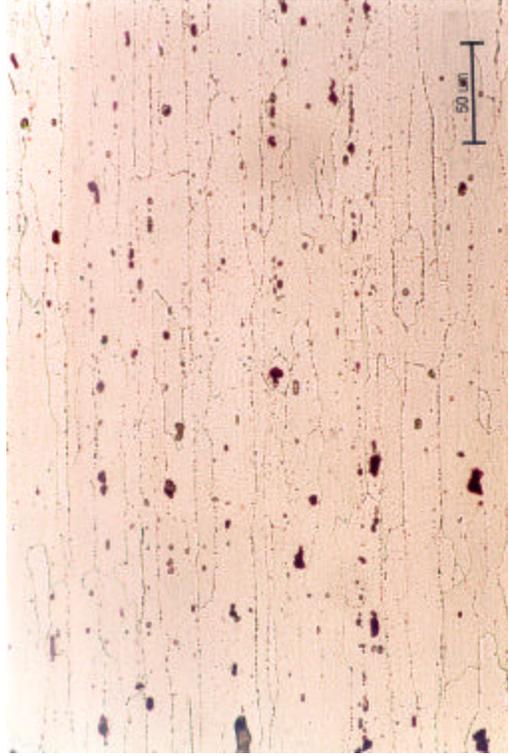
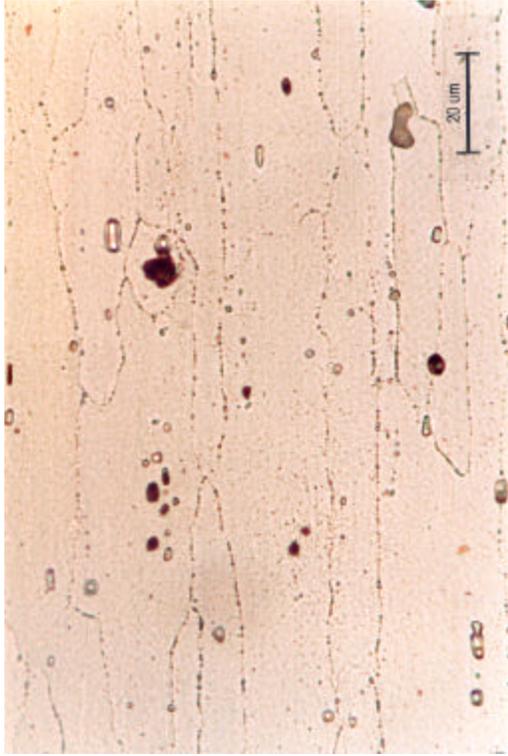
Figure 17. Optical Micrographs of Aluminum Alloy 7075-T6 from the KC-135 Fuselage Crown Section (a, b) and of Recently Fabricated Material (c, d)

The microstructures of aluminum alloys 7075-T6, 7178-T6, and 2024-T6 that were removed from different wing and fuselage lap joints were examined and compared with similar, but recently produced alloys. The photomicrographs in Figure 17 show the microstructures of aluminum alloy 7075-T6 removed from the fuselage crown lap joint (a and b) and the recently produced alloy 7075-T6. From the micrographs, it becomes immediately obvious that the older alloy removed from the lap joints has a microstructure containing several relatively large intermetallic particles distributed throughout the microstructure. Some stringer formation as a result of processing can be seen on the lower magnification micrograph (see Figure 17b). The photomicrographs further show distinct grain boundary precipitates in the new alloy, whereas in the lap joint alloy such precipitation is not clearly marked.

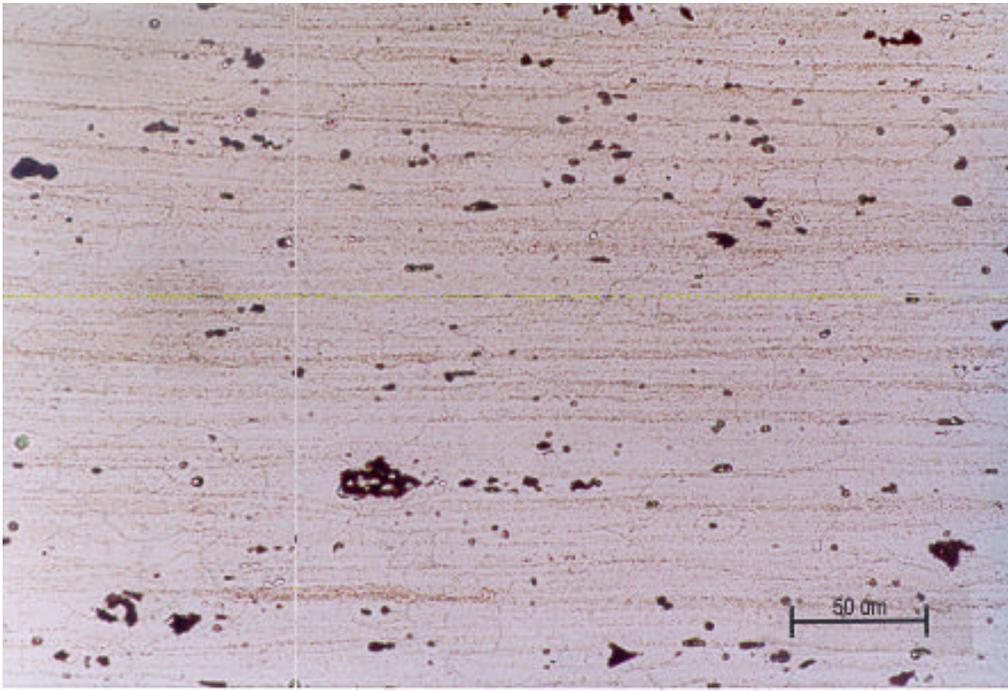
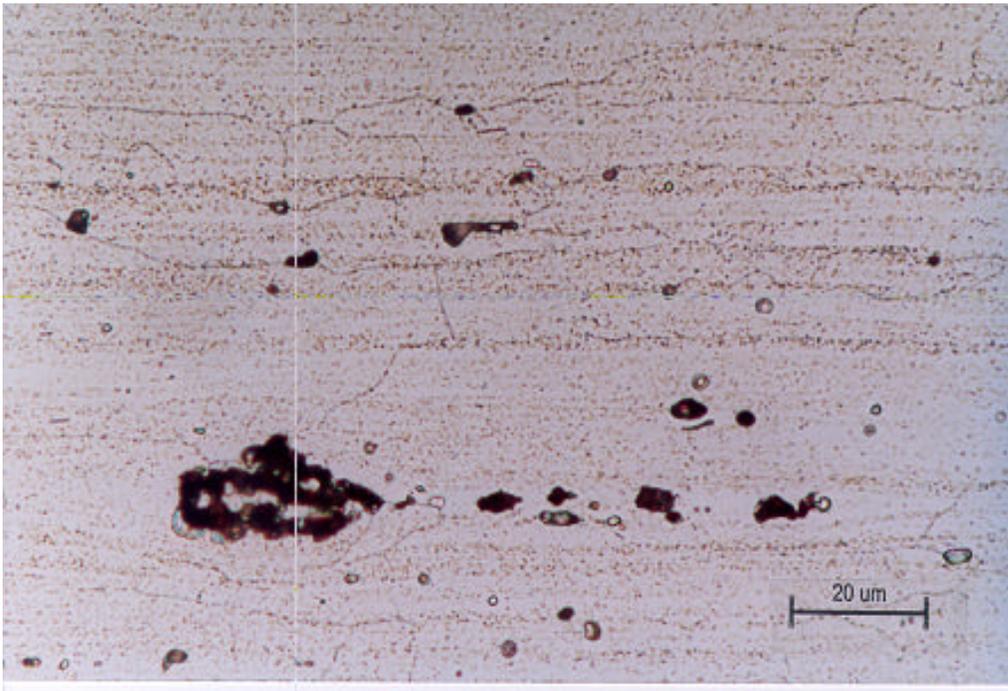
Figure 18. Optical Micrographs of Aluminum Alloy 7178-T6 from the KC-135 Upper Wing Skin

Figure 18 shows optical micrographs of aluminum alloy 7178-T6 removed from the upper wing section lap joint. Although this alloy is similar to alloy 7075-T6, its microstructure appears to be different. Particularly, the grain boundaries are not clearly marked and fine precipitates occur in bands in the rolling direction. Like the 7075-T6 alloy, the alloy shows a high density of coarse intermetallic precipitates distributed throughout the alloy.

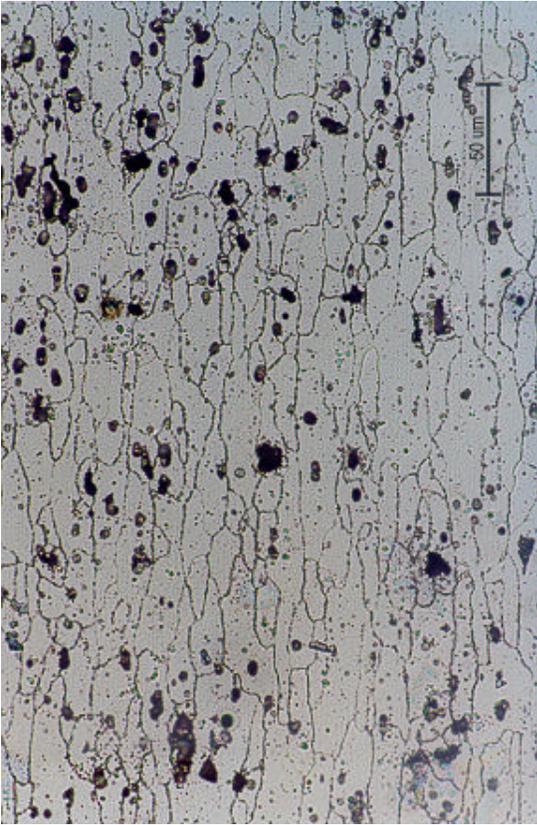
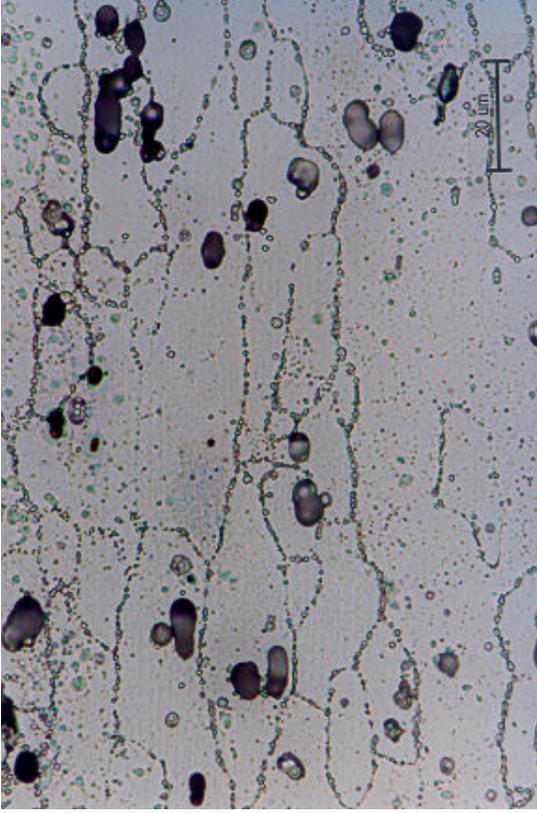
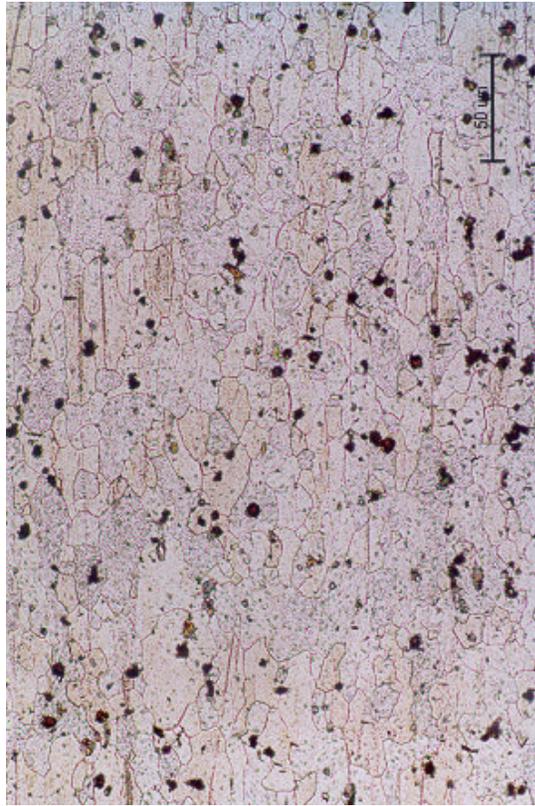
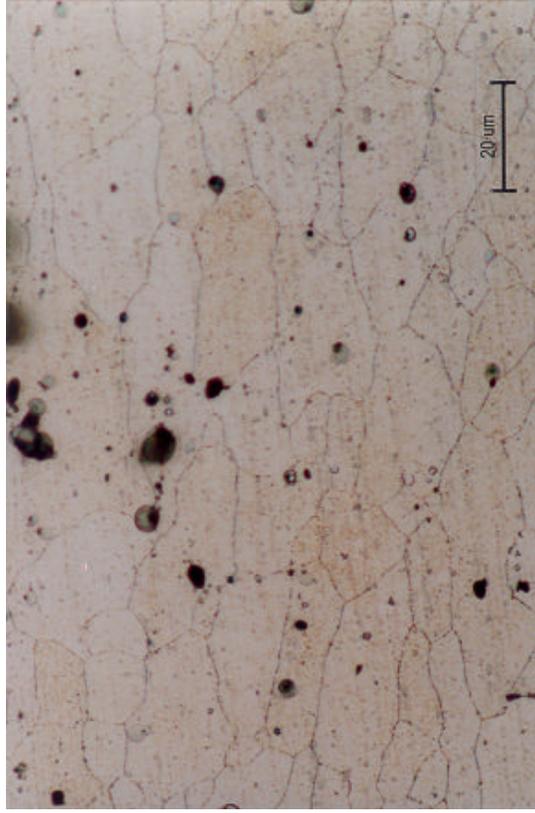
Figure 19. Optical Micrographs of Aluminum Alloy 2024-T3 from the KC-135 Fuselage Skin (a, b) and of Recently Fabricated Material (c, d)

When comparing the microstructure of the aluminum alloy 2024-T3 skin with newly fabricated alloy 2024-T3, a number of differences are found. Figure 19 shows that the older skin alloy has clearly defined continuous grain boundaries, whereas the newer alloy has distinct particles marking the grain boundaries. Also, the grains of the skin alloy appear to be more equiaxed than those of the newer alloy.

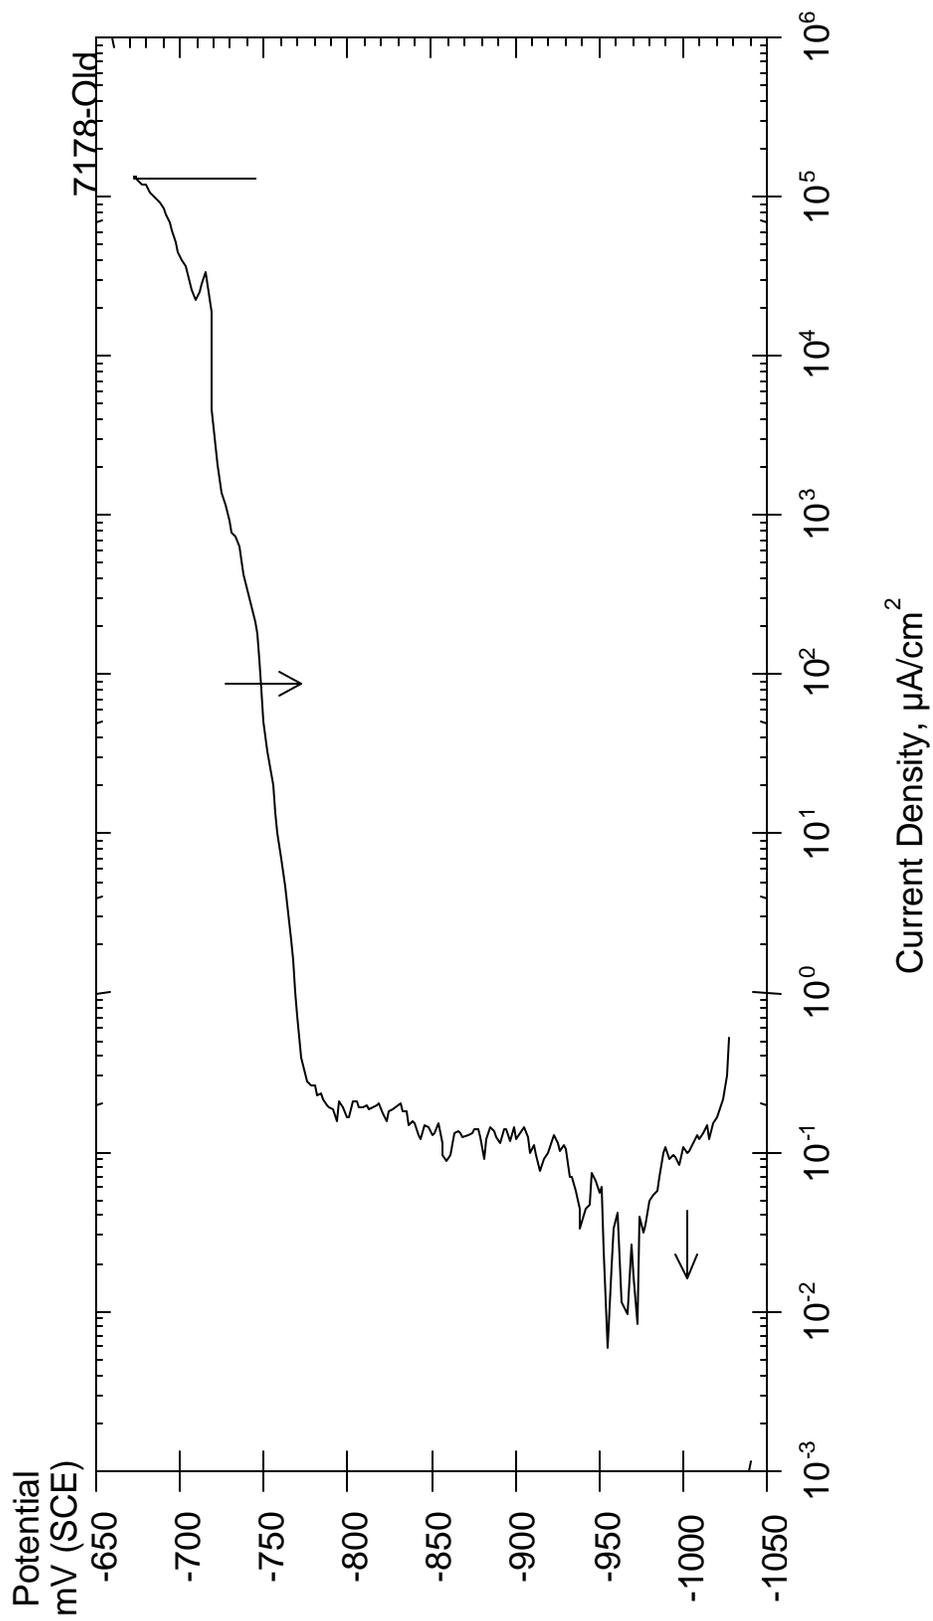
Figure 20. CPP Curve for Alloy 7178 Aluminum in Deaerated 3% (Wt) NaCl at 20°C

The anodic polarization curve for 7178T6 from the fuselage crown section is shown in Figure 20. The polarization curve indicates a corrosion potential (E_{cor}) of -850 mV versus SCE. Also on this curve, two different breakdown potentials are observed, at -780 mV versus SCE and -700 mV versus SCE. Each of these breakdown potentials is characterized by a rapid increase in current density. Based on the potentiodynamic scan, alloy 7178-T6 samples were potentiostatically polarized at the two breakdown potentials for a period of 4 days. After exposure, the specimens were cross-sectioned, polished, and etched with Kellers etchant. The results of the potentiostatic tests are shown in the optical micrographs in Figures 21 and 22. The micrographs in Figure 21 show that at the first breakdown potential (-780 mV versus SCE), pitting corrosion occurred, whereas Figure 22 shows that at the second breakdown potential (-700 mV versus SCE), intergranular corrosion is the prevalent mode of attack.
