December 1998  
NSRP 0520  
N3-96-4

# **THE NATIONAL SHIPBUILDING RESEARCH PROGRAM**

## **Productivity Study of Hydroblast Removal of Coatings**

U.S. DEPARTMENT OF THE NAVY  
CARDEROCK DIVISION,  
NAVAL SURFACE WARFARE CENTER

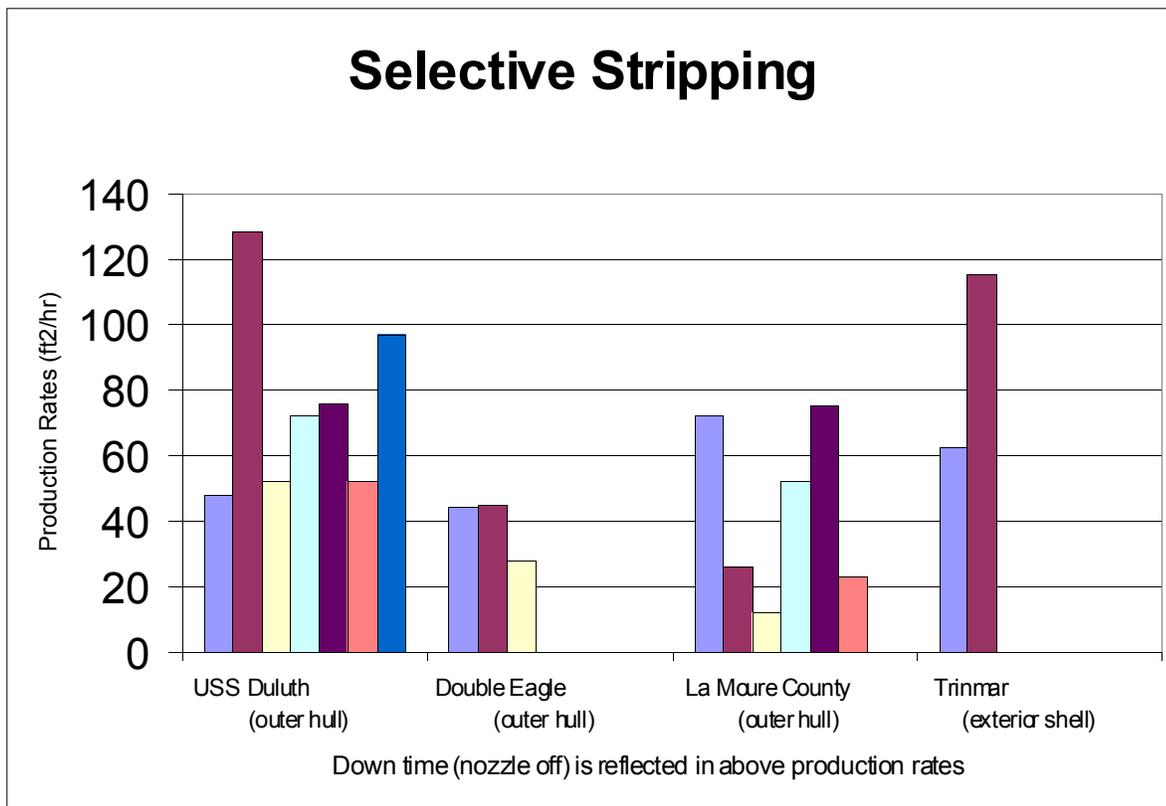
**Graph 1:**

Graph 1 represents production rates for structures that received a partial coating system removal down to a specified “tightly” adhered coating. All coating removal was performed using open cycle, hand-held lances.

The first grouping of data (Graph 1), labeled “USS Duluth” contains seven production runs. The first six are for freeboard coating removal of ~ 12 mils of gray silicone alkyd down to an intact anti-corrosive epoxy (Navy F-151). The last production run in this group represents the removal of a 3-coat anti-fouling layer down to the topcoat of anti-corrosive epoxy on the underwater hull. Production rates ranged from 48 ft<sup>2</sup>/hour/gun to 128 ft<sup>2</sup>/hour/gun with an average of 85 ft<sup>2</sup>/hour/gun.

The second group, “Double Eagle” contained three production runs. The coating removal specified was to remove all three coats of anti-fouling (17 mils total) down to sound gray anti-corrosive epoxy on the underwater hull. This observation was performed during new construction; the anti-fouling had started to delaminate from the anti-corrosive layer prior to immersion. Production rates ranged from 28 ft<sup>2</sup>/hour/gun to 45 ft<sup>2</sup>/hour/gun with an average of 39 ft<sup>2</sup>/hour/gun.

The third group of data represents production rates observed on USS La Moure County. The removal specified was to remove all alkyd (approx. 6 layers @ 3-4 mils each) and epoxy coatings (2 coats @ 6-8 mils each) down to the inorganic

The final group of data on Graph 1 were the production rates observed from the exterior shell of the Trinmar offshore pumping station. The removal specified for the exterior shell was to selectively strip the painted surface down to intact primer, and remove all corrosion products down bare metal. The coating system for the exterior shell consisted of four coats: primer (~2 mils), black intermediate (~2 mils), gray (~5 mils) and orange top-coat (~5 mils). For this outer shell area about 12 mils of coating were selectively stripped. The production rates for the exterior shell ranged from 63 to 115 ft<sup>2</sup>/hour/gun (average 89 ft<sup>2</sup>/hour/gun).

Note that the production rates for selective stripping are somewhat similar for the removal of the freeboard system on the Duluth and the La Moure County as well as the exterior shell of the Trinmar pumping station. The lower observed productivity levels on the Double Eagle hull were chiefly due to worker orientation. In all other outer hull trials, workers were standing up, usually working from a high-lift, and blasting perpendicular to a vertical hull. On the Double Eagle, the blasters were removing coating on the cramped underbelly. They were sitting down, holding the guns vertically or at an angle toward the horizontal surface overhead. The low docking blocks created a cramped situation for the workers, resulting in lower productivity.

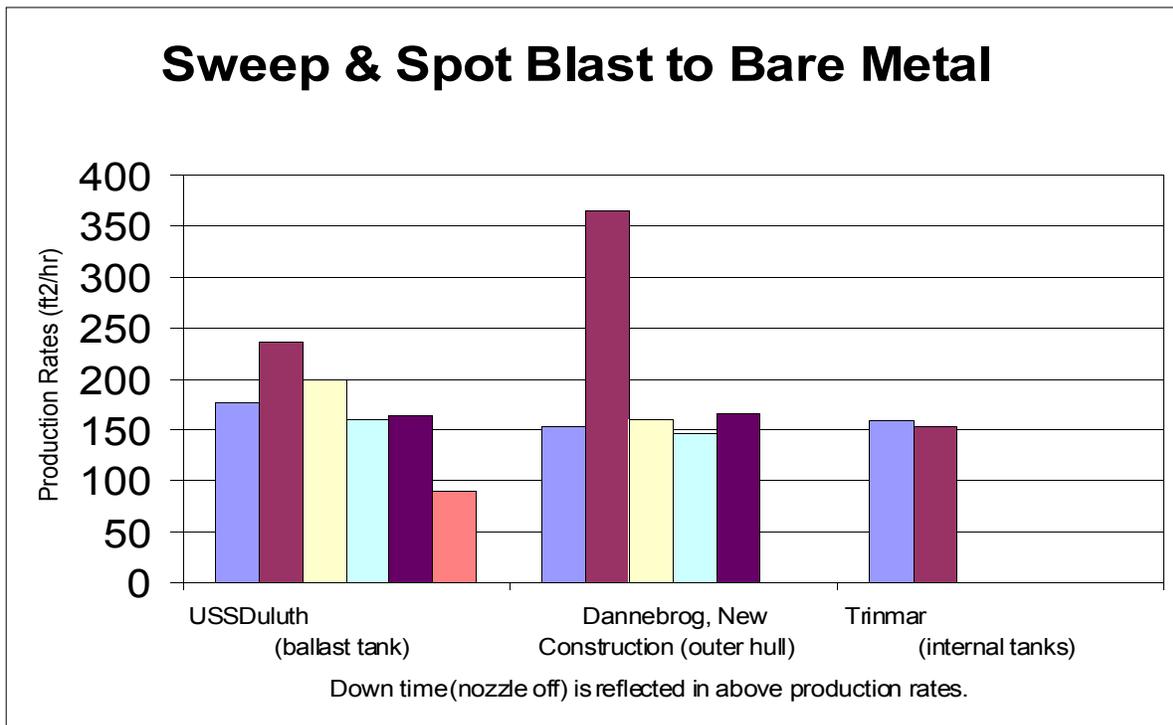
**Graph 2:**

Graph 2 represents production rates for removal involving a sweep and spot blast to bare metal. The sweep blast was intended to stress the coating system leaving only tightly adherent paint remaining. Corroded areas were spot blasted to bare metal. All coating removal was performed using open cycle, hand-held lances. Production data for the USS Cleveland is not included in the “Sweep and Spot Blast” graphs due to the low production (ft<sup>2</sup>/hr) rates observed because of new blaster training during our on-site visit. Including this data would have skewed the results and realistic numbers for this type of preparation would not have been presented. However, production rates observed from USS Cleveland were reported in the on-site visit summary (section 4.7.7).

The first group of data (Graph 2), “USS Duluth (ballast tank)” were production rates from the hydroblasting of ballast tank 8-84-4-W. The specification for the blasting of this tank was to spot blast to bare metal all corroded areas and sweep blast all other areas in order to remove staining, and provide a clean, profiled surface for subsequent coating adhesion. This ballast tank had a two-coat MIL-P-23236 epoxy system, averaging 9.8 mils DFT. Production rates ranged from 90 ft<sup>2</sup>/hour/gun to 236 ft<sup>2</sup>/hour/gun with an average of 171 ft<sup>2</sup>/hour/gun.

The second group of data represents the production rates observed for the removal of damaged shop primer on the outer hull of the Dannebrog Hull 47 chemical tanker during new construction at Alabama Shipyard. The specified blast was to sweep blast the entire painted surfaces and remove any damaged areas down to bare metal (i.e. charred areas from internal welding, areas damaged by scraping, handling and erection joints). The shop primer ranged from 0.5 to 2.0 mils DFT. Production rates ranged from 146 to 365 ft<sup>2</sup>/hour/gun with an overall average of 198 ft<sup>2</sup>/hour/gun.

The final group of data on Graph 2 were the production rates observed from the internal tanks of the Trinmar offshore platform. The coating system for the tanks consisted of only two coats: epoxy primer (~1 mil), epoxy topcoat (~10 mils). The average production rate for the spot and sweep blast inside of the tanks was 157 ft<sup>2</sup>/hour/gun.

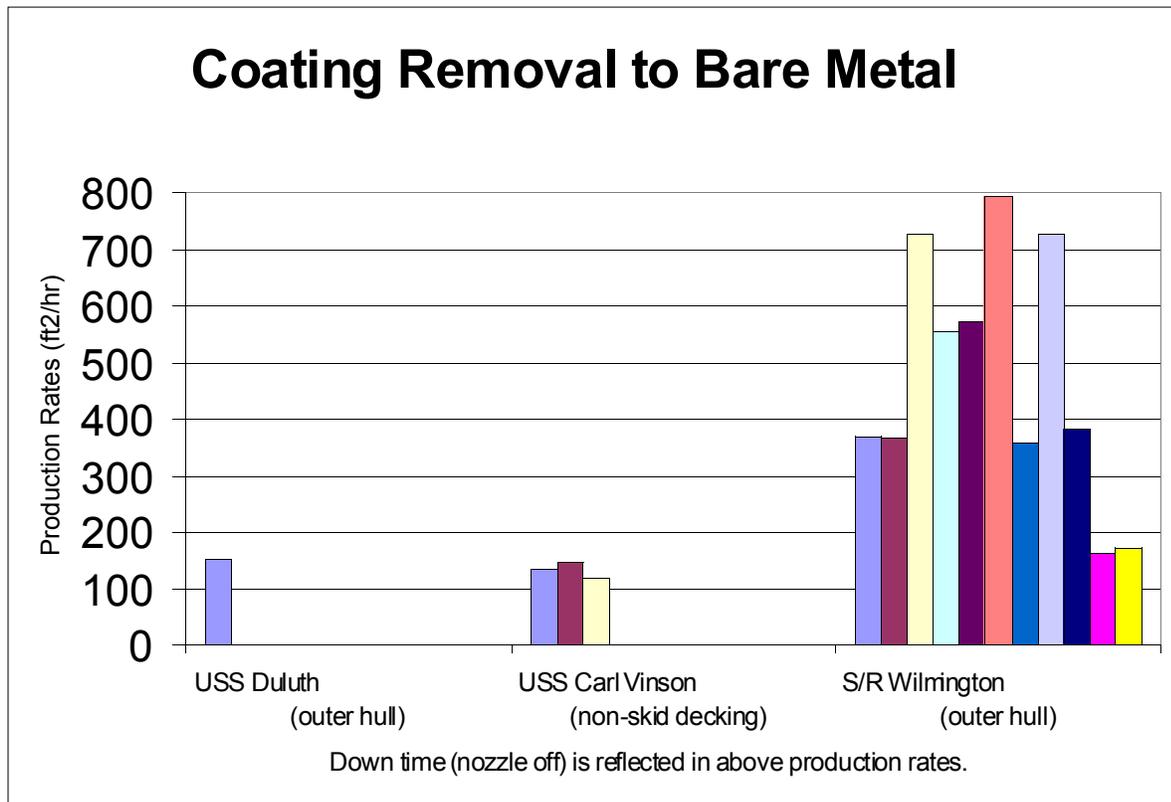
**Graph 3:**

Graph 3 represents production rates for areas on the ship where total coating system removal down to bare metal was either specified, or required due to prior corrosion and coating failure.

The first group of data (Graph 3), “USS Duluth (outer hull)” contains only one production run where coating was removed to bare metal. The anchor chain damaged an area of the underwater hull and all coatings in the area were specified to be removed. This system included three coats of anti-fouling (~3 mils remaining), and two coats of anti-corrosive epoxy (~ 14 mils DFT). The production rate for this area was 152 ft<sup>2</sup>/hour/gun.

The next data grouping, “USS Carl Vinson” contains three production runs all of flight deck non-skid removal, using the Navy’s Pratt & Whitney fully closed-loop system. The specification called for an SSPC SP-10 near white metal blast. The decking material consisted of a 3-4 mil epoxy primer under a thick (up to 150 mils) non-skid matrix of epoxy and aluminum oxide grit. Production rates ranged from 121 ft<sup>2</sup>/hour to 146 ft<sup>2</sup>/hour with an average of 134 ft<sup>2</sup>/hour.

The final group, “Sea River Wilmington” contains eleven production runs for coating removal using the Hammelmann Dockmaster, a self contained open cycle machine, which treats the water on-site, however discards the treated water to the river, as opposed to reusing/recycling the water. The entire freeboard coating system [one coat modified chlorinated rubber (~5 mils) and two coats of anti-corrosive epoxy (~11 mils total)] was to be removed completely to bare metal. About the first twelve feet of the underwater hull area directly under the freeboard area was also removed down to bare metal. This system consisted of two coats of ablative anti-fouling (totaling ~14 mils), and two coats of anti-corrosive epoxy (totaling ~11mils). In both the freeboard and underwater hull areas 100% removal of the red anti-corrosive epoxy was not achieved, however. From 5% to 20% traces of a red primer residue still remained after blasting. Production rates ranged from 162 ft<sup>2</sup>/hour to 792 ft<sup>2</sup>/hour with an average of 471 ft<sup>2</sup>/hour.

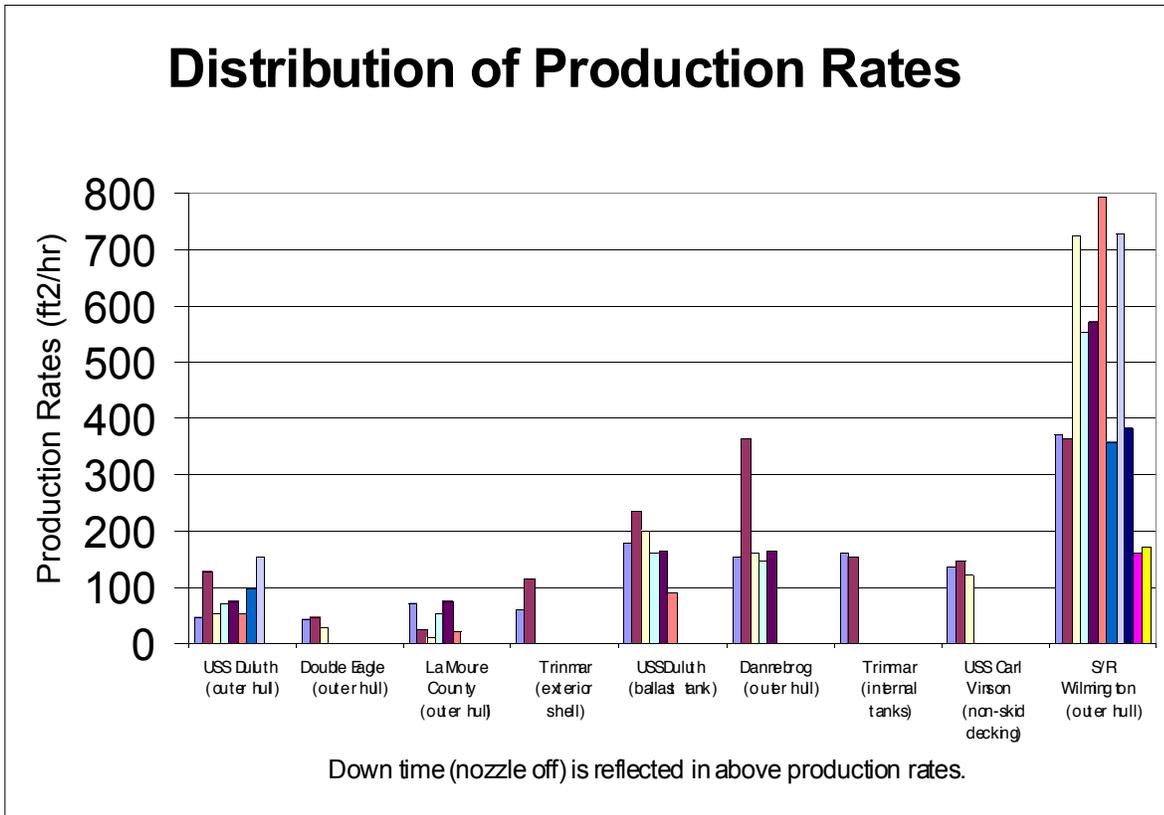
Graph 4:

Graph 4, located on the following page, shows the production rates of all hydroblasting observations. Graph 5 is similar to Graph 4, but it represents the overall average production rates observed at each vessel. As seen from both Graphs 4 and 5, the production rates from the Sea River Wilmington exceed all the other production rates. A correlation between the USS Carl Vinson and the Sea River Wilmington would not be meaningful since the two represented the removal of two totally different coating systems. However, both systems represented a semi-automated method of coating removal, waste handling, and treatment which demonstrates the grouping of all technologies associated with shipyard water-jetting. All other methods observed utilized hand held lances and “open-cycle” jetting, which is a simpler, less involved way of removing coatings.

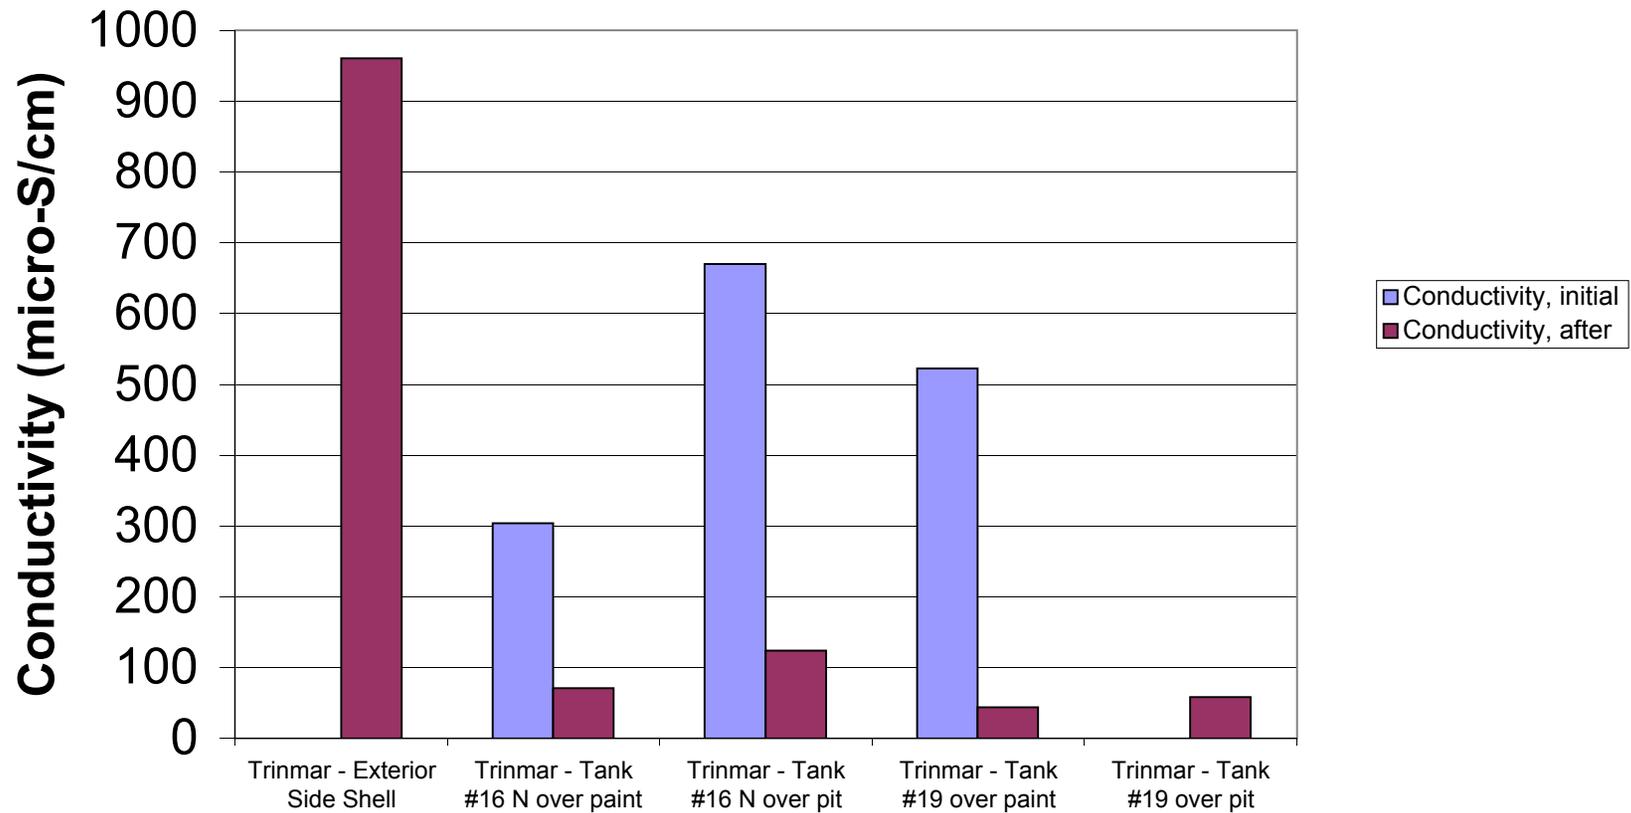
Graph 9:

## Conductivity Readings For Trinmar Block 25 Pump Station

The data on Graph 9 shows that jetting with seawater with the secondary fresh water blast did significantly (77% to 92%) reduce the surface conductivity. However, the residual surface conductivity was still high compared with the final values achieved with potable water, water-jetting. As a test, conductivity measurements were taken after the filtered seawater blast and prior to the fresh water rinse on the exterior shell only. For the exterior shell as noted in Graph 9, conductivity levels were quite high (960  $\mu\text{S}/\text{cm}$ ) confirming the necessity of the secondary fresh water blast.
