USAAVSCOM TECHNICAL REPORT

STUDY OF HELICOPTER TRANSMISSION SYSTEM DEVELOPMENT TESTING

SIKORSKY ENGINEERING REPORT SER-50547

JUNE 1968

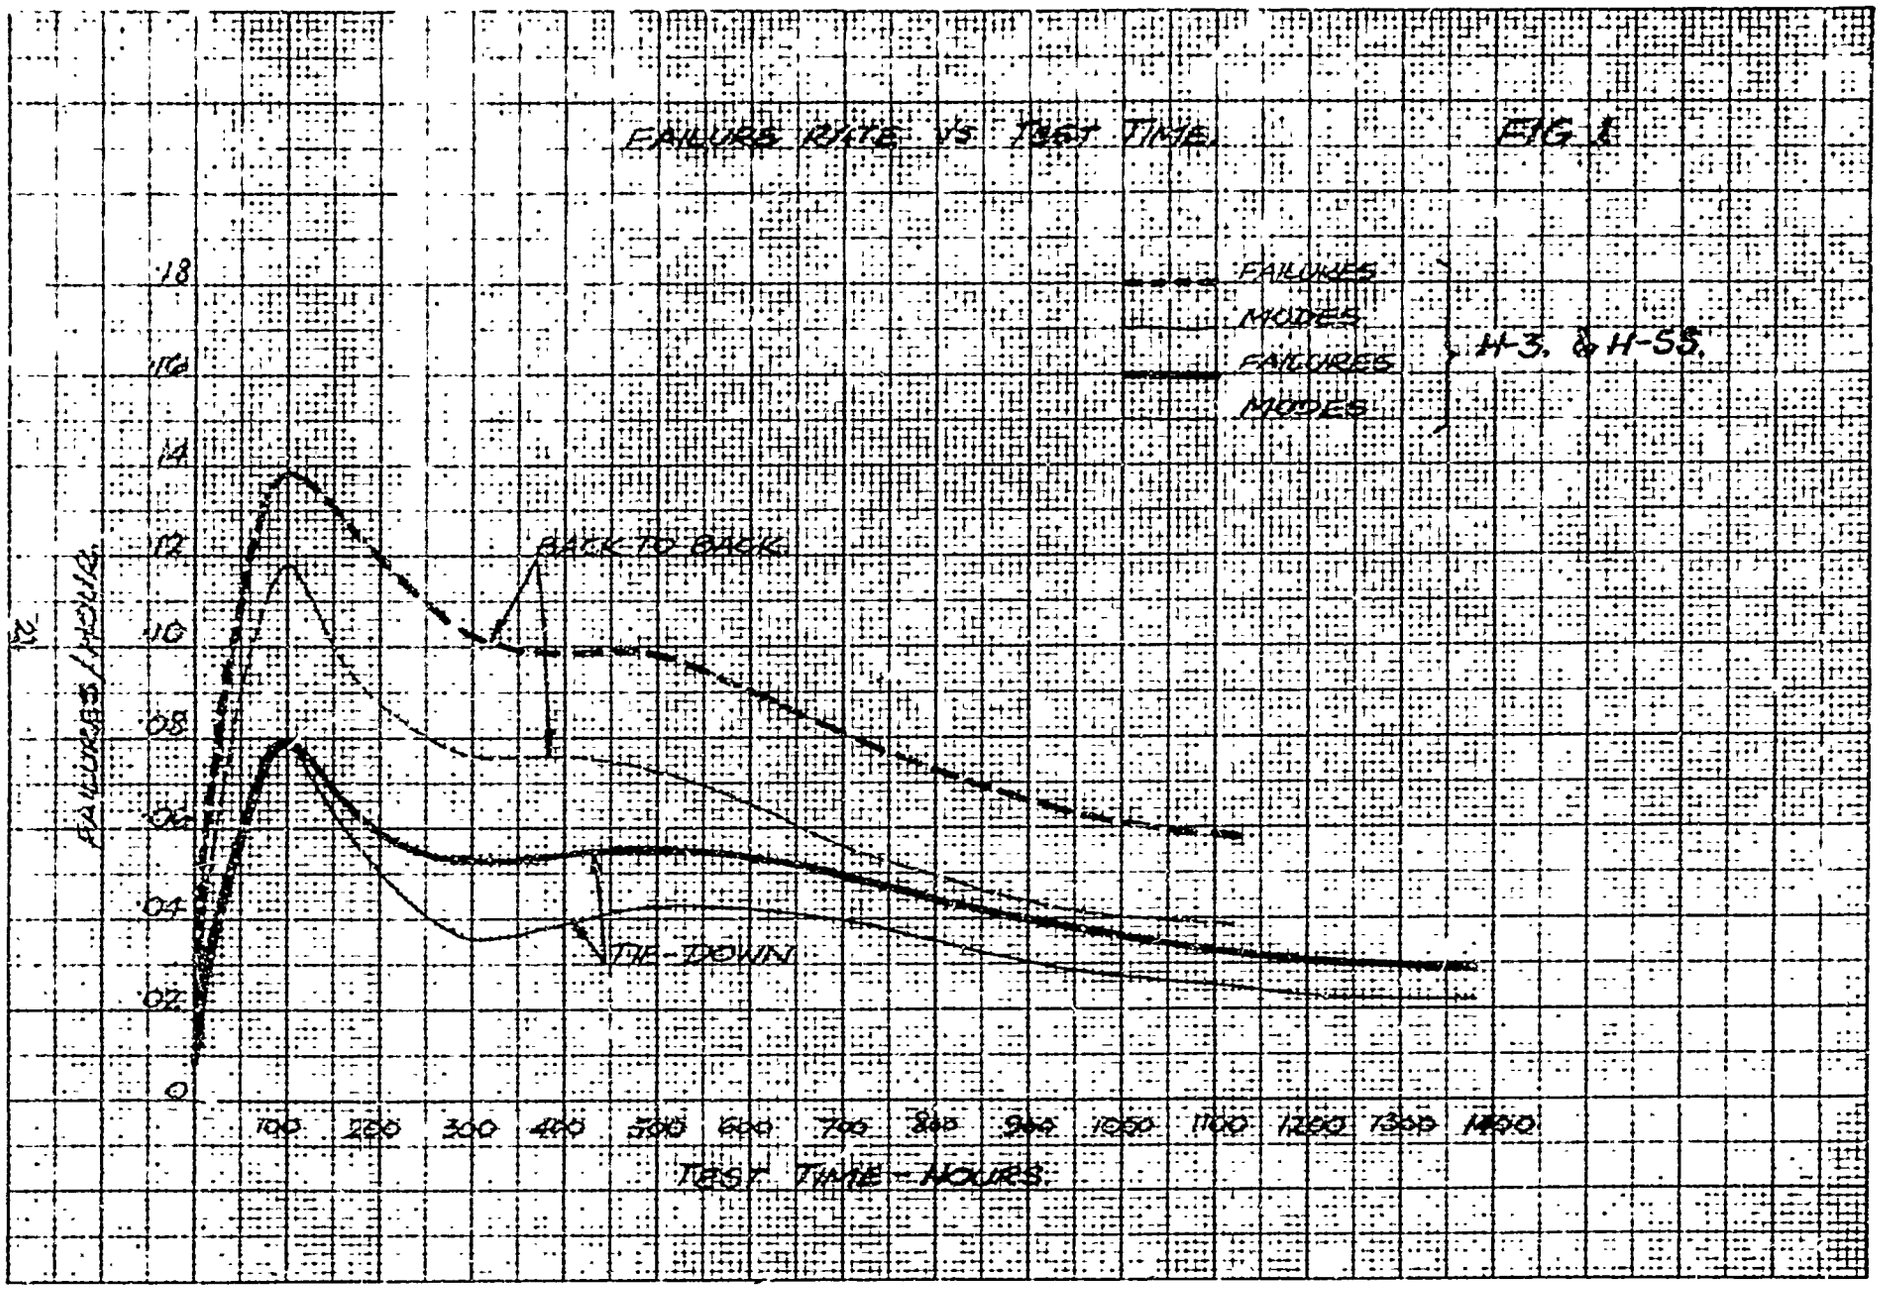
(a) A comparison was made of tie-down and bench testing. Figure 1 shows the rate of accumulation of modes and total failures verses test hours. These curves are based on the test malfunctions/failures for the main transmission of the H-3 and the H-53. One important fact is to be noted; that is the importance of multiple sample testing. The bench test employed two aircraft transmissions to form the regenerative loop, and as a result more different modes of failures were uncovered faster than the single sample used on tie-down test, although acceleration factors were about equal.

FAILURE RATE VS TEST TIME.
FIG. 1
FAILURES
MODES
FAILURES
MODES
H-3. & H-55.
BACK TO BACK.
TIE-DOWN
FAILURES / HOUR.
.18
.16
.14
.12
.10
.08
.06
.04
.02
0
100
200
300
400
500
600
700
800
900
1000
1100
1200
1300
1400
TEST TIME - HOURS.

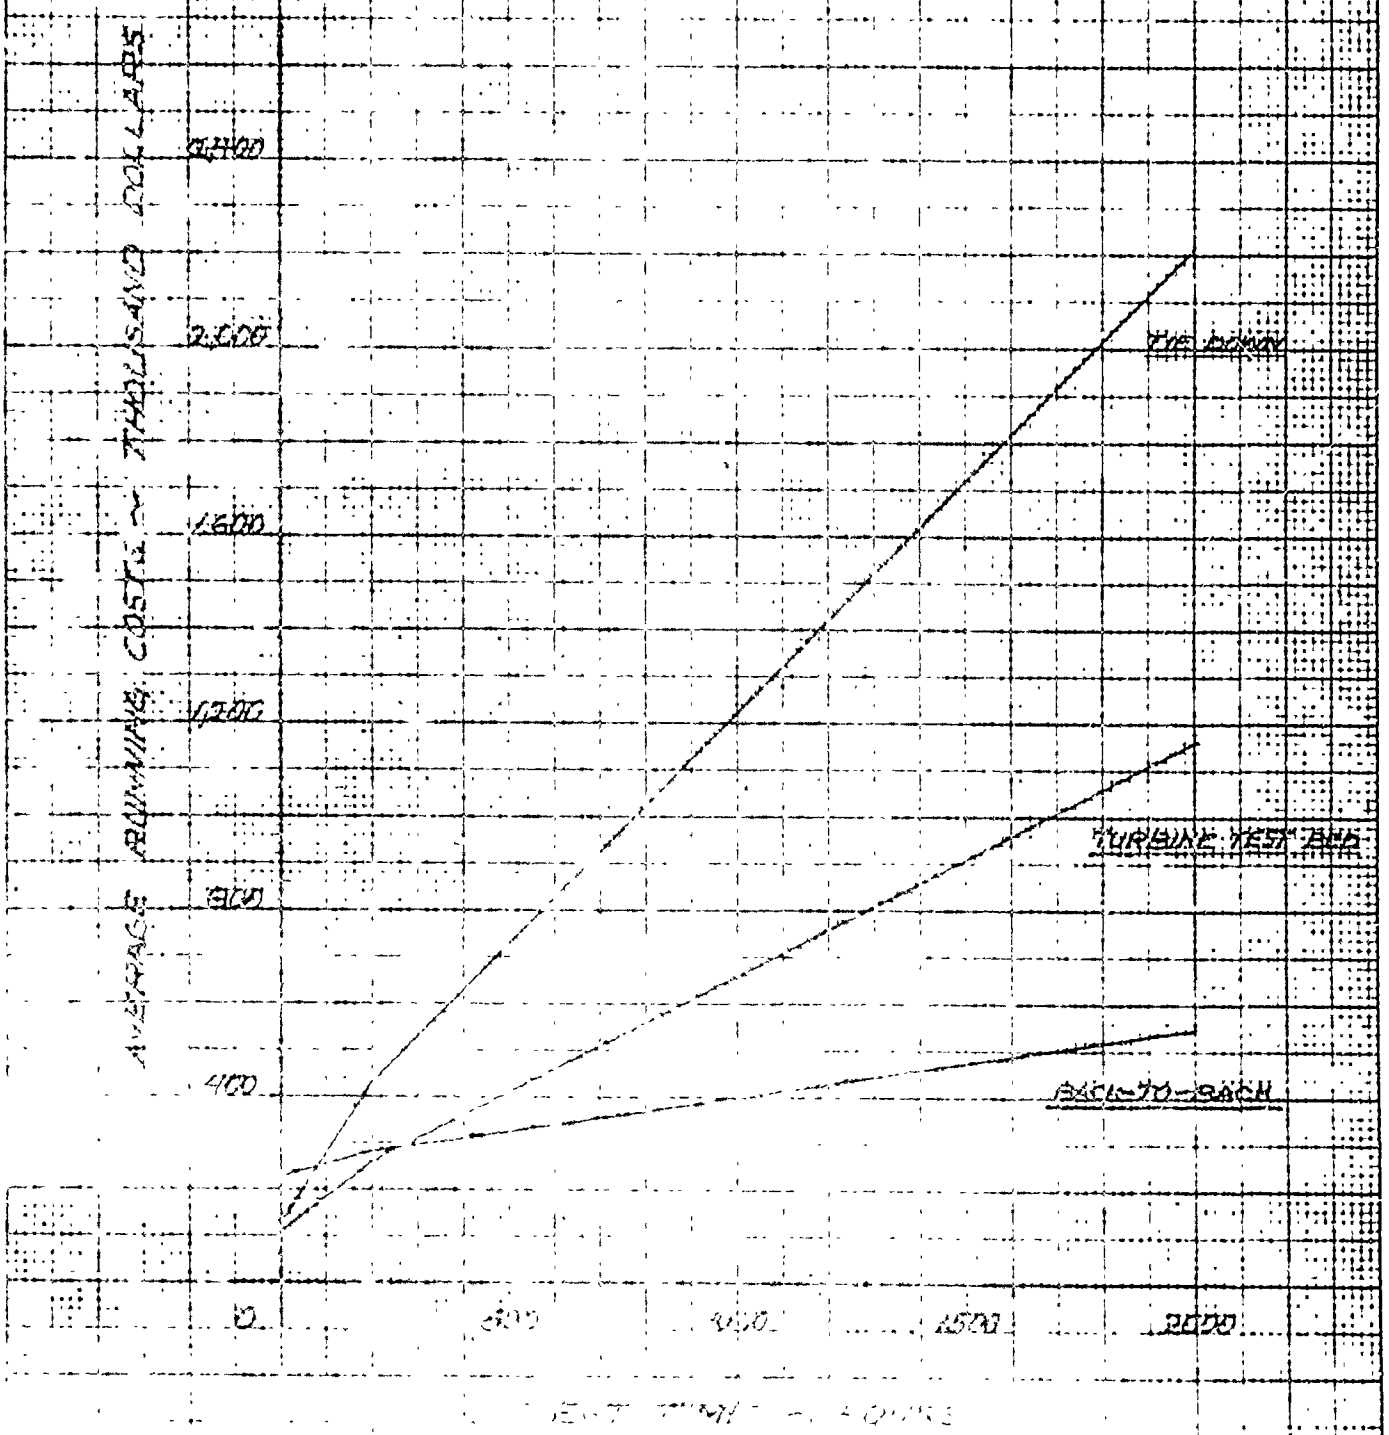
FIGURE 2

(c) To establish an overall cost effectiveness for each type of testing an analysis of the actual costs of the bench, tie-down and dynamic systems test for each aircraft was also made. Since the latter two tests are used to substantiate/develop other aircraft components, the total costs of these programs cannot be reasonably charged against the transmission system. The test costs assigned to transmission testing was established by proportioning the number of transmission failure/malfunctions experienced during the test to the total number of malfunctions experienced on all components during the test. Figure 2 shows the relative costs of three types of ground testing, bench, tie-down, and dynamic system.

AVERAGE RUNNING COSTS VS TEST TIME
FOR MAIN TRANSMISSION

An analysis of the failure and cost data of Figures 1 and 2 was made to establish a relative factor of cost effectiveness for each type of transmission development testing.

From Figures 1 and 2 and the data of Appendix (1) the average measure of effectiveness of each type of testing is

It is therefore apparent on the basis of these data that extensive and early bench tests will "pay their way" in reducing the number of failures in the tie-down test and early flight test programs.

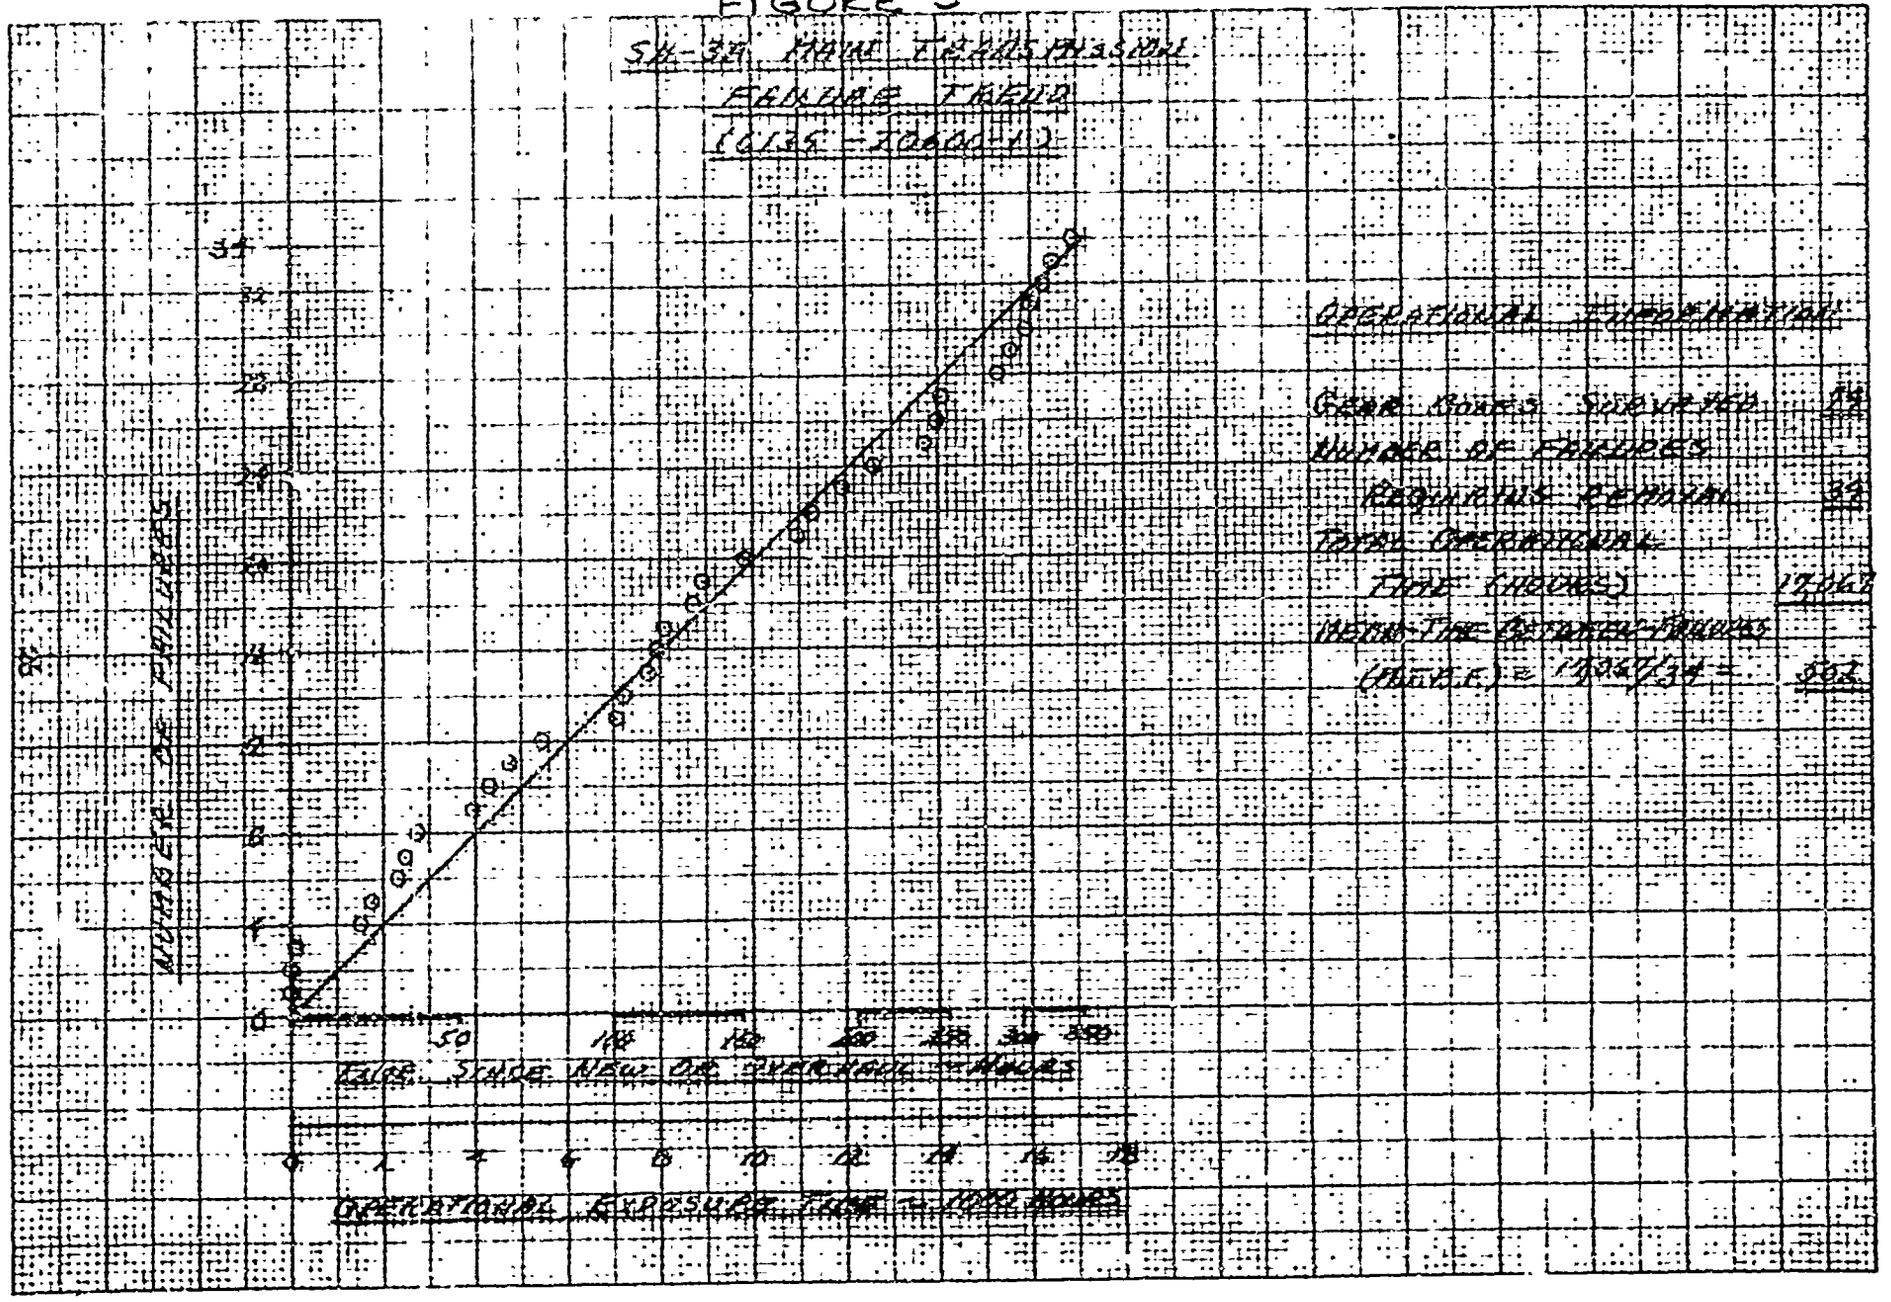
FIGURE 3

- Figure (3) shows the initial SH-3A production main transmission design to have a constant failure rate with no single dominating mode of failure. (MTBF = 502 hours)

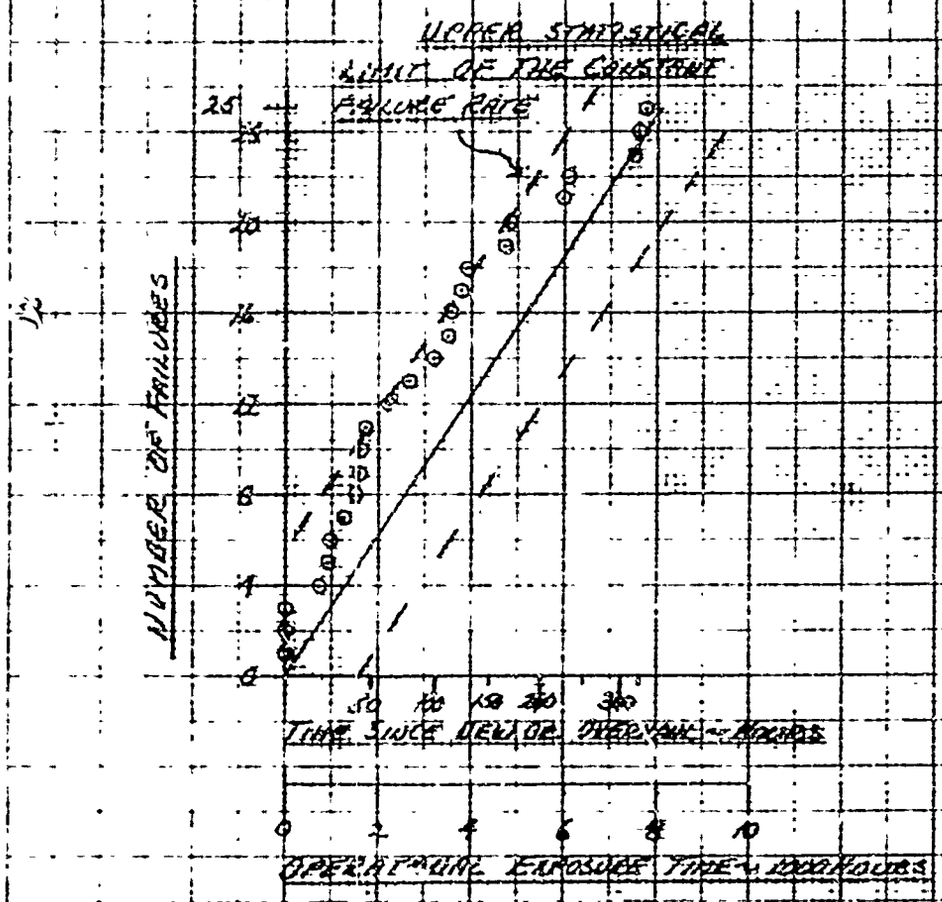
FIGURE 4

- Figure (4) shows the failure trend of a modified version of this gearbox. The failure trend for this unit exceeds the upper statistical limit of the normally-expected variation about the constant rate. This validates the conclusion that for this gearbox the rate is not constant but is governed by an unusually high early failure rate occurring in the initial hours after installation on the aircraft. Improper preloading of a bearing and failure of a snap-ring were found to be the causes of this

failure rate. Time histories of these two failures are shown in the upper two diagrams of Figure (4a). The first curve illustrates that the preload problem was essentially a zero-time failure. The second shows that the snap-ring malfunction was an "infant mortality" (usually occurring within the first sixty hours of gearbox operation).

The lower diagram shows that the remaining failures of the gearbox exhibit a constant failure rate pattern. (MTBF = 321 hours)

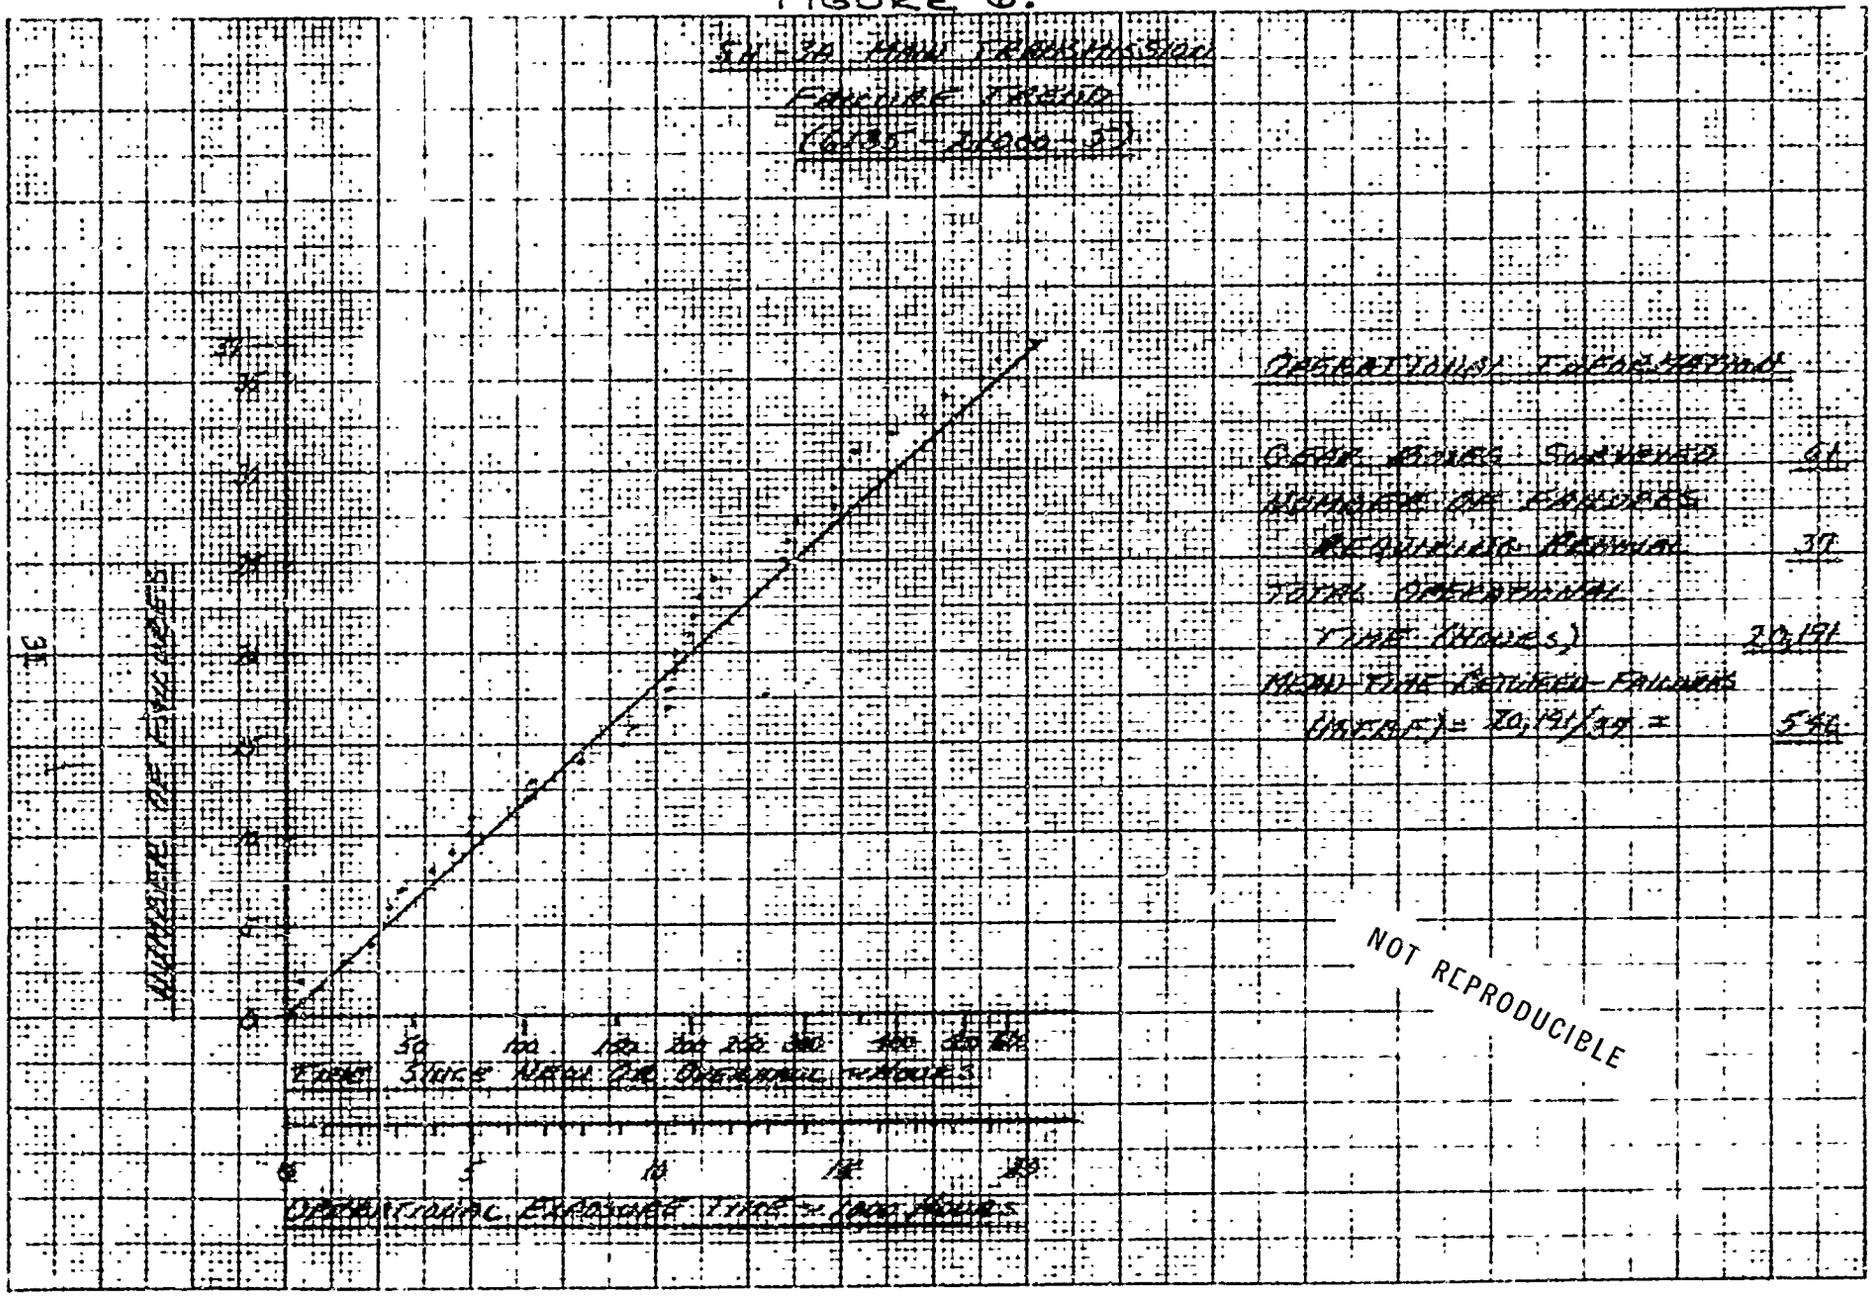
FIGURE 6.

- Figure (6) covers data on the S6135-21000-5 gearbox which was the next production version of the H-3 gearbox. This unit incorporated further design improvements lowering the failure rate (still constant).
  (MTBF = 546 hours)

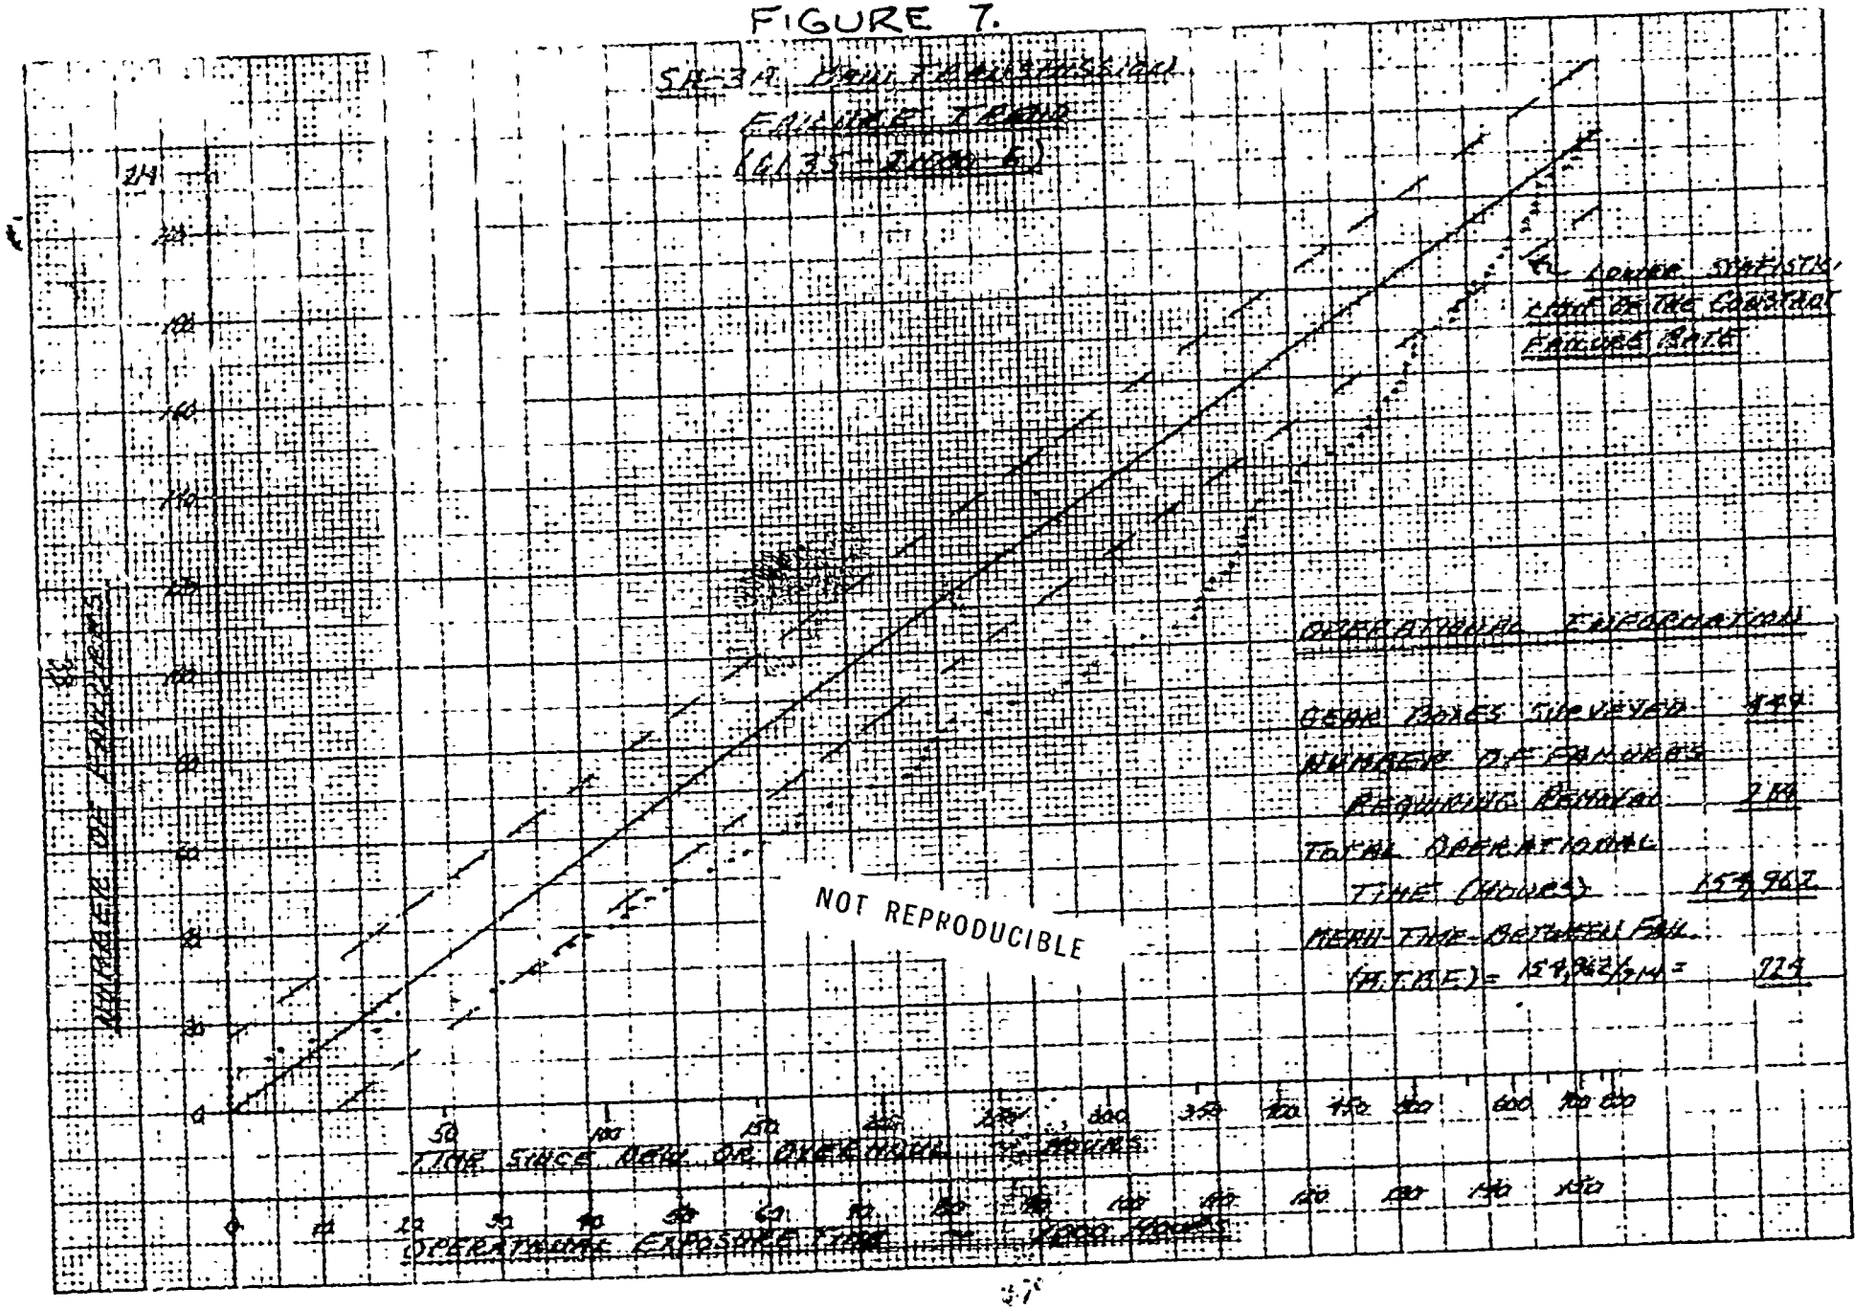
FIGURE 7.

- Figure (7) shows failure trend data on a gearbox with a higher service interval and reflects a substantial amount of high time gearbox operation. This curve shows a "wear-out" pattern* or trend associated with an increasing failure rate of the driven bevel gear. The degree to which the driven bevel failure dominates the MTBF of this gearbox is shown in Figure (7a).

There were essentially no driven bevel gear failures in the first 125 hours of operation since new or overhaul, some failures before 400 hours and a rash of failures after 400 hours. Other less significant modes of failure also influenced this "wear-out" pattern. Figure (7b) shows the slight but noticeable influence of failures of the planetary pinion. (MTBF = 724 hours)

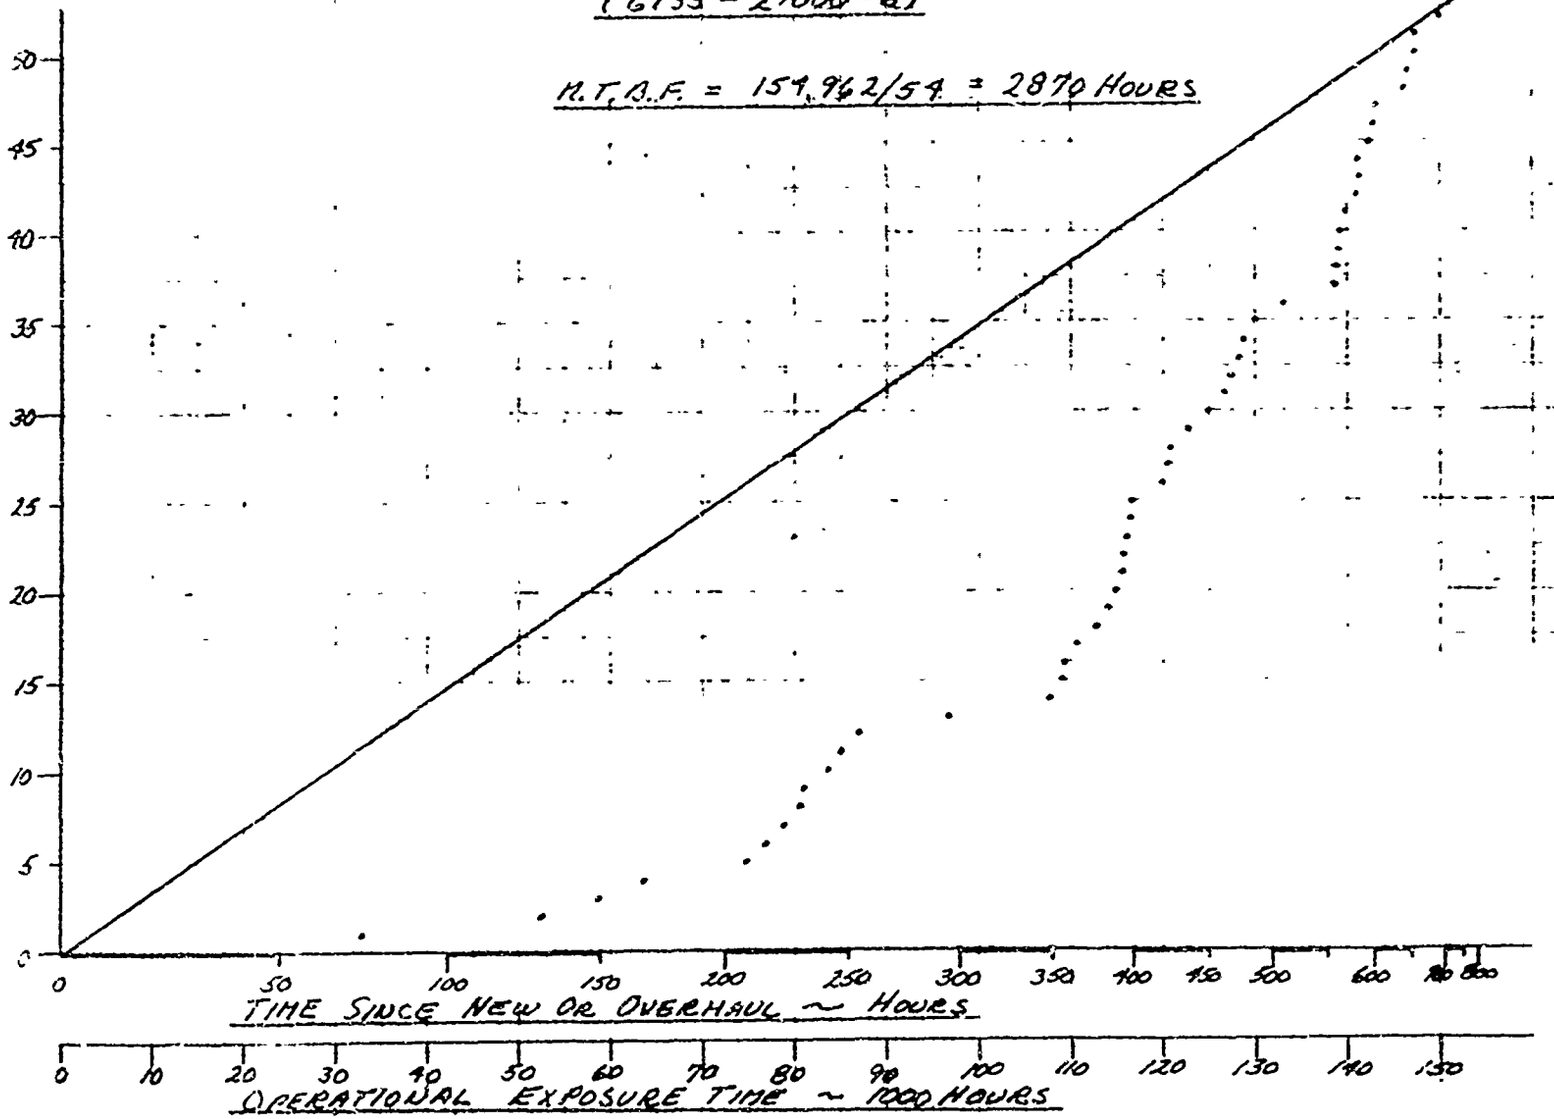
FIGURE 7a

FAILURE TREND OF THE DRIVEN BEVEL GEAR

M.T.B.F. = 154,962/54 = 2870 HOURS

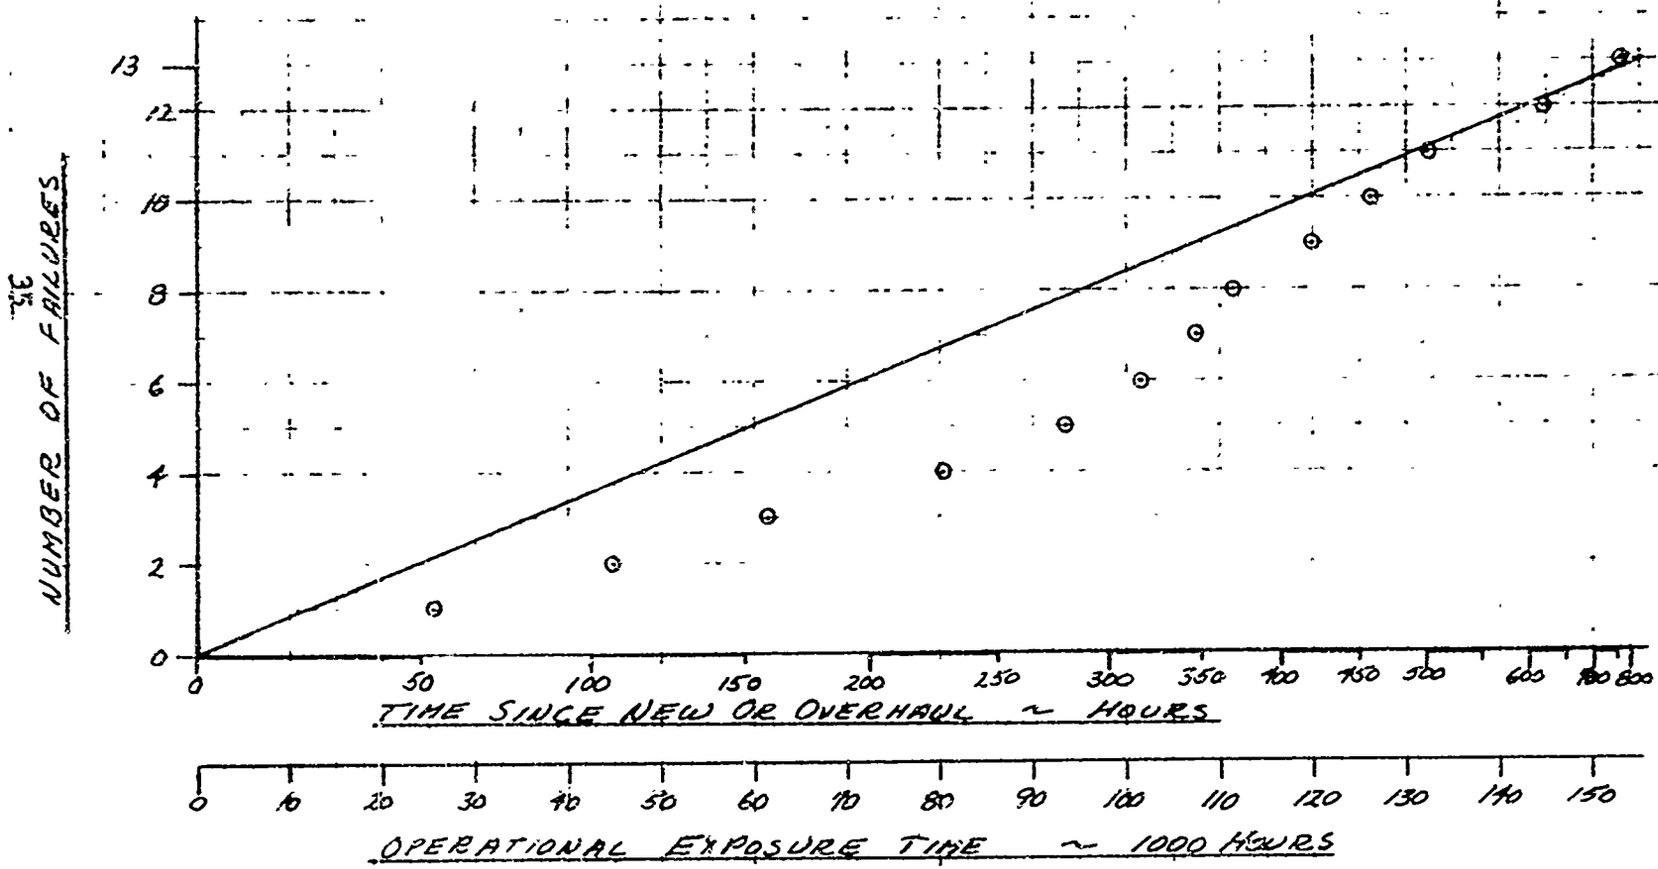
FIGURE 7(b)

FAILURE TREND OF THE PLANETARY GEAR

M.T.B.F. = 154,962/13 = 11,920 HOURS

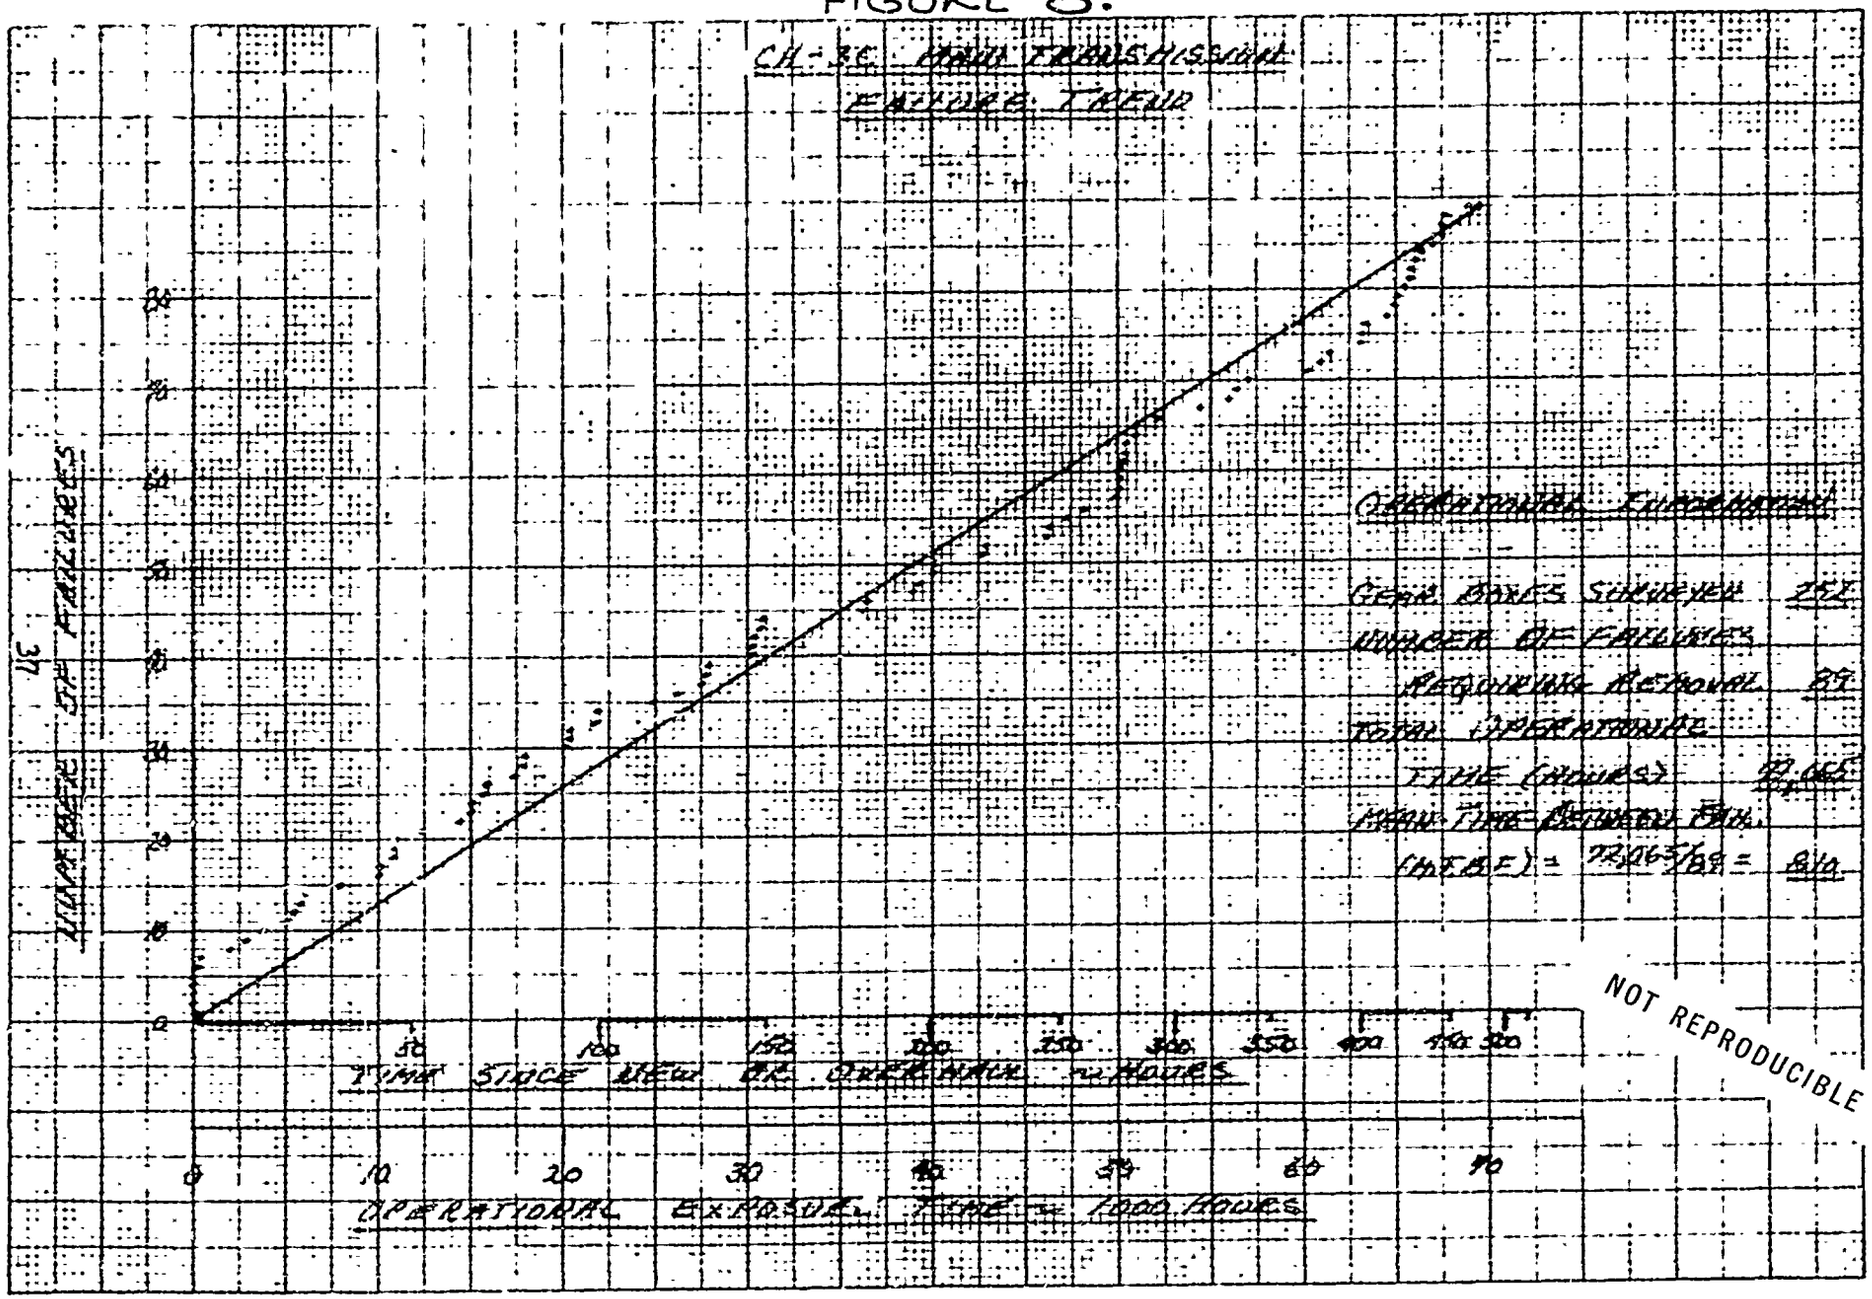
FIGURE 8.

- Figure (8) shows the failure rate (constant) for the U.S. Air Force CH-3C main gearbox.
  (MTBF = 810 hours)
- Figure (9) is the failure trend of the CH-53A main gearbox. While some failures of the first stage planetary pinions have occurred recently, there have not been a sufficient number to indicate a trend for this component.
  (MTBF = 949 hours)

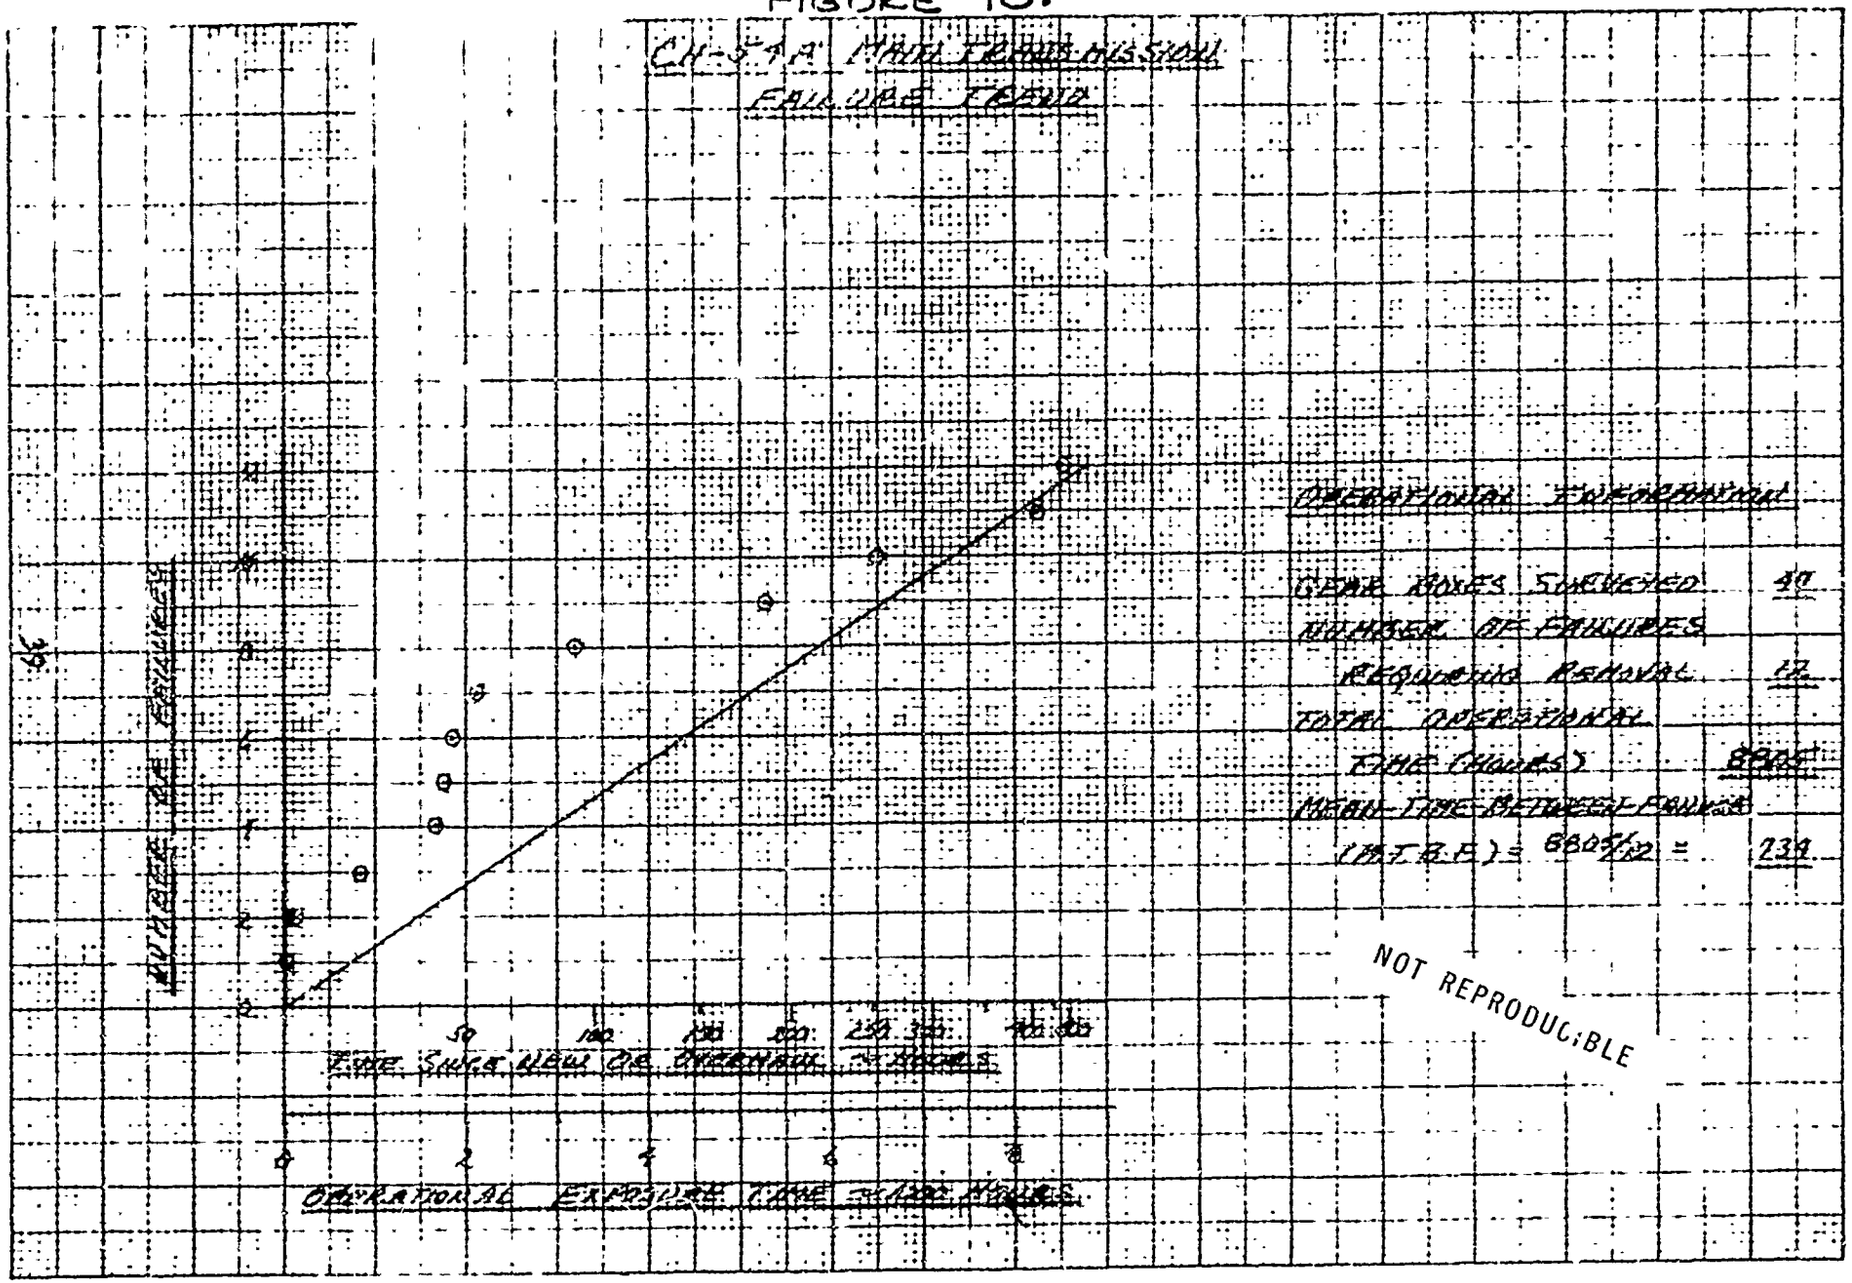
FIGURE 10.

- Figure (10) shows the failure rate of the main gearbox of the U.S. Army CH-54A. Most of the early removals were due to overtemperature problems and lubrication pump seizures. Improved gear shielding and the use of a higher viscosity oil (SATO 35) eliminated these problems.
  (MTBF = 734 hours)
