USAAVSCOM TECHNICAL REPORT

STUDY OF HELICOPTER TRANSMISSION SYSTEM DEVELOPMENT TESTING

SIKORSKY ENGINEERING REPORT SER-50547

JUNE 1968

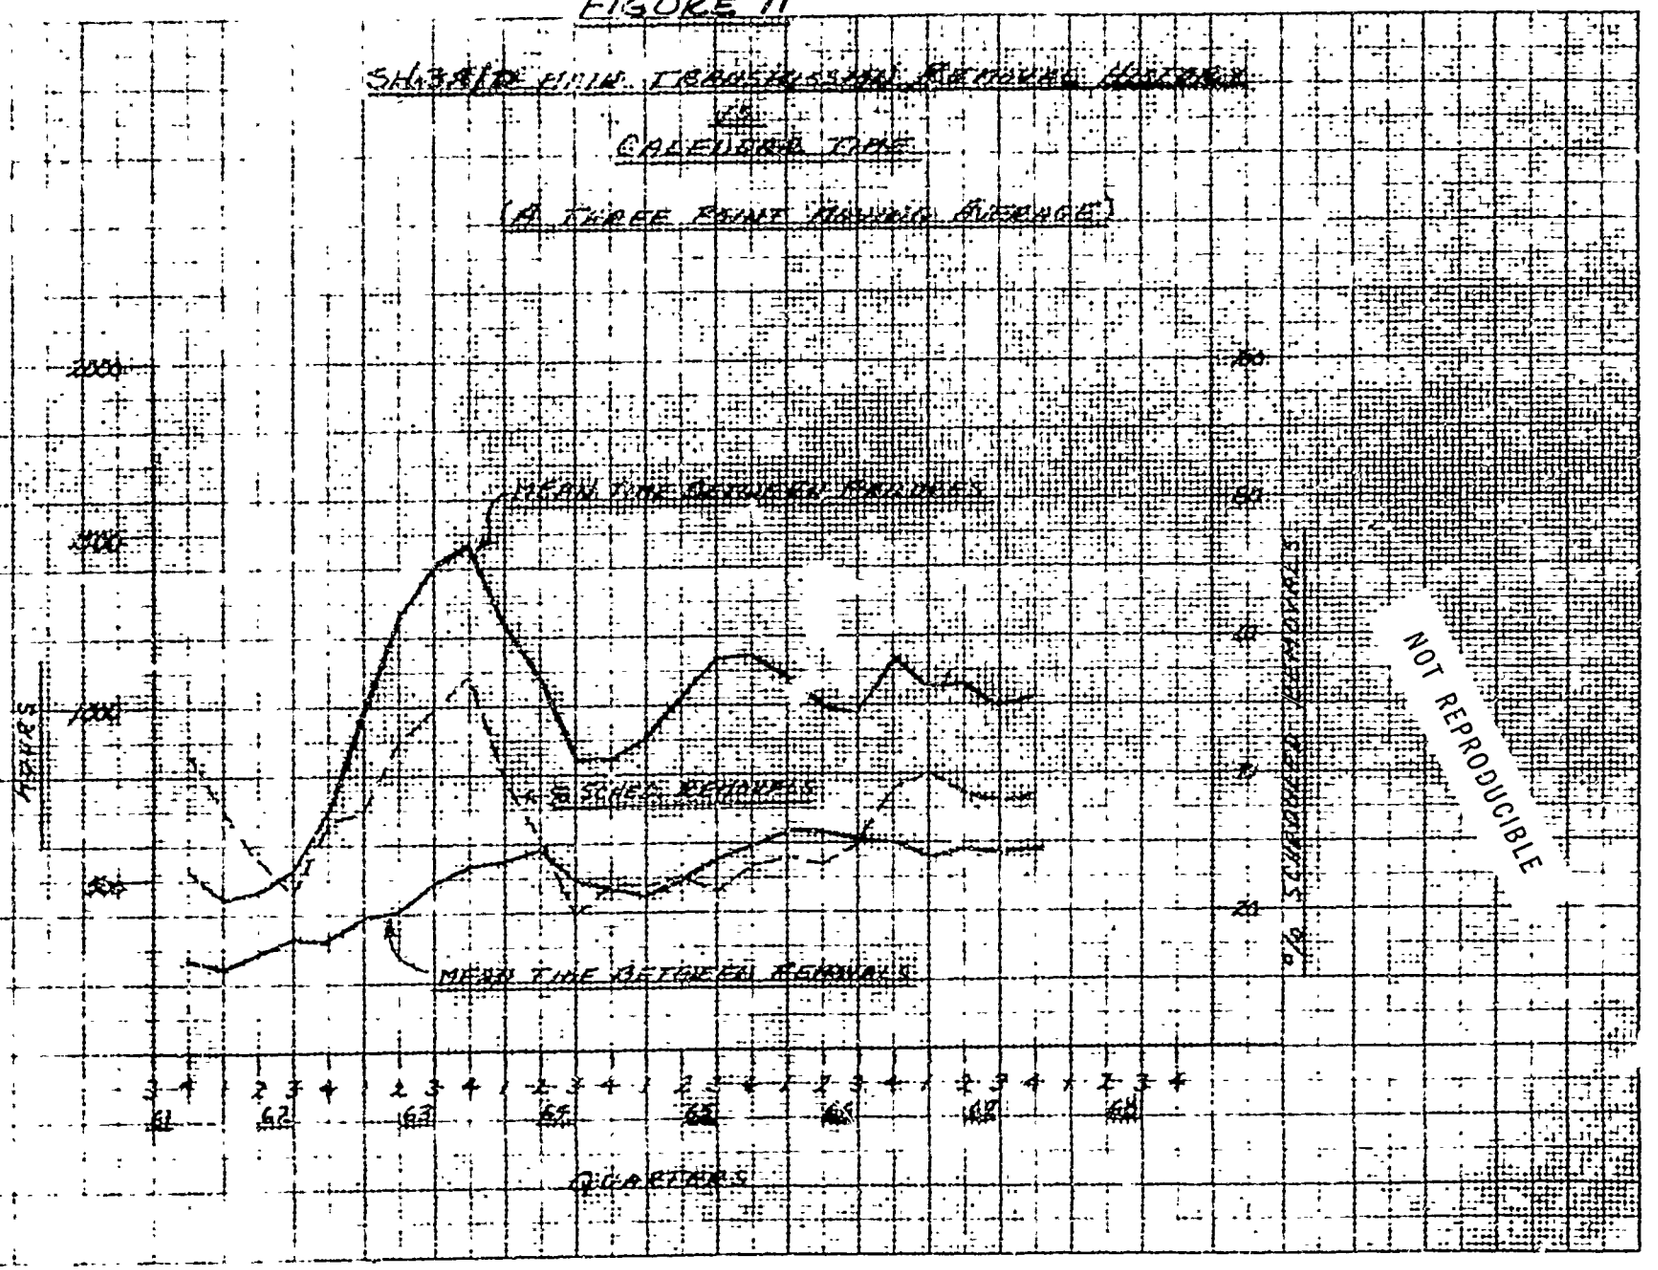
FIGURE 11

- Figure (11) shows the failure and removal history of the SH-3A and SH-3D main transmissions obtained from data gathered, averaged and plotted quarterly. The MTBF improvement noted at the end of 1963 was the result of successive gearbox refinements. The MTBF degradation

during 1964 was due to failures of the planetary pinion gear teeth caused primarily by the introduction of an engine with increased power capability. With the incorporation of further refinements and the incorporation of the "beefed-up" SH-3D transmission (larger bevel gears and planetary), the MTBF has improved and remained relatively stable.

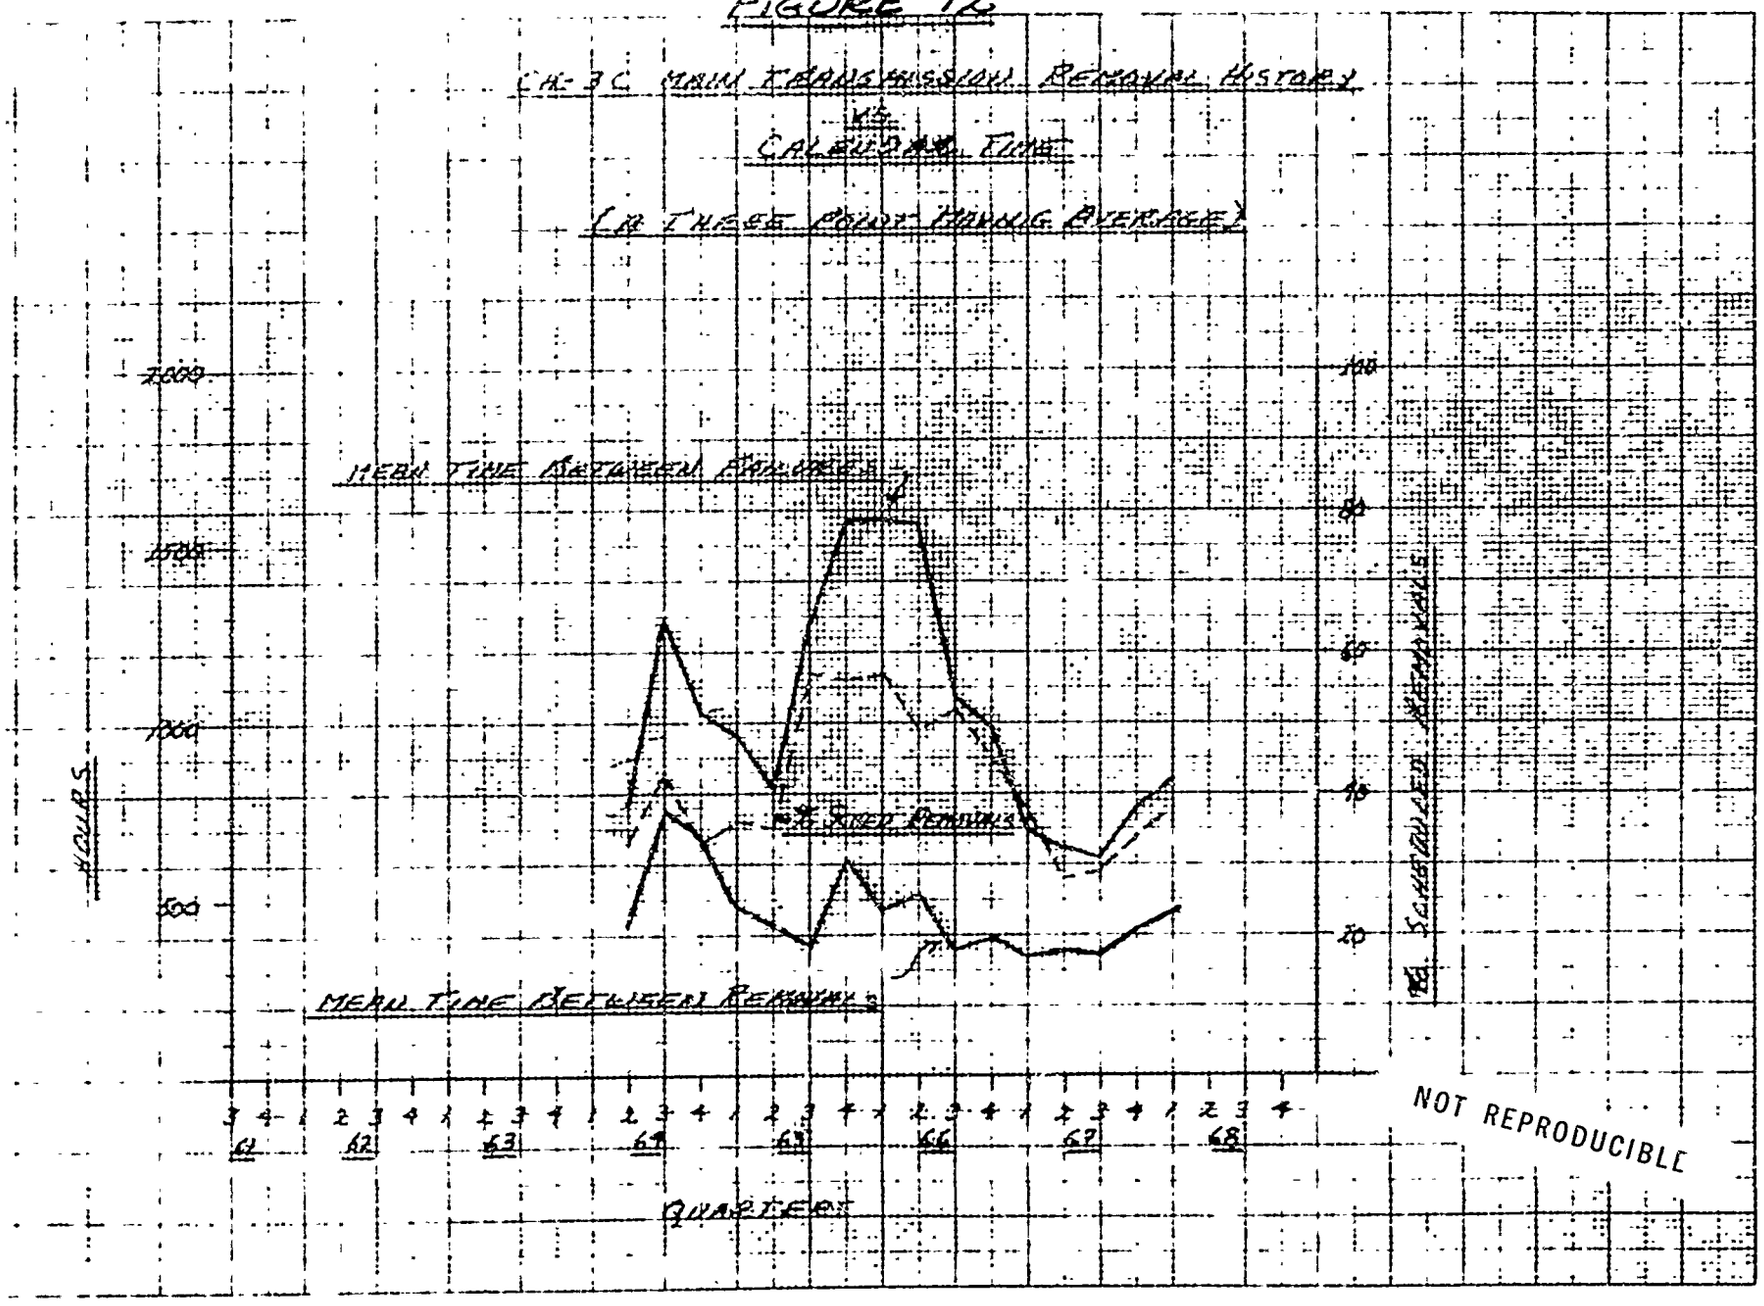
FIGURE 12

- Figure (12) shows the chronological history of the CH-3C main gearbox MTBFs. The large degradation of the MTBF in 1966 and 1967 was due primarily to stripped threads in gearbox housings at lubrication fittings. The incorporation of steel inserts at all fitting locations (late 1967 - early 1968) has improved this situation. Several of the removals of this unit were based on exceeding arbitrarily established SOAP (Spectrographic Oil Analysis Program) levels. In nearly every case, no discrepancy was found in the gearbox on disassembly. A further discussion of Spectrographic Analysis is included in a later section.

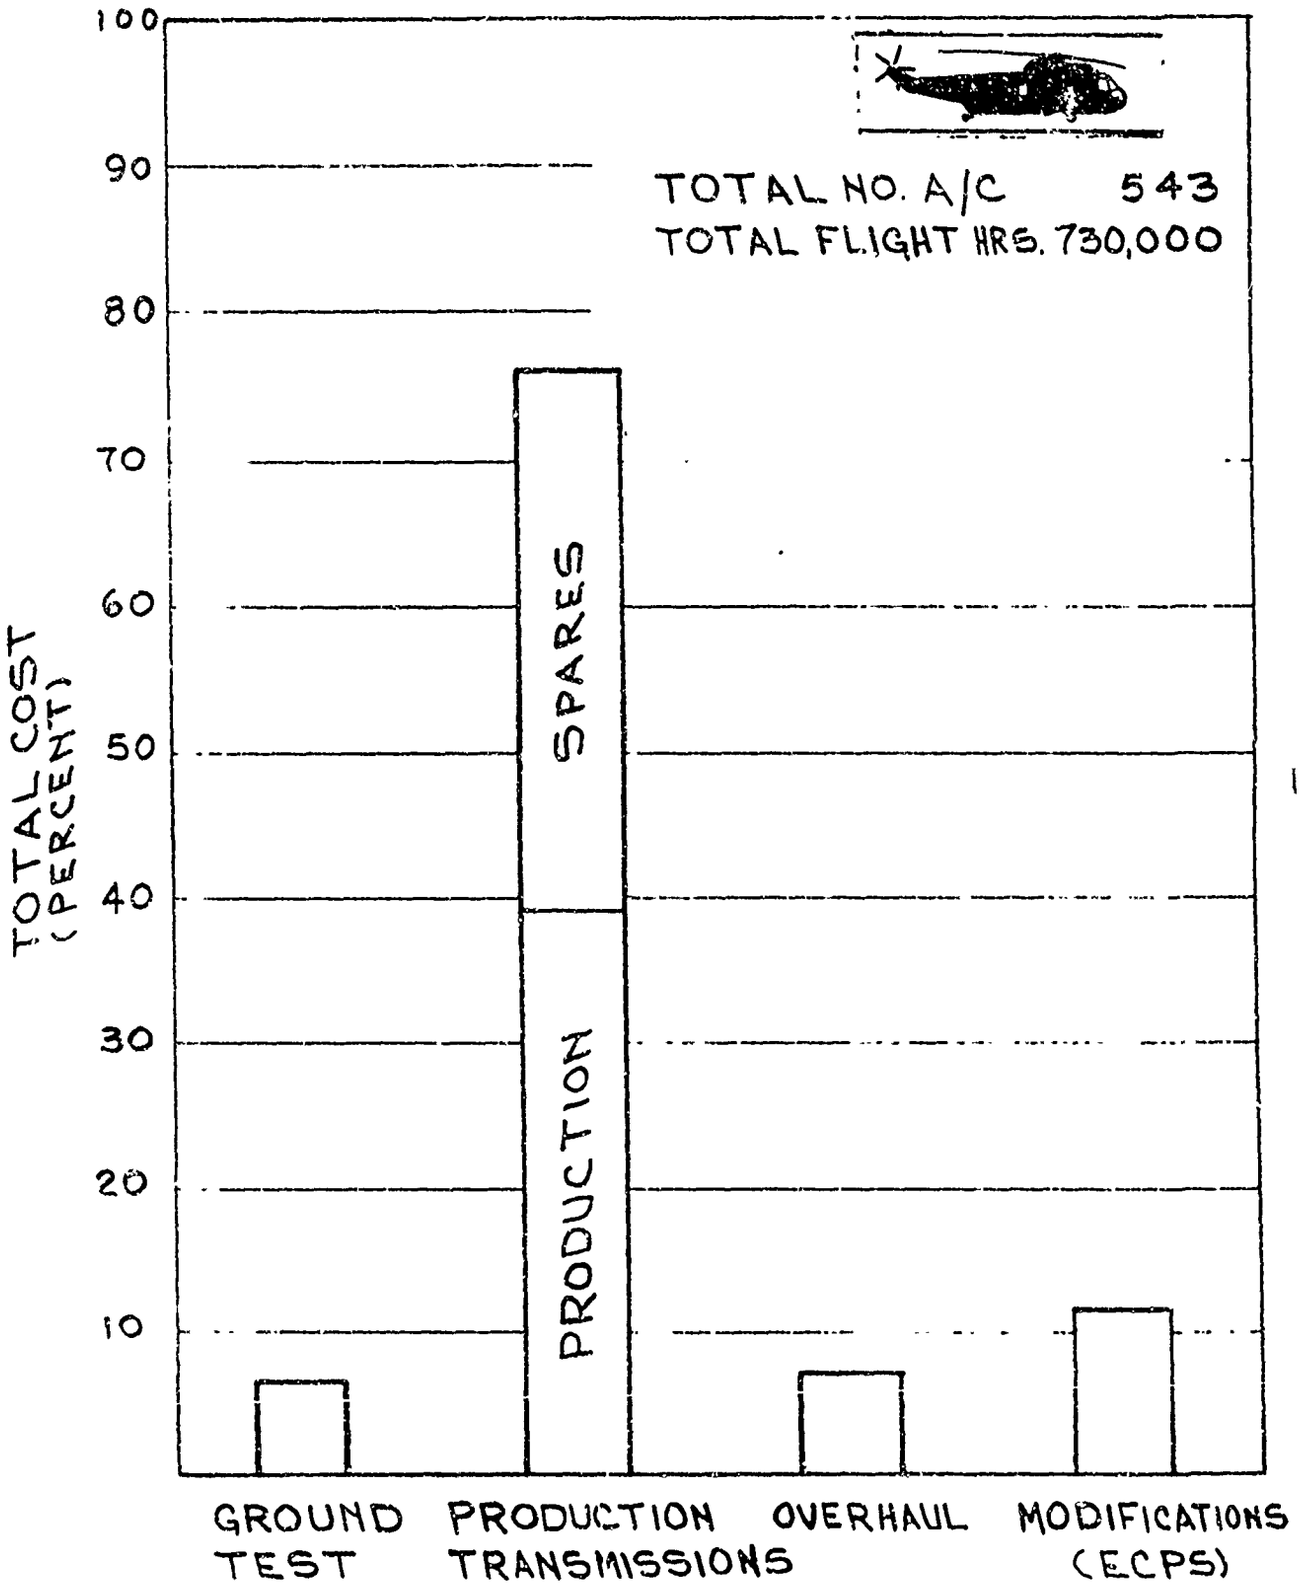
FIGURE 13.
H-3 TRANSMISSION COST

The cost data does not include the initial engineering design effort nor the cost of production tooling.
