USAARL Report No. 88-11

**A Comparison of Two Whole-Body Vibration Standards
as Applied to Rotary-Wing Aircraft:
ISO 2631 vs ADS 27**

July 1988

**United States Army Aeromedical Research Laboratory
Fort Rucker, Alabama 36362-5292**

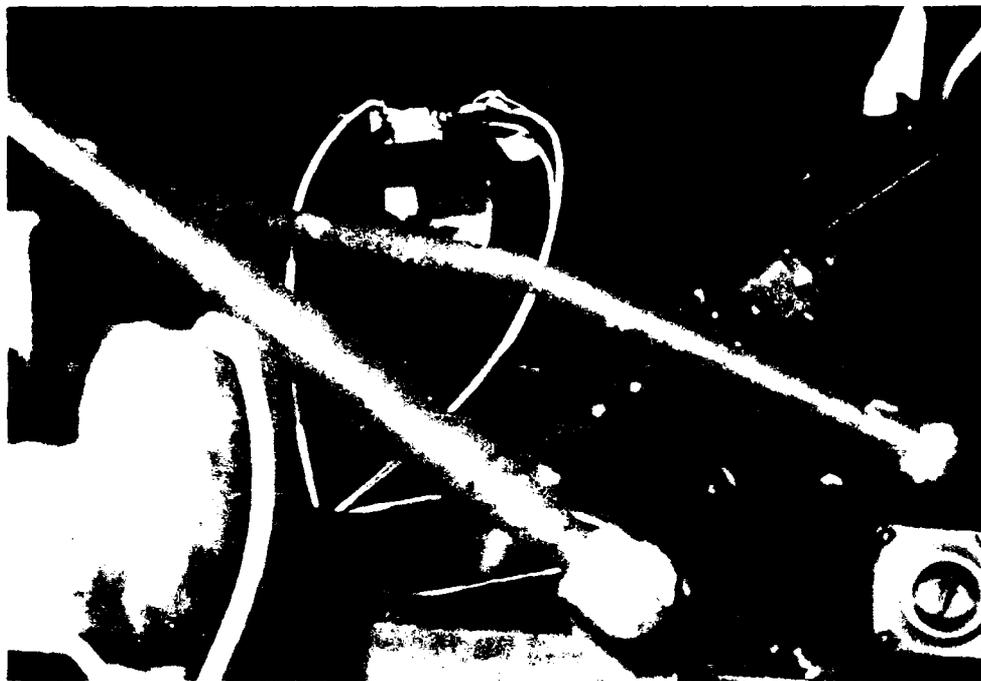
Figure 2. Triaxial accelerometers positioned to transmit vibration signals from seat pan location.

WBV signatures were collected from two different Army helicopter types: the UH-60, a twin-engined four-bladed system, and the UH-1, a single engine, two-bladed system. Triaxial accelerometers were positioned to transmit vibration signals from the following six locations: directly on top of the pilot and copilot seats (referred to as the "seat pad" locations) (Figure 1), hard-mounted to the underside of the pilot and copilot seats (referred to as the "seat pan" locations) (Figure 2), and hard-mounted to the helicopter frame directly beneath the pilot and copilot seats (referred to as the "floor" location) (Figure 3). The seat pad triaxial accelerometers (B & K model 4322*) were mounted in flat, flexible rubber disks approximately 12 inches in diameter, taped to that portion of the seat cushion in direct contact with the pilot or copilot and, therefore, measured vibration transferred directly from the helicopter seating system to the pilot or copilot. The seat pad location was specified by ISO 2631. The seat pan triaxial accelerometers (B & K model 4321*) measured the input vibration to the pilot or copilot seat cushion. Seat pan transducer locations were specified by ADS-27. Hard-mounted floor accelerometers (B & K model 4321) were used to pick up the helicopter frame vibration, or that vibration considered to be the input to the pilot and copilot seating systems.

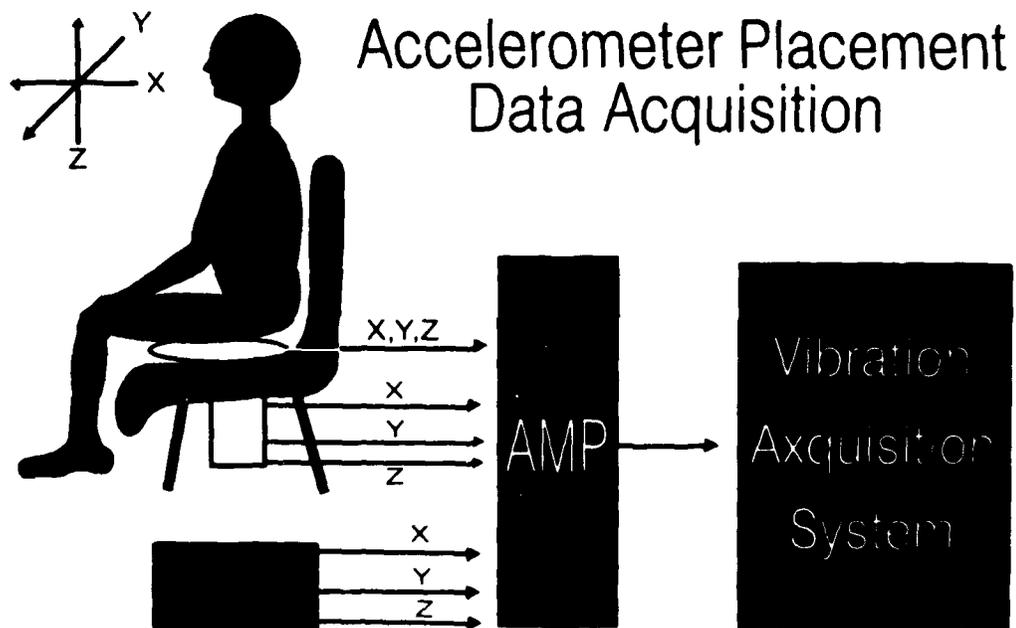
Figure 4. Vibration data acquisition diagram.

Helicopter vibration signals in the X-, Y-, and Z-axis of motion are transmitted from the piezoelectric triaxial accelerometers*, amplified by Kistler model 5041BM01 charge amplifiers* and recorded on TEAC HR-30 portable analogue cassette recorders*. The TEAC HR-30 is a 7-channel record-only device with a frequency response range from 0.5 to 1250 Hz, limited by a tape recording speed of 4.8 cm/s. These recorders generate a frequency which compensates for noise in recorded signals. To allow for a proper signal-to-noise ratio, the portable recorders were set to an input range of ± 1 volt. One of the recorder channels was used as a voice monitor for documentation. High quality analogue 7-channel cassettes were used for the vibration data acquisition phase (Figures 4 and 5).

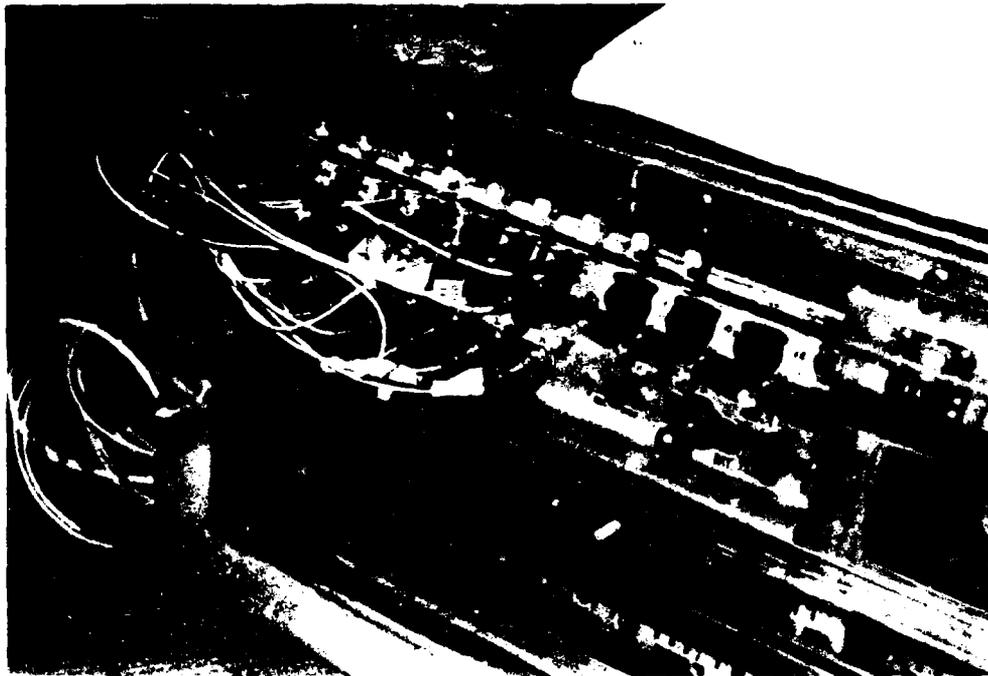
Figure 5. Data acquisition system.

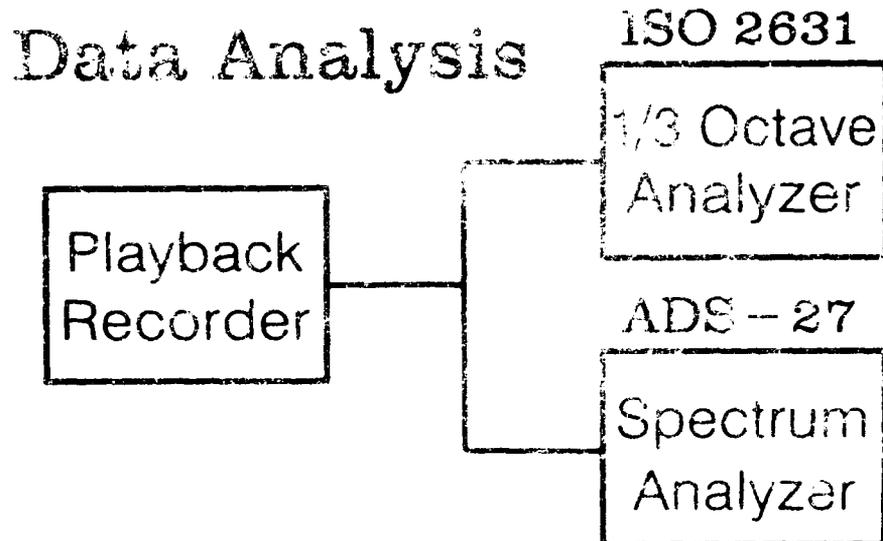
Figure 6. Data analysis diagram.

The same recorded WBV signals were played back on a TEAC model MR-30 14-channel recorder/player* into two different signal analyzers. A Larson Davis RTA 1/3 octave analyzer* was used for the ISO 2631 method of vibration analysis, and a Dynamic signal analyzer* was used for the ADS-27 standard method for the analysis of vibration (Figure 6).

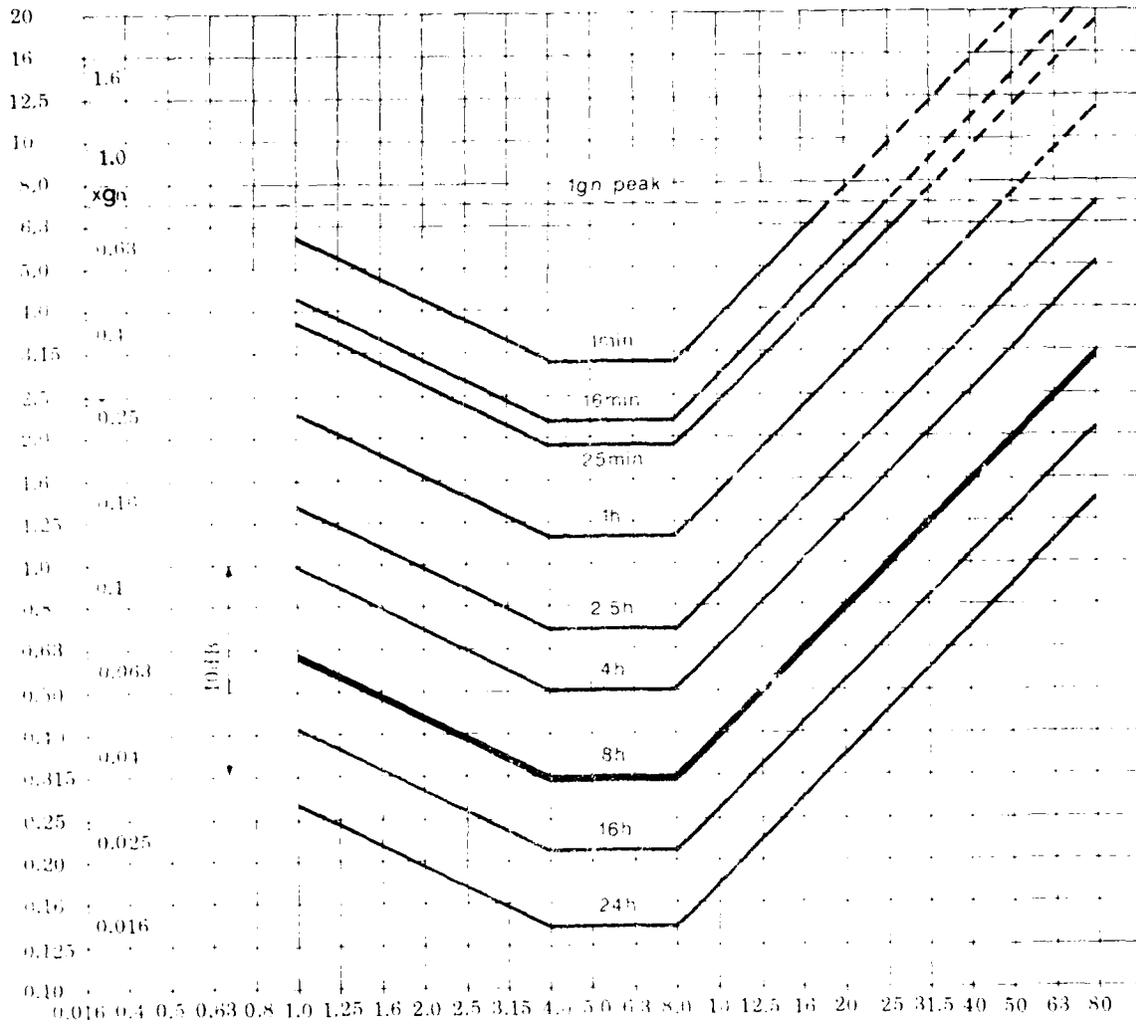
Figure 7. ISO 2631 8-hour FDP curve limit, vertical axis.

WBV translated directly to the pilot, copilot, and crewmembers was measured in terms of root mean square acceleration magnitudes contained in third-octave bands covering a frequency range from 1 to 80 Hz. The Larson Davis 3100 third-octave analyzer* measured the recorded vibration signals and derived magnitudes for all 20 third-octave bands, all flight conditions, and all 3 orthogonal axes of motion. The 8-hour fatigue decreased proficiency (FDP) curve was used as a limit "not to exceed" for the comparison of the two standards. This 8-hour FDP curve is used to determine acceptable vibration levels during the GHA of Army tactical ground vehicles and rotary-wing aircraft. Third-octave levels then were compared to their corresponding ISO 2631 8-hour FDP curve acceleration limits. Conditioned WBV signatures either fell above or below the 8-hour curve FDP limit yielding a respective "unacceptable" or "acceptable" vibration level for that particular flight condition and accelerometer location. All 20 third-octave measurements for all three axes of motion were required to fall under the ISO 2631 8-hour FDP curve limit for that flight condition and accelerometer location to yield an "acceptable" level of WBV.

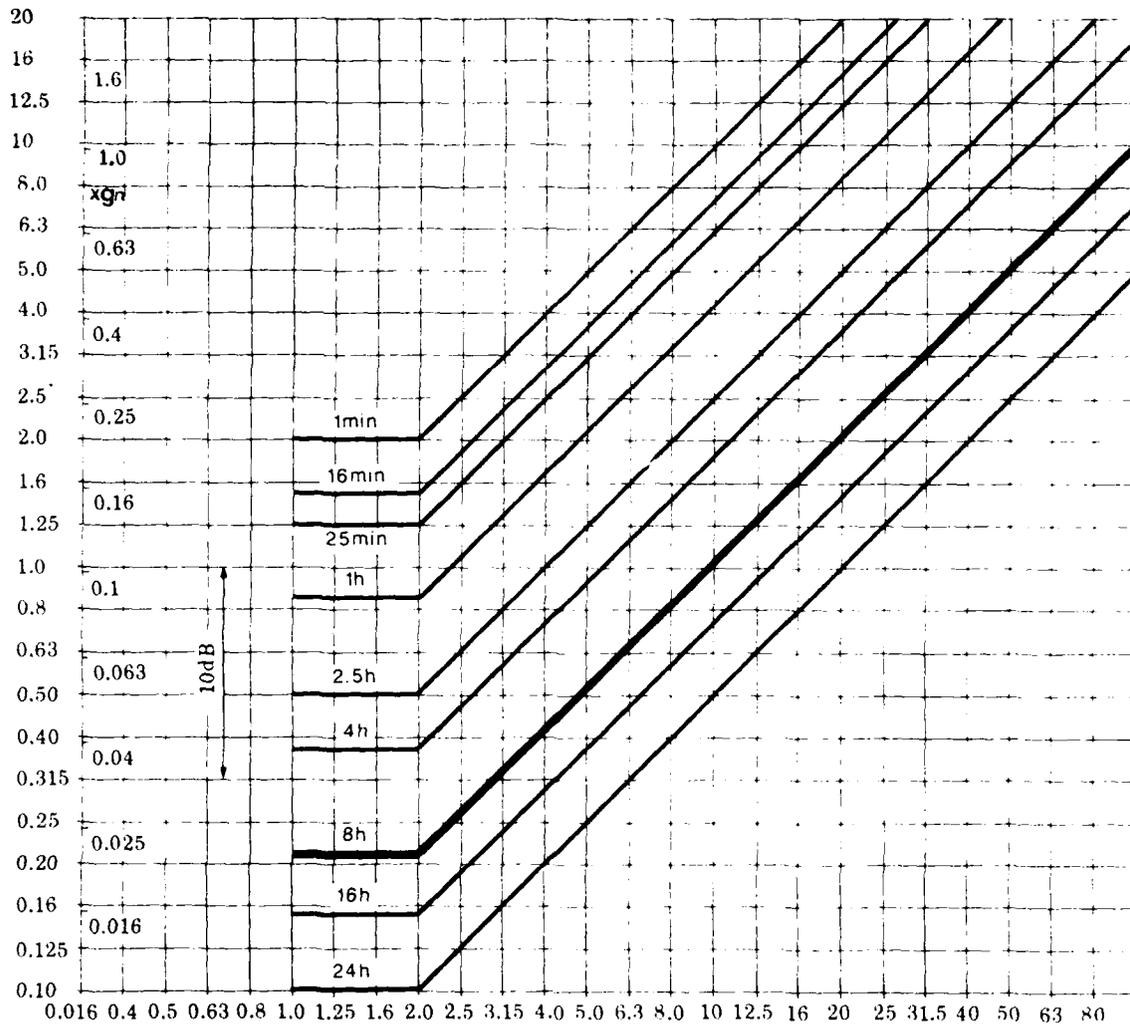
Figure 8. ISO 2631 8-hour FDP curve limit, longitudinal and lateral axes.

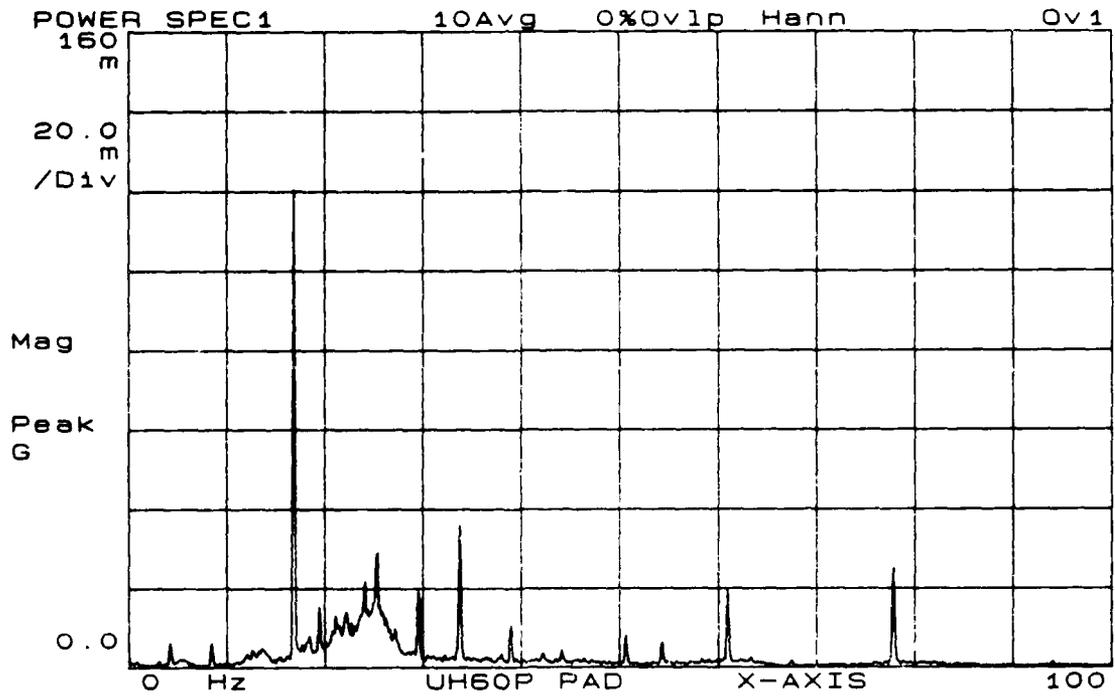
Figure 9a. UH-60 seat pad power spectrum, X-axis.

The Hewlett-Packard (HP) 3562 dynamic signal analyzer* is used to obtain a fast fourier transform power spectrum display of WBV signatures for each of the three orthogonal axes of motion, accelerometer position, and flight condition (Figures 9 and 10). A power spectrum displays the discrete sinusoid vibration peaks produced by all types of rotary-wing aircraft. These discrete frequency peaks, lying within the ADS-27 targeted frequency range (0 to 60 Hz), were used to derive a statistical matrix of the WBV produced by each flight condition.

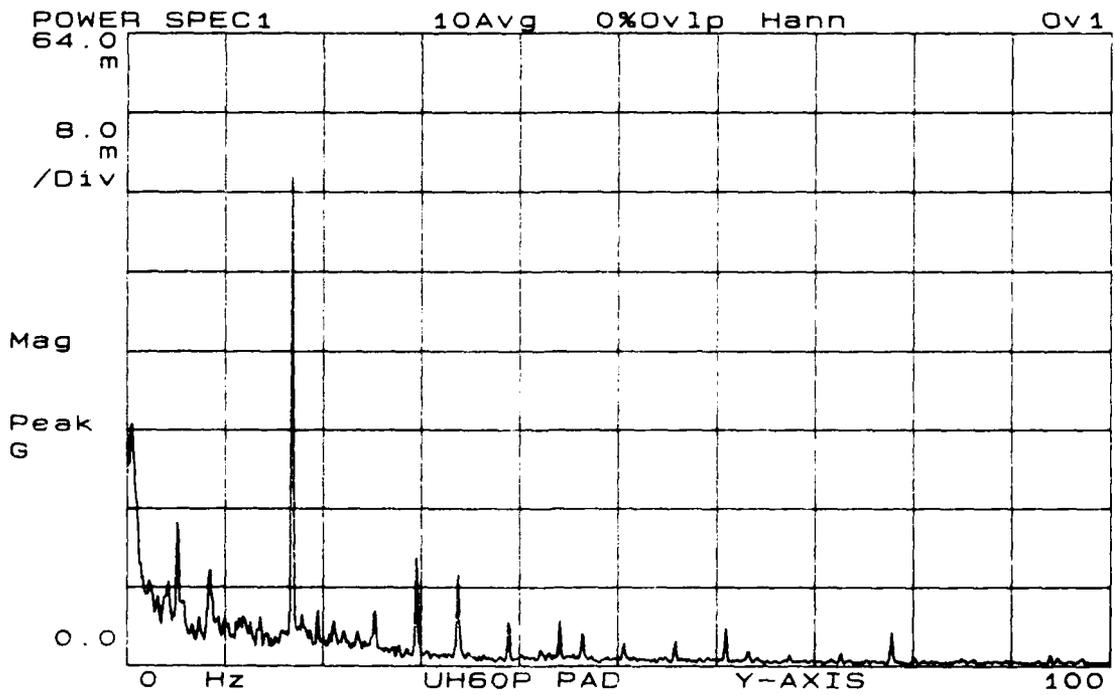
Figure 9b. UH-60 seat pad power spectrum, Y-axis.

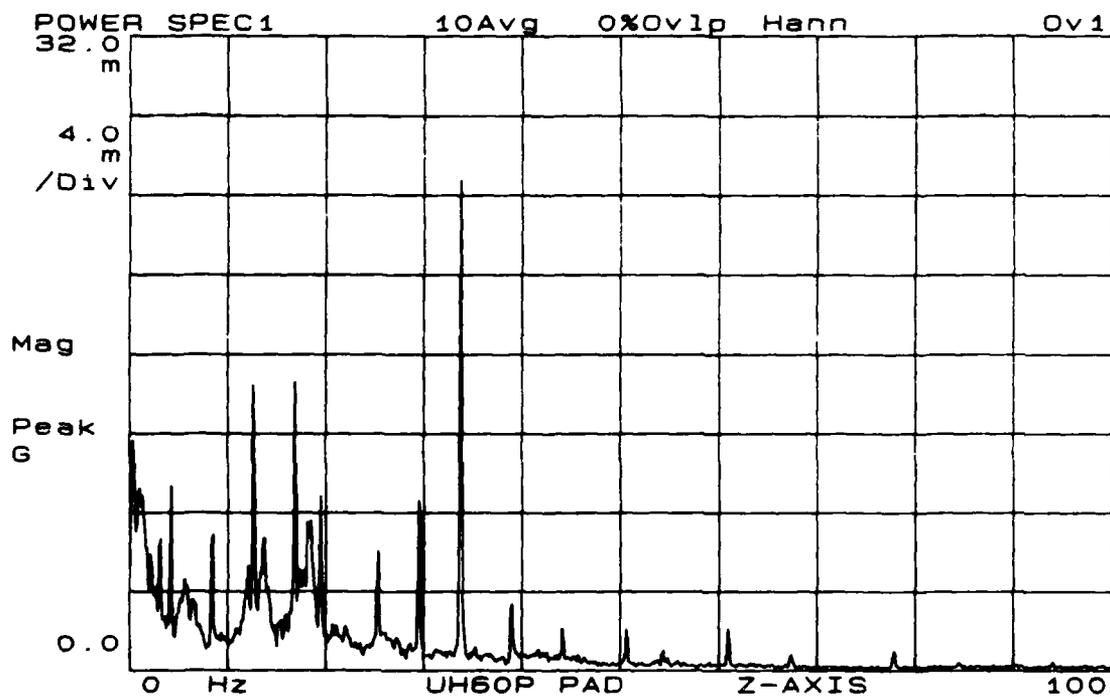
Figure 9c. UH-60 seat pad power spectrum, Z-axis.

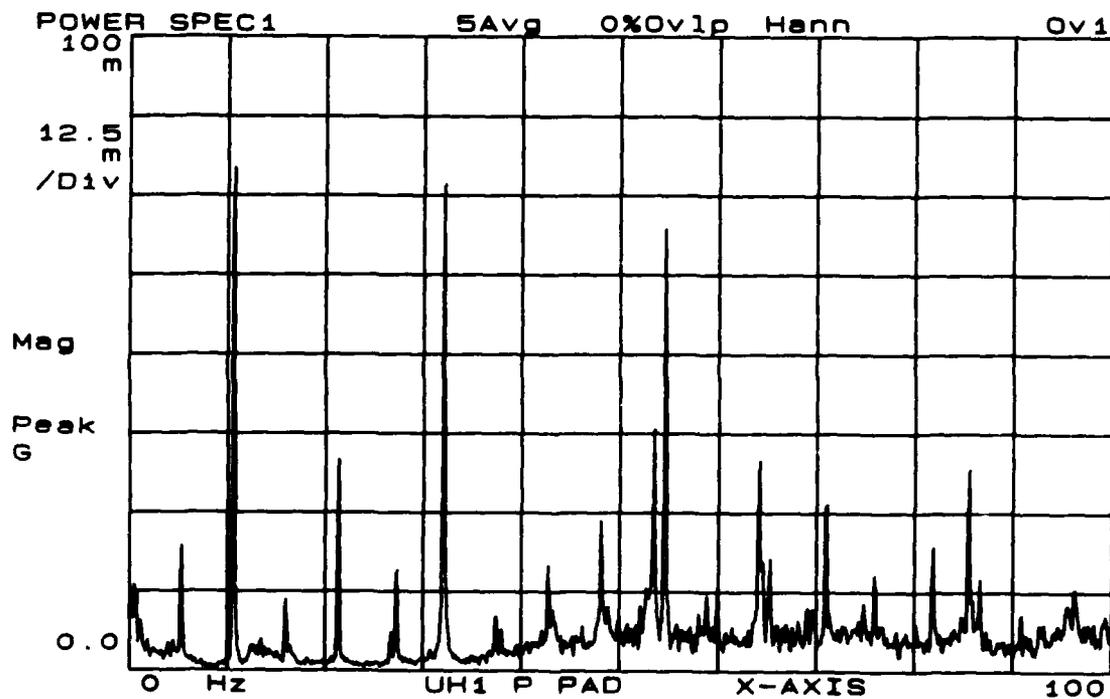
Figure 10a. UH-1 seat pad power spectrum, X-axis.

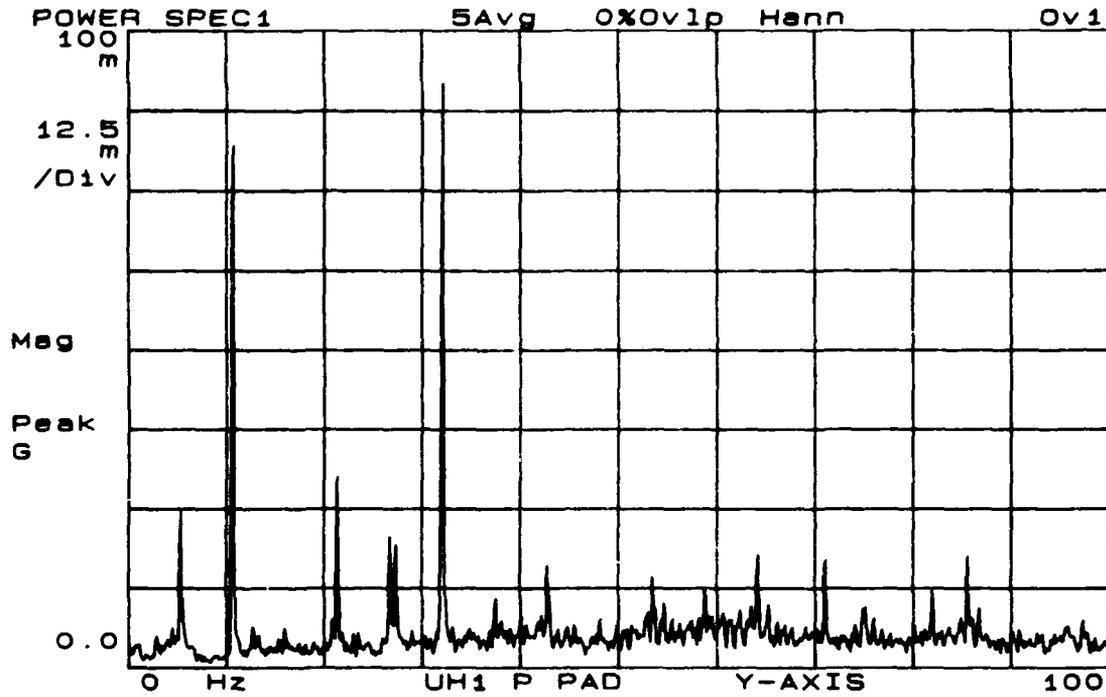
Figure 10b. UH-1 seat pad power spectrum, Y-axis.

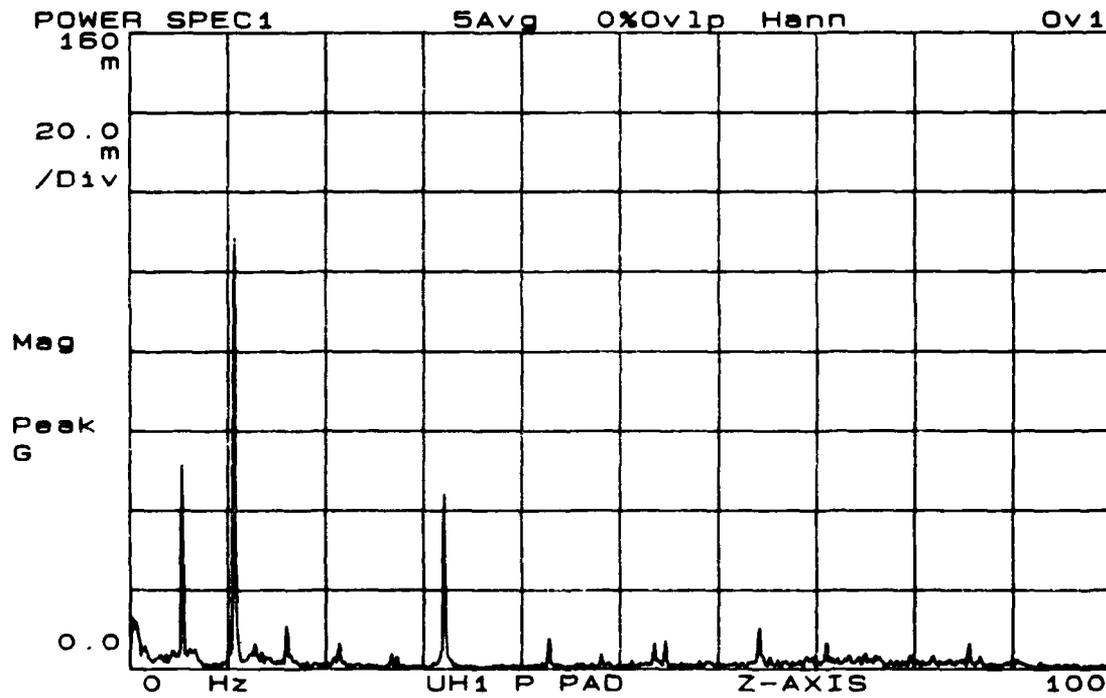
Figure 10c. UH-1 seat pad power spectrum, Z-axis.

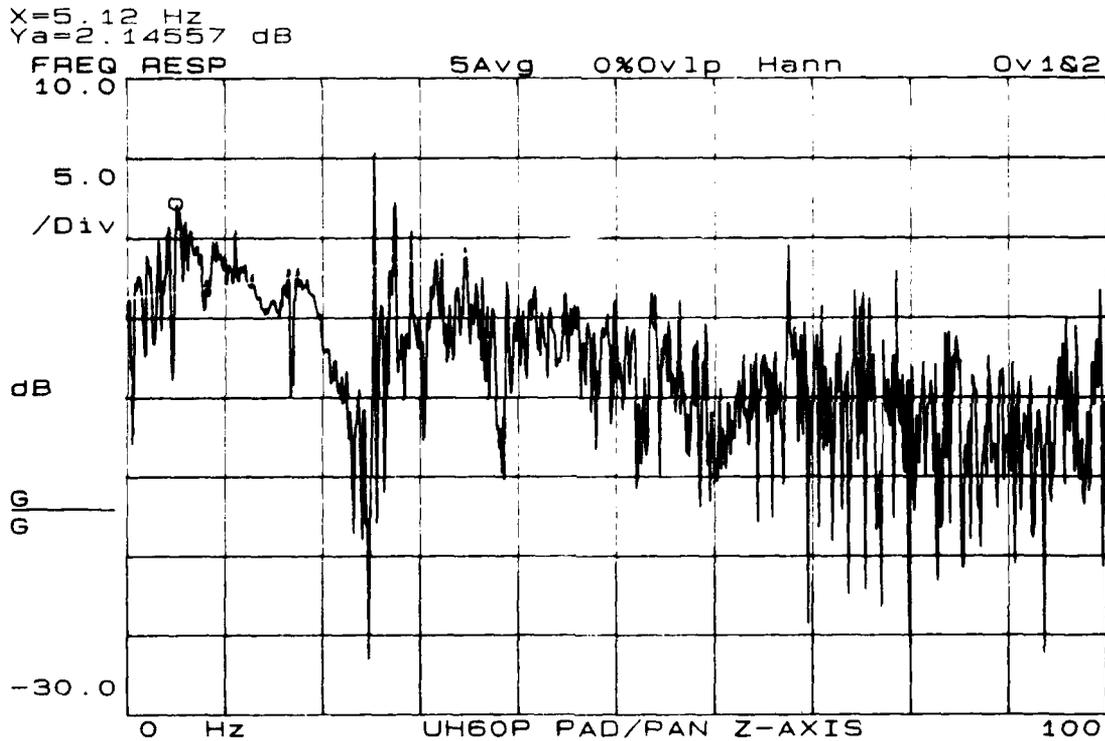
Figure 13. Frequency response graph, UH-60, between pad and pan locations, Z-axis.

To determine the vibration differences between the seat cushion and the seat frame, TEAC MR-30 14-channel recorder/player* and HP 3562A dynamic signal analyzer* were used to obtain a frequency response between seat pan and seat pad accelerometer locations. Frequency responses were used to yield gain and phase differences between input and an output vibrating elements. The input element was the seat pan and the output element was the seat pad. The HP 3562A is configured with channel 1 as the input and channel 2 as the output. Z-axis frequency responses (Figures 13 and 14) were measured during each flight condition for both UH-1 and UH-60 and plotted on a dB versus frequency graph at a frequency range of 1-100 Hz (Figures 9 and 10).

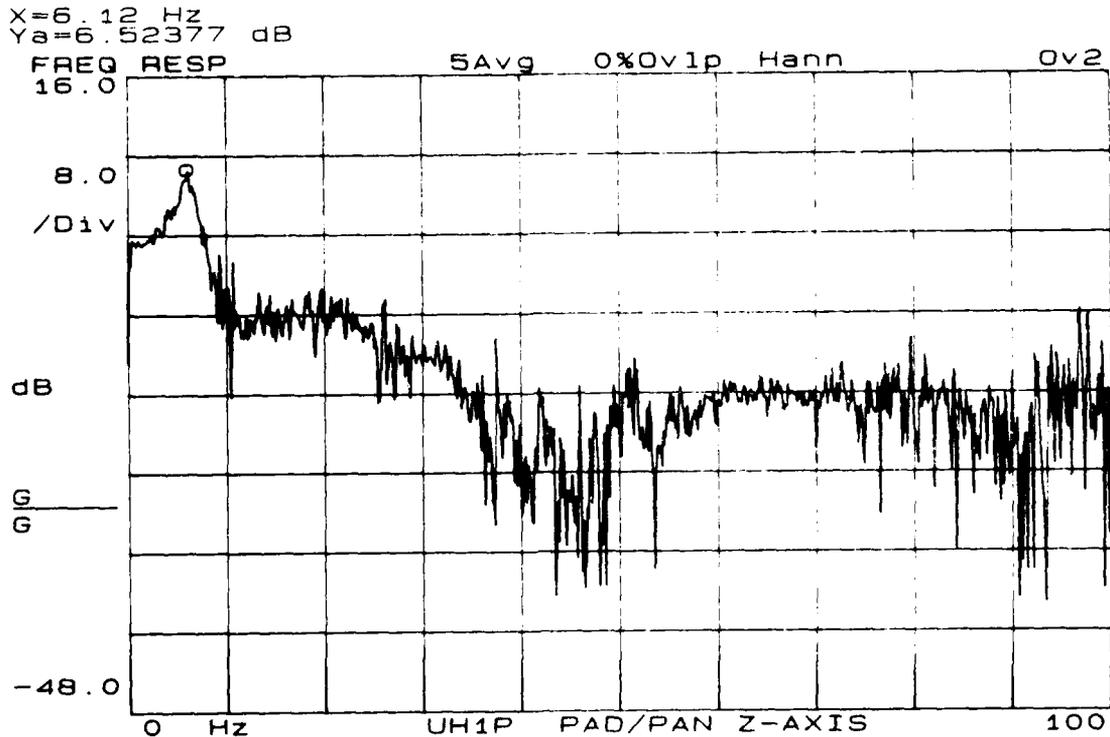
Figure 14. Frequency response graph, UH-1, between pad and pan locations, Z-axis.
